Green Glade Sr. Public School Rain Garden Retrofit

Location: Mississauga
Constructed: 2011

Project Objectives, Design & Performance

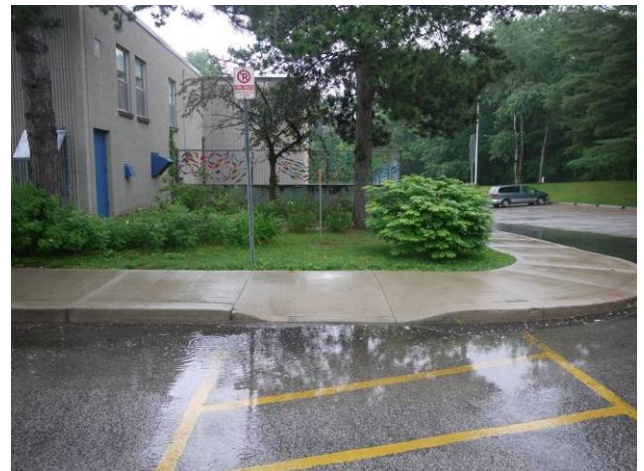
Prior to implementation of the rain garden, issues with ponding were taking place in the school's parking lot. Ponding was centralized in a pedestrian walkway area, near the front entrance to the school. An example of this ponding is shown below.

Nuisance ponding in pedestrian walkway

To address the ponding issue along the front walkway the curb and walkway was cut in two locations to provide an inlet and an outlet (outlined in red in the figure below). The design of the inlet cannot address the ponding issue completely. However, when the school's parking lot is resurfaced, the grade of the lot can be modified to direct more of the water into the rain garden inlet to further reduce any ponding. In addition, the rain garden design accounted for the roof top drainage which was directed to a dry river bed which then flowed into the depression (outlined in blue in the figure below).

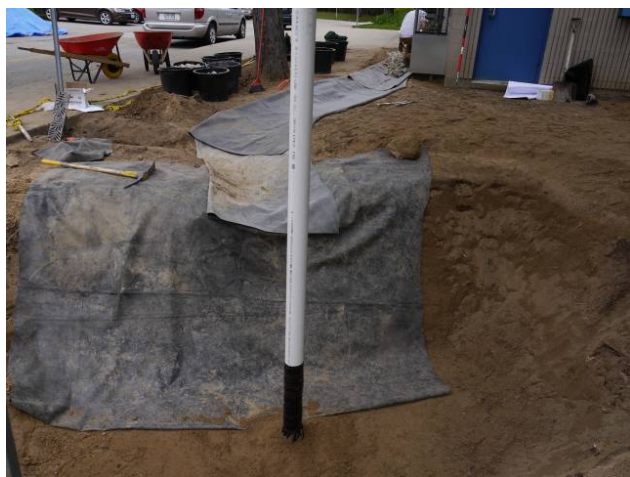
[Foreground]-observation well, [Background]-pond liner covering dry river bed and rear wall of the bioretention area

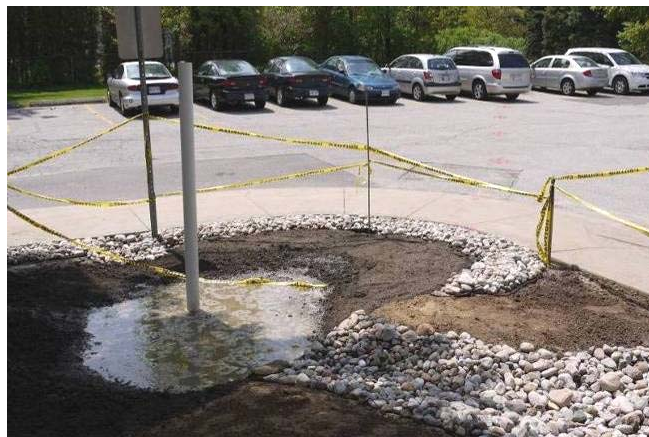
An issue that was identified shortly after construction was that the rain garden was not infiltrating runoff at an appropriate rate, resulting in a drawdown rate far greater than 24 hours. Although the first batch of soils delivered to the site did meet specifications (as determined through soil testing), further batches delivered to the site were not tested. A review of soil

test results from a composite from the as-built garden found that overall the bioretention soil media did not meet specifications, and thus the soil was the source of the problem. An example of the poor drainage conditions in the rain garden are provided in the following image.

Water not properly draining into through the soil media

The soil supplier indicated that the bioretention did not meet specification due to an improper mixing process. The supplier had used topsoil to meet the bioretention mix's organic and fines requirements. However, the composition of the topsoil was highly variable and was added to the mix without being properly measured. Thus, test results showed that the amount of fines in the mix had reached 30 – 40% although specifications

for fines by weight should only be 8 – 12%. The high amount of fines led to the failure of the rain garden to properly infiltrate runoff.

The only means of addressing this issue was through the removal of the improper bioretention soil media and replacing it with the proper mix of sand, fines and organics. The costs associated with this remediation work were incurred by the soil supplier and CVC. Excavation of the faulty bioretention mix required use of a mini-excavator, dump truck to haul the mix away, and a slinger truck to add the new bioretention mix.

To address this issue with the manufacturing process, topsoil was removed as a component material and only sand and organic mulch were used to create the mix. However, before the mix was installed, the manufacturer needed to ensure that the bioretention mix met specification. Three soil samples were provided for testing and verification prior to installation.

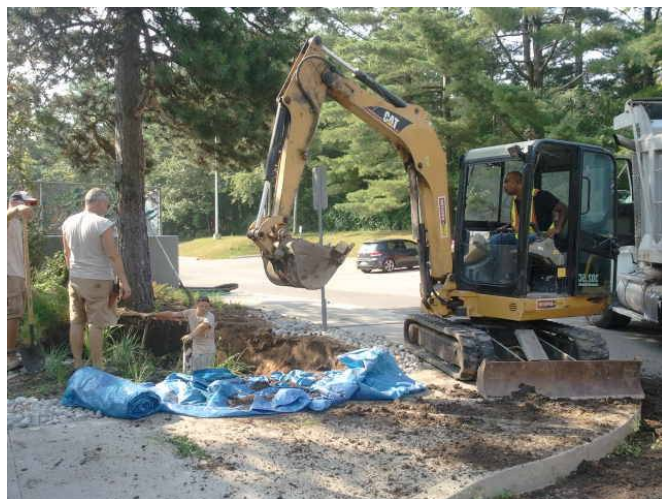
Removal of the soil media with mini-excavator
