Central Parkway

Location: Mississauga
Constructed: Fall 2014

Road Right-of-Way Retrofit

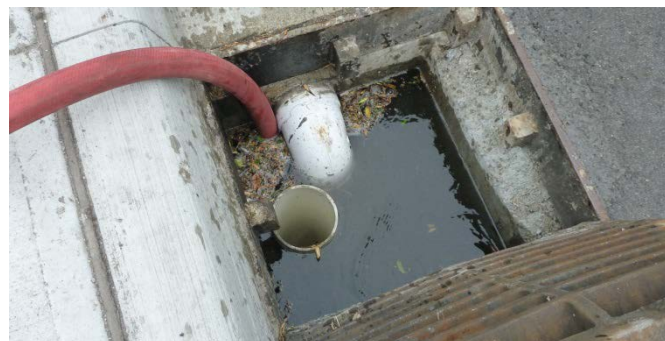
By videoing the site during a particular event, staff observed runoff bypassing the system by entering the overflow pipe in the west catch basin and not entering the inlet pipe to the Silva Cell system. This suggested that the inlet pipe had been inadvertently installed at a higher elevation than the overflow pipe.

Based on this observation, a water test was conducted by pouring water directly into the two catch basins that receive runoff before entering the LID feature. The water test confirmed that the invert of the overflow pipe was at a lower elevation than the invert of the inlet pipe in the west catch basin. Water did not enter the inlet pipe at any point during the test, indicating that the

drainage area of the west sub-catchment was bypassing the feature entirely.

Figure 8: Water test in the east catch basin

In addition, an obvious drawdown of water was observed in the west catch basin, indicating that a significant leak was also occurring. Observations indicated that surface flows from the east sub-catchment area directly entered the open overflow pipe as a result of its location close to the curb-side of the catch basin. A slight drawdown was observed in the east catch basin.

As a result of these observations, several repairs were performed. The overflow pipe in the west catch basin was raised several inches and fitted with an elbow to prevent bypass, and the overflow pipe in the east catch basin was fitted with an elbow to prevent direct surface flows. The sumps for both catch basins were filled, with the new bottoms raised to approximately the obvert of the existing overflow pipes.

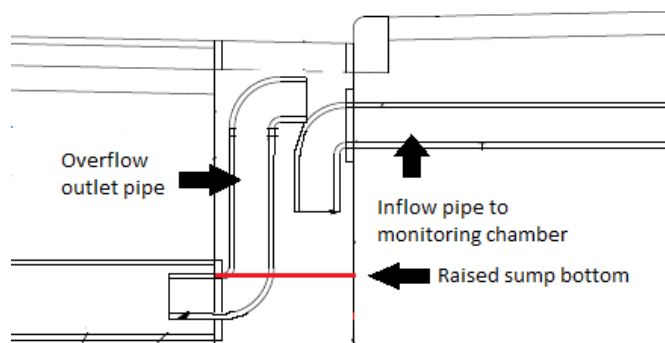
Figure 9: Example catch basin with a raised sump bottom

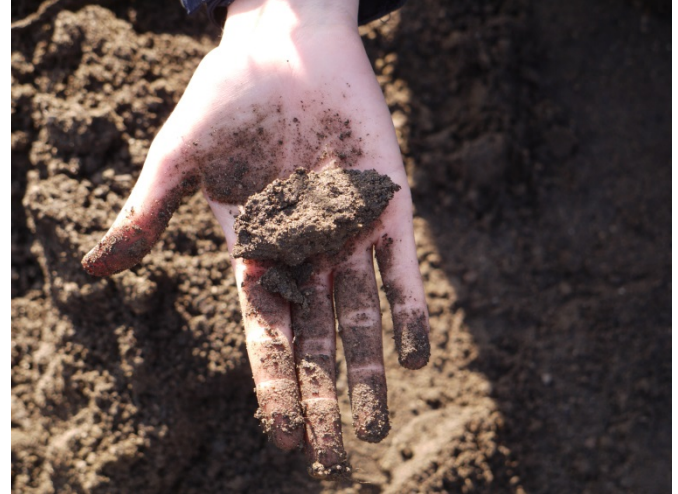
A minor soil mixing issue occurred when a dump truck installed one batch of bioretention soil into the Silva Cells. It was identified by a CVC construction inspector that there appeared to be some clay-based topsoil within the batch.

This was verified quickly on site by a ribbon test. The CVC inspector notified all involved parties and it was determined that the dump truck had previously dumped a load of topsoil at another site. Some of the remaining topsoil came in contact and mixed with the bioretention soil. This can negatively impact the biomedica composition.

Figure 10: Ribbon test by CVC staff

It was determined that the extent of mixing was minor. The contractor removed the visible topsoil to the best of their ability and to the satisfaction of the site inspector. The contractor then ensured that no dump trucks would be used for topsoil prior to bioretention media.

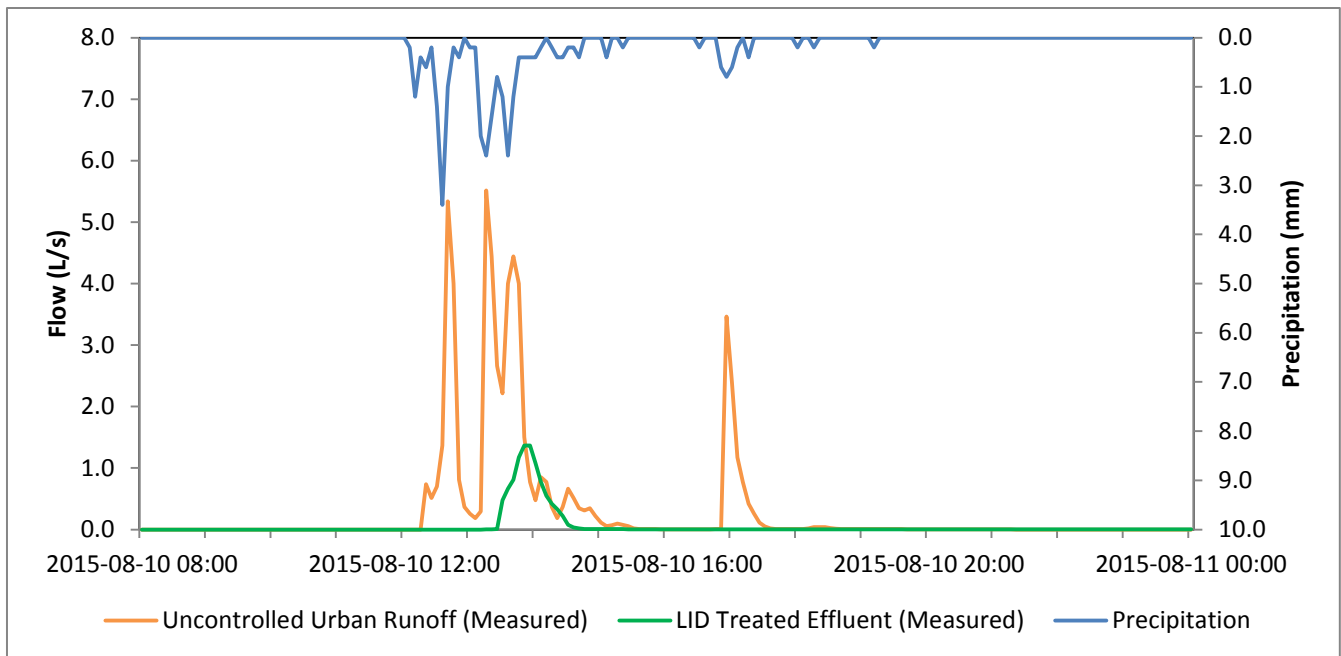
Figure 16: Response to the August 10, 2015 event at Central Parkway

Figure 16 demonstrates an event from August 10, 2015. This storm event had a 22 hour duration and a precipitation depth of 28.8 mm, with a peak rainfall intensity of 40.8 mm/hr. Volume reduction for this event was estimated to be about 83% and peak flow reduction was estimated to be about 75%. These estimates are affected by many variables including normal variability in measurements and rainfall-runoff assumptions. A lag time of approximately 35 minutes was observed between the inflow runoff peak and the outflow peak for this large event.
