Lake Ontario Integrated Shoreline Strategy Moore Creek: Fluvial Geomorphology Assessment

A report submitted by:
Aquafor Beech Ltd.

October 31, 2014

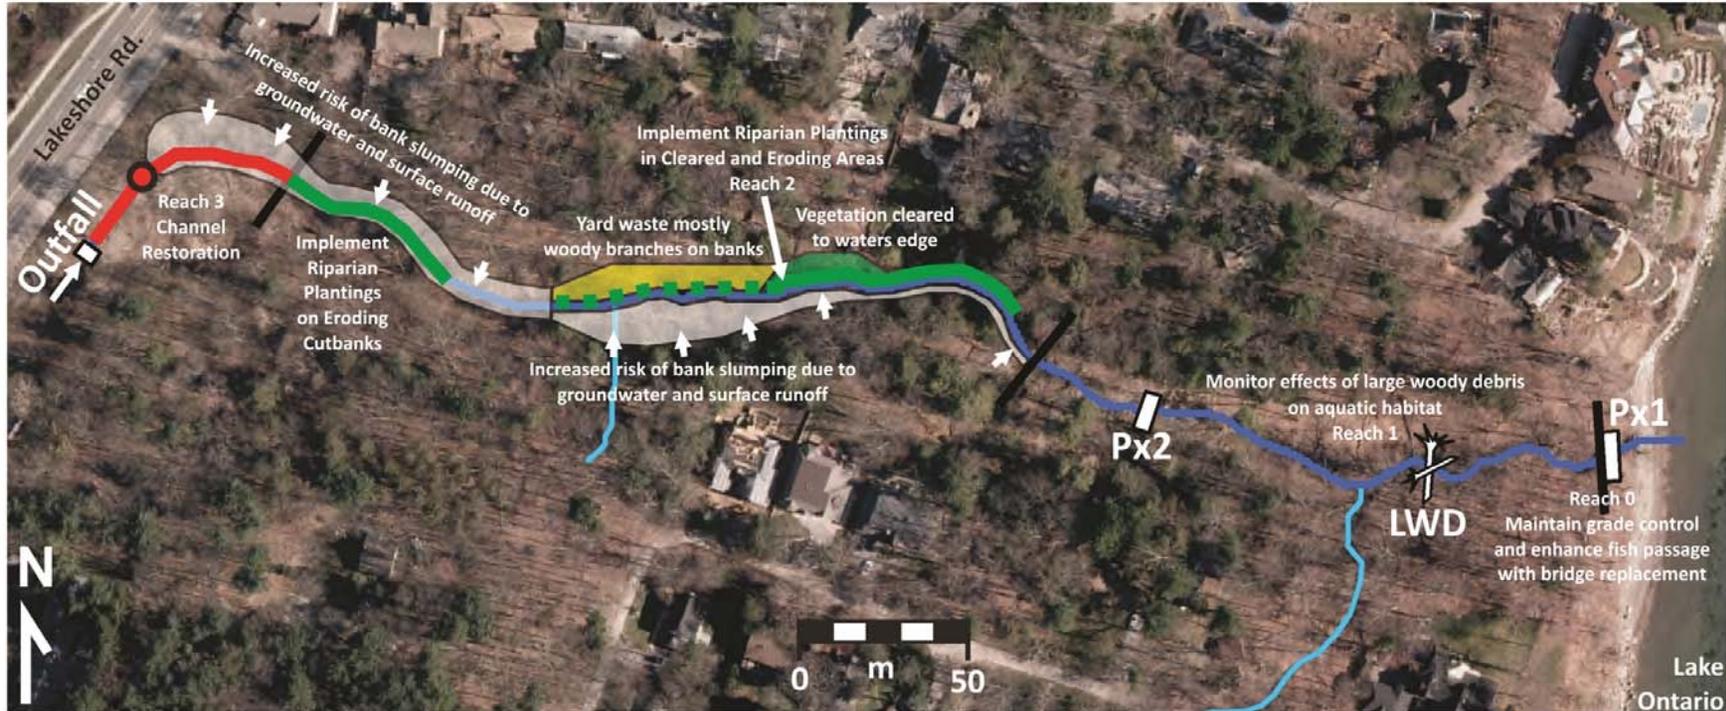
Figure I: Moore Creek fluvial geomorphology assessment executive summary map. Recommended stream restoration of Reach 3 is highlighted in red. General areas of recommended riparian plantings in Reach 2 are highlighted in green (e.g., on eroding cutbanks in upstream sections of Reach 2), also including areas of cleared vegetation and yard waste shaded in green and yellow, respectively. General areas of high groundwater input are shaded in white (with white arrows) based on field evidence of saturated banks and slumping. **Notes:** Other general notes where indicated; Px1 and Px2 are the pedestrian bridges; LWD = large woody debris jam.

Management Recommendations	Priority	
Corridor Erosion Hazards	<ul style="list-style-type: none"> Existing erosion along Moore Creek to be preserved within a 32 m wide erodible corridor, with residents limiting activities within 10 m from active channel banks. For Reaches 1 and 2, no direct intervention is recommended in terms of bank or channel restoration, other than select riparian plantings (Figure I). 	Medium
Channel Restoration	<ul style="list-style-type: none"> Severe erosion issues and bank failures in Reach 3 require mitigation by way of channel engineering and restoration (Figure I). It is recommended that these works maintain gravel sediment supply to downstream reaches, balancing vertical channel realignment and slope stabilization with dynamic fluvial processes within a restored meander belt and stream corridor. 	High
Riparian Habitat	<ul style="list-style-type: none"> Prevent further clearing of vegetation and dumping of yard waste along creek banks (Figure I). Implement riparian plantings to strategically enhance riparian vegetation and bank stability for select locations (Figure I). 	Medium Medium

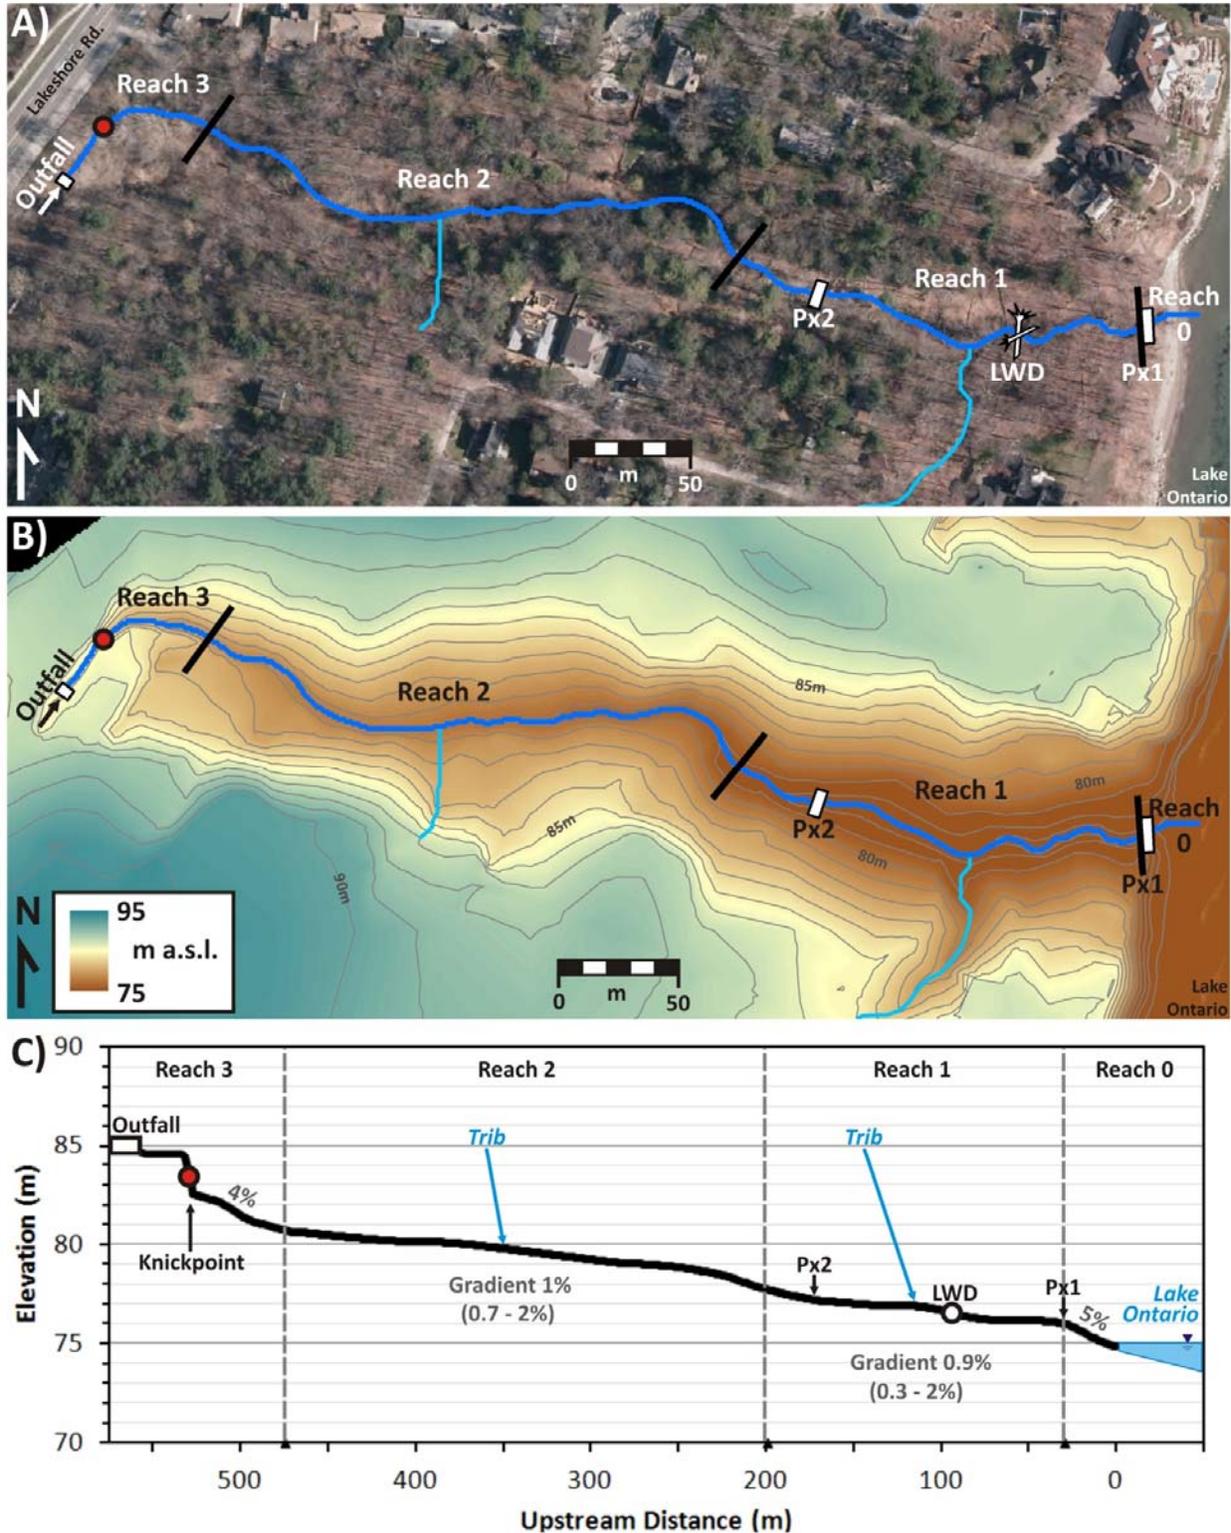
Moore Creek is about 550 m in length between a 750 mm diameter storm outfall south of Lakeshore Rd W and the creek's outlet at Lake Ontario (**Figure 2.1**). In total, four (4) stream reaches were identified within the study area, with the majority (85%) of the channel length contained within two reaches (Reaches 1 and 2). As such, Reaches 0 and 3 were identified as transitional reaches upstream of Lake Ontario and downstream of Lakeshore Road, respectively. Although at least two small tributary drainage features were noted in the field and in the base mapping, channel slope, boundary materials, and fluvial processes were instead the primary criteria used for reach delineation. Tributary confluences may be appropriate locations to designate divisions between sub-reaches of Reaches 1 and 2. The locations of two pedestrian bridges were also confirmed in the field and added to the base mapping. With reference to **Figure 2.1** and photographs in **Appendix A**, the field conditions and RGA scores for each stream reach are outlined below proceeding from the outlet at Lake Ontario upstream to Lakeshore Rd:

Reach 0 is a short transitional reach between the creek outlet at Lake Ontario and the first pedestrian bridge (Px1; reach length ~30 m). Beach-ridge cobble deposits (and perhaps the pedestrian bridge structure) act as established grade control for Moore Creek resulting in a ~1.5 m drop from the invert of the bridge orifice to the lake level (slope of ~5%). This drop includes a number of cobble/tree-root steps with intervening plunge pools. Scour associated with the pools has exposed bank material locally, including some fine-grained glacial till or beach deposits. The average RGA stability index for Reach 0 was calculated to be 0.37 which is considered to be a *transitional* score based on some field evidence of stream adjustments. Given that this reach represents a knickpoint in the profile of Moore Creek, processes of channel degradation were most evident. However, aggradational features were also present.

Reach 1 extends upstream from the first pedestrian bridge (Px1) to about 30 m upstream of the second pedestrian bridge (Px2; reach length ~170 m). The average RGA stability index for Reach 1 was calculated to be 0.47 which is considered to be an *in adjustment* score based on field evidence of stream adjustments. Indicators of **aggradational** processes were most dominant (all 7 indicators were observed), with minor evidence of other fluvial adjustment processes also observed in Reach 1 (i.e., degradation, widening, planform adjustment). The average stream gradient from the DEM longitudinal profile was estimated to be 0.9% (with range of 0.3 – 2%); however, more than half of the elevation drop (0.6 of 1.1 m) occurs locally where there is an accumulation of large woody debris (LWD, **Figure 2.1**). Consequently, low gradients (0.3 – 0.4%) and associated aggradational processes tend to limit most sediment transport to sand grain-sizes which move during frequent storm flow events, with temporary storage in bars.

Figure 2.1: Stream reaches for Moore Creek. **A)** Reach breaks (black lines) and features of interest with 2013 aerial photography (source: CVC); **B)** Digital elevation model (1 x 1 m DEM) and 1 m contour interval (source: City of Mississauga); **C)** Longitudinal profile (generalized) based on DEM data with interpreted channel gradients for each stream reach (Vertical Exaggeration x10). **Notes:** Px1 and Px2 are the pedestrian bridges; LWD = large woody debris.

Reach 2 extends upstream about 275 m from its transition with Reach 1. The average RGA stability index for Reach 2 was calculated to be 0.46 which is considered to be an *in adjustment* score based on field evidence of stream adjustments. Indicators of **aggradational** processes were most dominant (5 of 7 indicators were observed); however, more evidence of degradation and widening processes was also observed as compared to Reach 1. The average stream gradient from the DEM longitudinal profile was estimated to be 1% (with a range of 0.7 – 2%; note most sediment transport during storm flow events is expected under energy gradients of 0.7 – 1%). The bed material in Reach 2 was observed to be a mix of sand and gravel, with some local exposure of the underlying glacial deposits. During the field assessment, sand and gravel bed materials were typically stored as lateral bars and point bars associated with dynamic bedload transport and channel meander bend development. Meander bend migration and lateral channel adjustments were notable in the upstream and downstream sections of the reach; however, a relatively straight (and entrenched) section was observed mid-reach immediately downstream of the small tributary (see Figure 2). A riffle-pool bed morphology was partially to irregularly developed in association with channel planform dynamics in Reach 2; however, dynamic sediment bar deposits and channel debris appeared to limit well-developed riffle-pool bed forms.

In the context of the completed geomorphic assessment of Moore Creek, a number of special considerations have been identified with respect to any future repairs or replacements of the two existing pedestrian bridges over the watercourse (see locations of Px1 and Px2, **Figure 2.1A**).

- **Downstream Pedestrian Bridge at Shoreline** (Reach 0, Px1) – the existing pedestrian bridge structure includes a concrete headwall with a wooden deck span of about 8 m and a ~0.8 x 2 m orifice in the concrete over the active stream channel. Repair or replacement of the bridge structure should include the following special considerations:

- **Upstream Pedestrian Bridge (Reach 1, Px2)** – the existing pedestrian bridge structure includes a wooden deck span of about 6 m with a recent retrofit of four 4”x4” wooden beams to brace the underside of the bridge. The recently installed wooden piers have a 2 m span over the creek which is less than the active bankfull width of 4 – 5 m. Repair or replacement of the bridge structure should include the following special considerations:

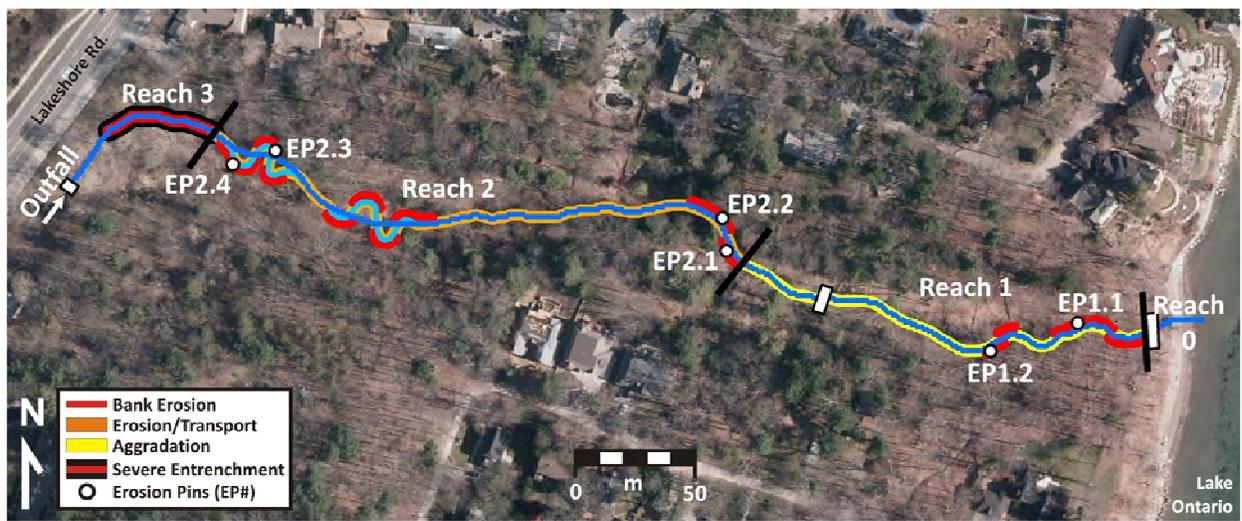
field measurements of the preliminary meander belt width were collected using a laser range finder. The maximum meander amplitude measured within Reaches 1 and 2 was **16 m**. Specifically within Reach 2, the approximate meander bend alignments missing from the DEM analysis were added to the mapping based on the field measurements (**Figure 7.1**).

To provide some baseline estimates of erosion rates, six (6) erosion pins were installed within Reaches 1 and 2 where evidence of ongoing bank migration was observed in the field (2 within Reach 1 and 4 within Reach 2, **Figure 7.1**). Results of the erosion pin measurements taken over a 105 day period from August 23rd, 2013 to December 6th, 2013 are presented in **Table 7.1**. Extrapolated annual erosion rates range from 0 to 0.5 m/yr (average = 0.17 m/yr); however, these should be interpreted very cautiously given the limited monitoring period. Further, given that most of Moore Creek within Reaches 1 and 2 is slightly to moderately entrenched (i.e., entrenchment ratios of 2.2 to 2.7 as per **Table 3.1**), these high lateral erosion rates are not considered realistic in the sense that the volumes of sediment to be eroded from entrenched banks (> 2 – 2.5 m in height) are much greater than the short term erosion of the bank toe by the active bankfull channel (~0.3 – 0.5 m in height). For example, a slump of bank material documented at EP2.4 has temporarily moved the bank toe back towards the active channel and lateral recession of the entire bank will require reworking of the slumped material before erosion of the entrenched embankment is more fully realized.

Figure 7.1: Erosion mapping for Moore Creek, including the locations of 6 erosion pins. Approximate meander bend alignments missing from the DEM data have been subsequently mapped based on field measurements (light blue lines).

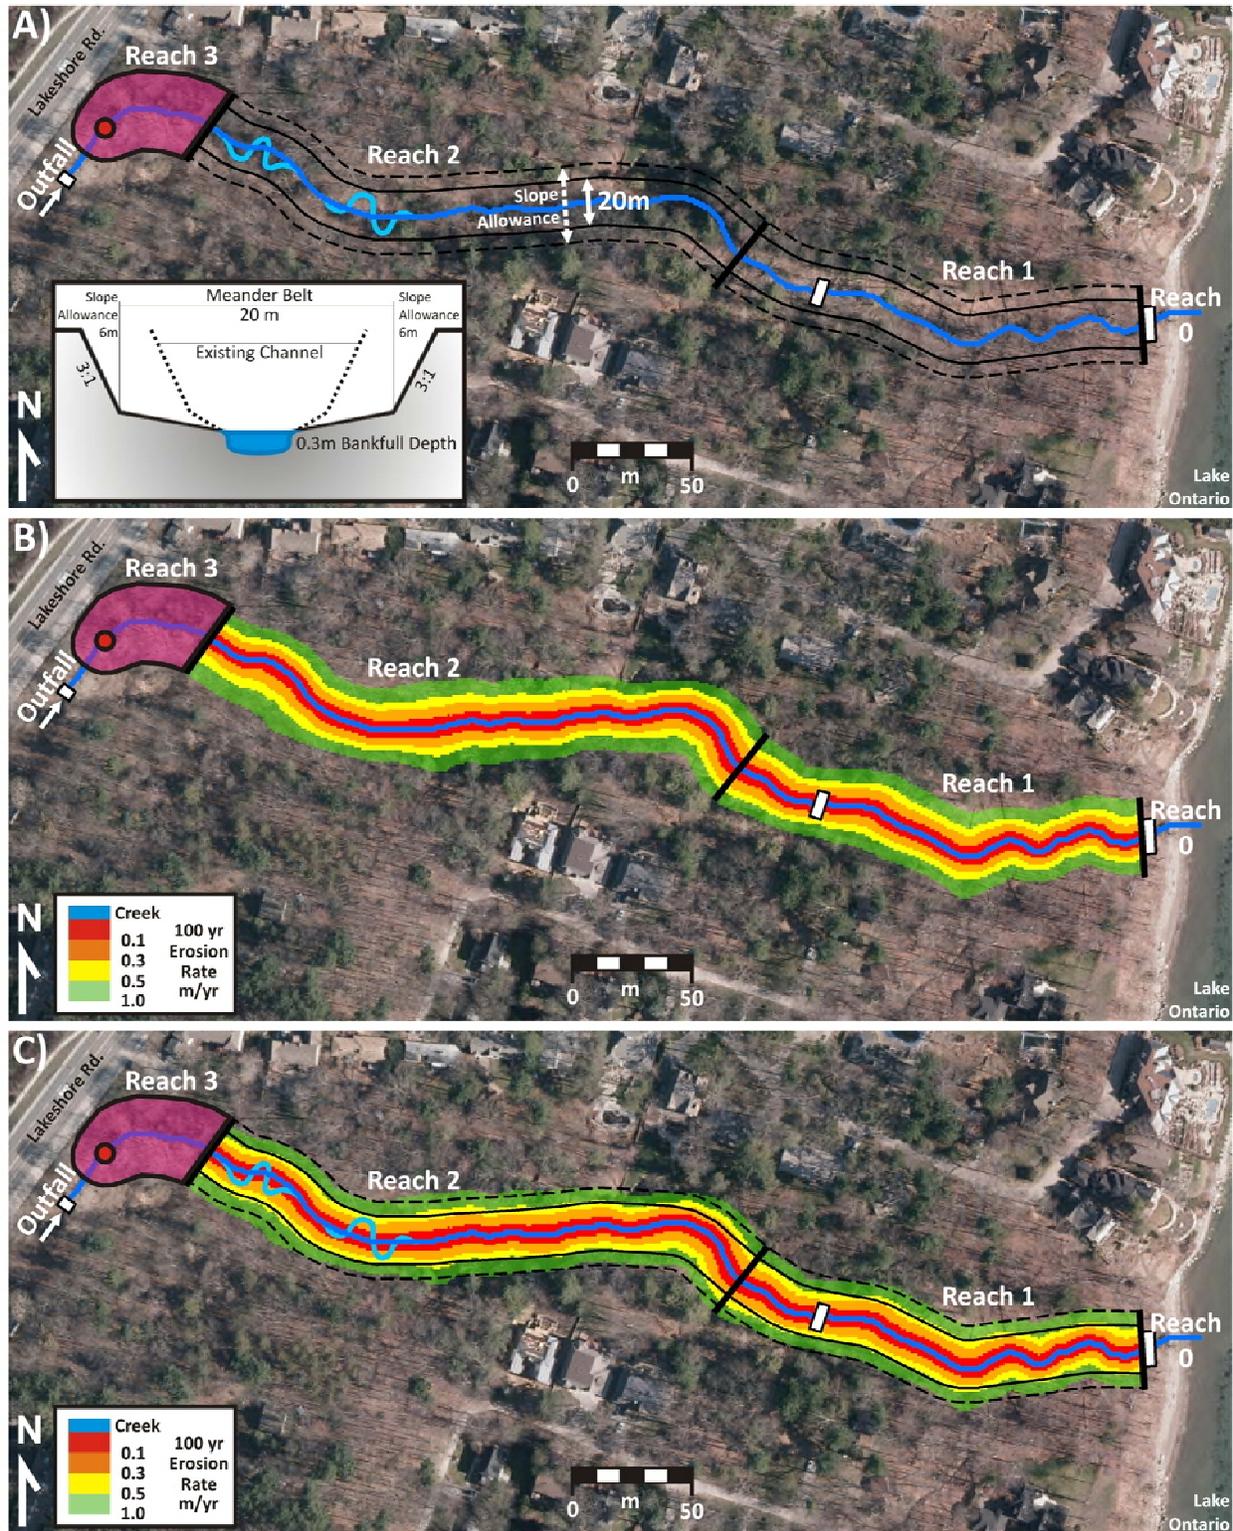
In lieu of accurate long-term erosion rates for entrenched banks on Moore Creek, a 1.25 factor of safety was applied for a **20 m** final meander belt width, which is expected to include a 100-year erosion allowance. The final meander belt mapping is presented in **Figure 7.2A**. However, due to the moderately entrenched channel conditions, an additional stable slope allowance is also required to contain the erosion hazard. Based on average entrenched bank heights of ~2 m and standard stable slope recommendations for sandy materials of 3 horizontal to 1 vertical (MNR, 2002), an additional stable slope allowance of 6 m was also delineated on either side of the meander belt erodible corridor (dashed lines in **Figure 7.2A**; total corridor width = 32 m).

Comparison of traditional meander belt mapping and the TEC model (**Figure 7.2C**) shows favourable agreement between the two independent methods. Generally, areas within the 20 m meander belt envelope would require bankfull lateral migration rates in the order of 0.5 m/yr (yellow zone) for equivalent volumetric erosion hazards within 100 years. Areas where meander bends are situated close to the corridor boundary may be subject to greater hazards at bankfull erosion rates of less than 0.3 m/yr (within range of data in **Table 7.1**), however, these rates are still considered to be conservatively high for Moore Creek. It should also be noted that the TEC model does not represent some meander bends upstream in Reach 2 which are missing in the DEM dataset. Generally, the TEC modeling approach confirms erosion hazard expectations as delineated by standard meander belt mapping techniques.

Figure 7.2: Erodible corridor and erosion hazard mapping for Moore Creek. **A)** Meander belt mapping of 20 m belt-width (16 m x 1.25 factor of safety) with inset schematic cross-section of proposed 32 m wide management corridor; **B)** Topographic Erodible Corridor (TEC) model of erosion probability (see text for details); **C)** Comparison of meander belt mapping with TEC model. **Note:** Area of Reach 3 identified for management considerations discussed in the text.

Erosion hazards have been delineated within a 32 m wide management corridor for a 100-year planning horizon. Based on the results of this study, **the recommended erosion hazard limit for Moore Creek is 32 m.** To enhance the long-term natural form and function of Moore Creek, and to potentially reduce long-term erosion hazard risks, it is recommended that property owners and residents limit their activities within **at least 10 m** of the nearest channel bank. Negative impacts to the creek may be associated with the following activities within the delineated stream corridor:

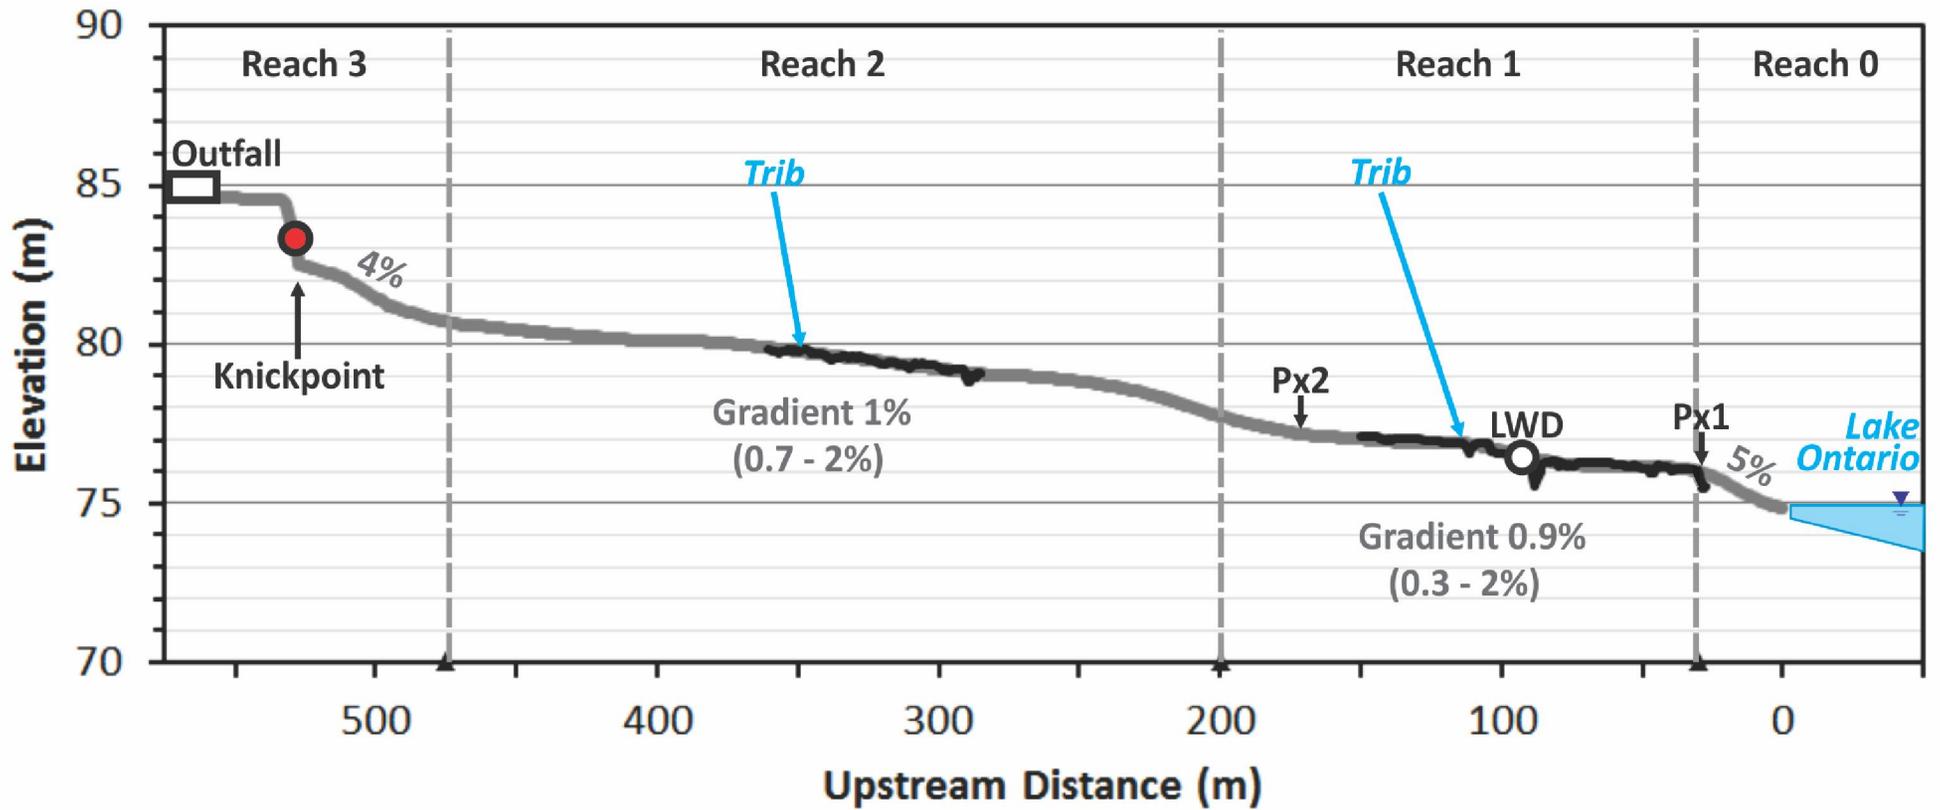
Appendix C (Figure 2.1C revised): Updated longitudinal profile (generalized in grey) based on DEM data with interpreted channel gradients for each stream reach (Vertical Exaggeration x10) with overlay of field surveyed profiles for Reaches 1 and 2 (black lines). Notes: Px1 and Px2 are the pedestrian bridges; LWD = large woody debris.
