**Showcasing Water Innovation  
Elm Drive  
December 2012/January 2013 Monitoring Update**

**Monitoring Progress**

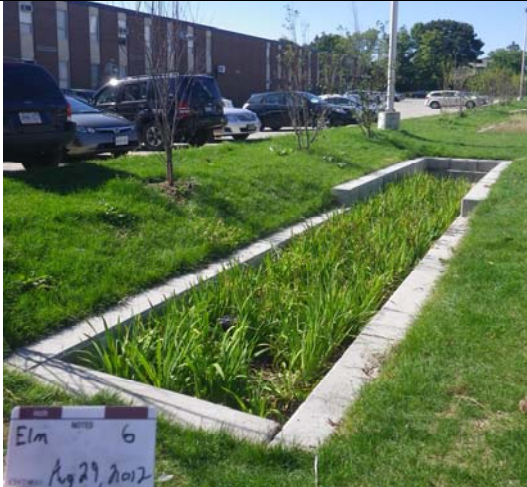
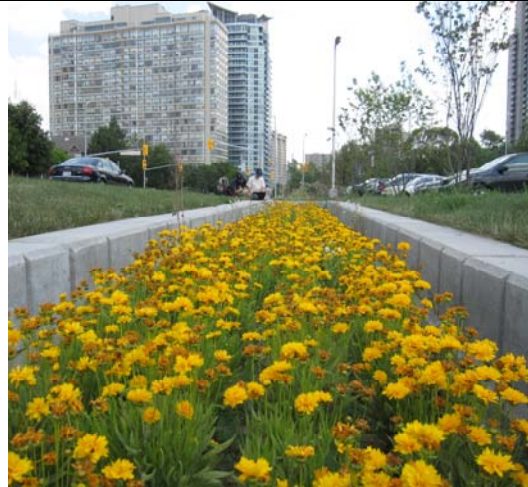
**Summer 2012**

**Seasonal photos of the Elm Drive rain garden planters**

- **Landscaping** - The construction contractor has completed the final weeding and plant replacement, and the City has now assumed the bioretention planters. A landscape design and installation contractor has added decorative fencing as well as trees and shrubs that will bring more colour, year round interest and vertical height to the planter boxes.

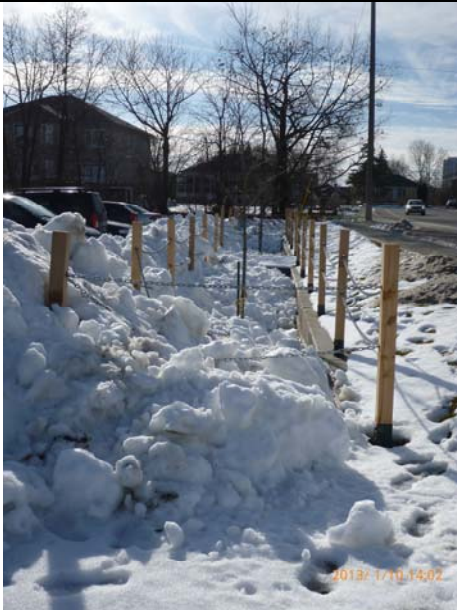
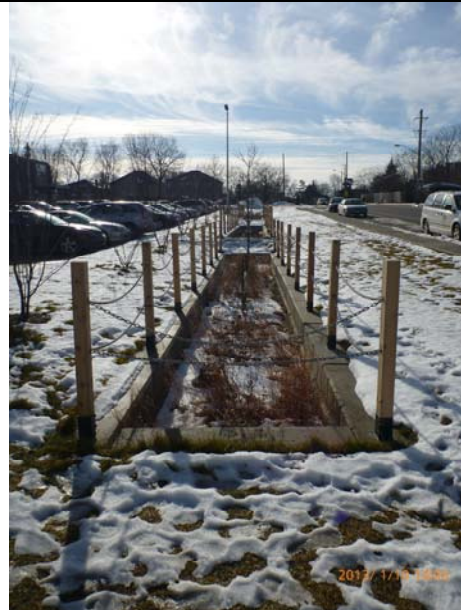
**Winter 2013** – The first photo shows a snow dump from plowing the parking lot

- **Maintenance** – As the LID site is next to an adult education school, litter continues to be a significant maintenance issue. The improved landscaping and educational signage will help to bring attention to the issue of litter and the purpose of these practices. Also, CVC will engage the City in developing a maintenance strategy for the site. Weeding and litter removal were performed by CVC's Conservation Youth Corps in August 2012. As can be seen in the pictures, the plants have died back for the winter. A large snowfall event at the end of December resulted in snow being plowed from the parking lot into the two most up-stream cells of the site.

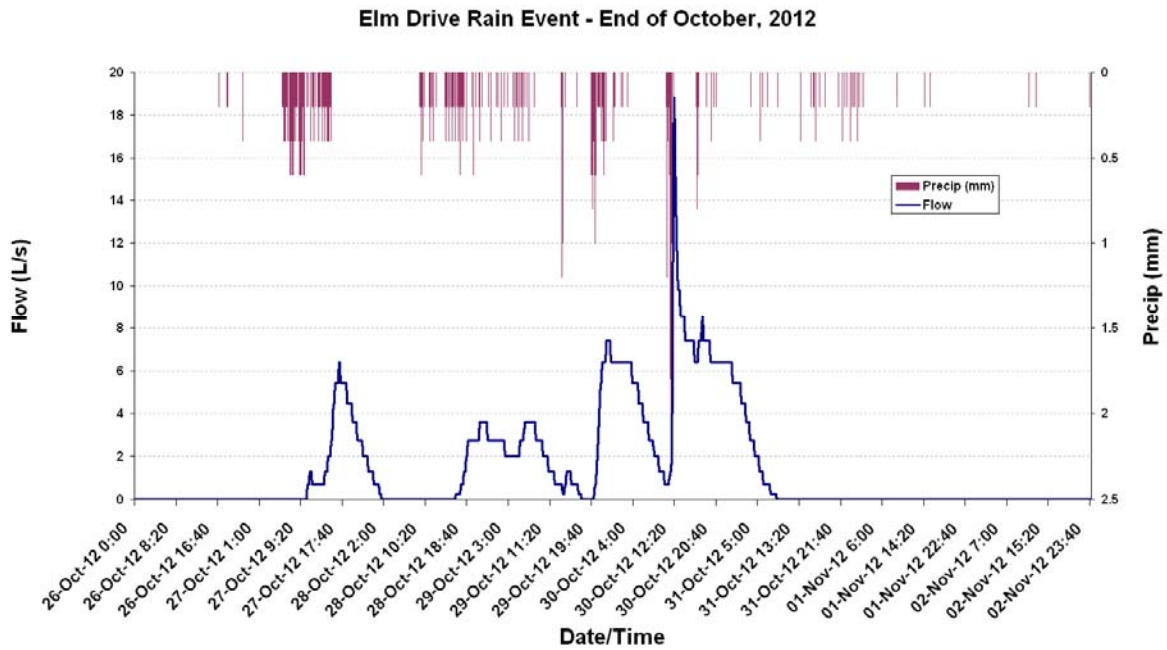
Figure 1. Hydrograph showing water flows from the Elm Drive LID site and precipitation from the large storm events at the end of October 2012

The largest precipitation event recorded to date was during Hurricane Sandy at the end of October, with a total of 50 mm over several days (October 27 – November 1, 2012).

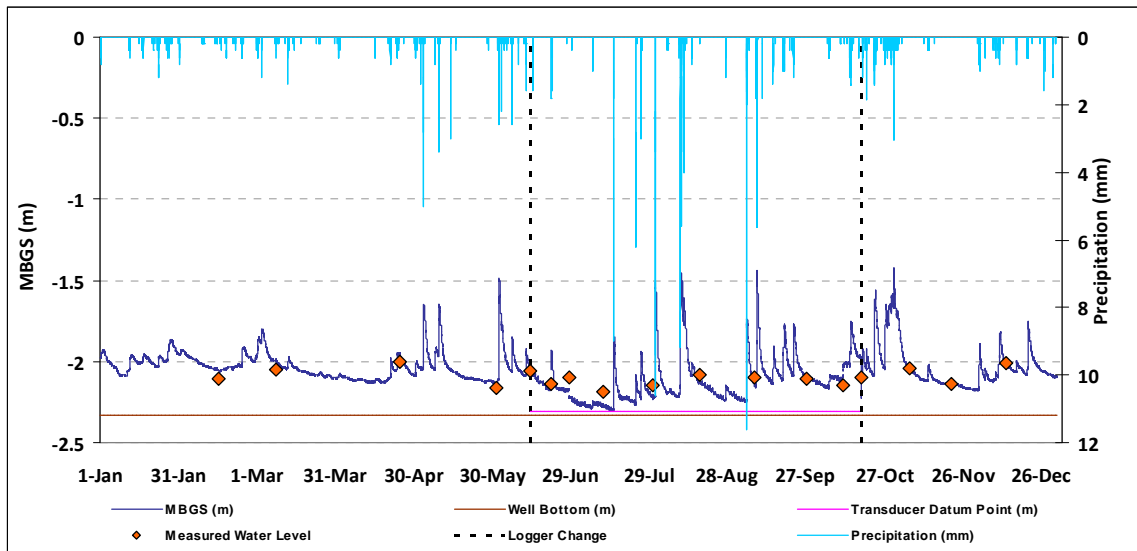
Figure 2. Elm Drive Water Level and Precipitation at Observation Point 2 from January to December 2012

- **Water Levels** - Initial results from the observation well level loggers have shown that the rain garden is operating properly. Monitoring of flows from the site has found that in 1 year, 1.9 million litres of stormwater (1.3 Olympic size pools) has been stored and infiltrated by the rain garden planters. For rain events up to 13 mm, no outflow from the rain garden planters was measured.

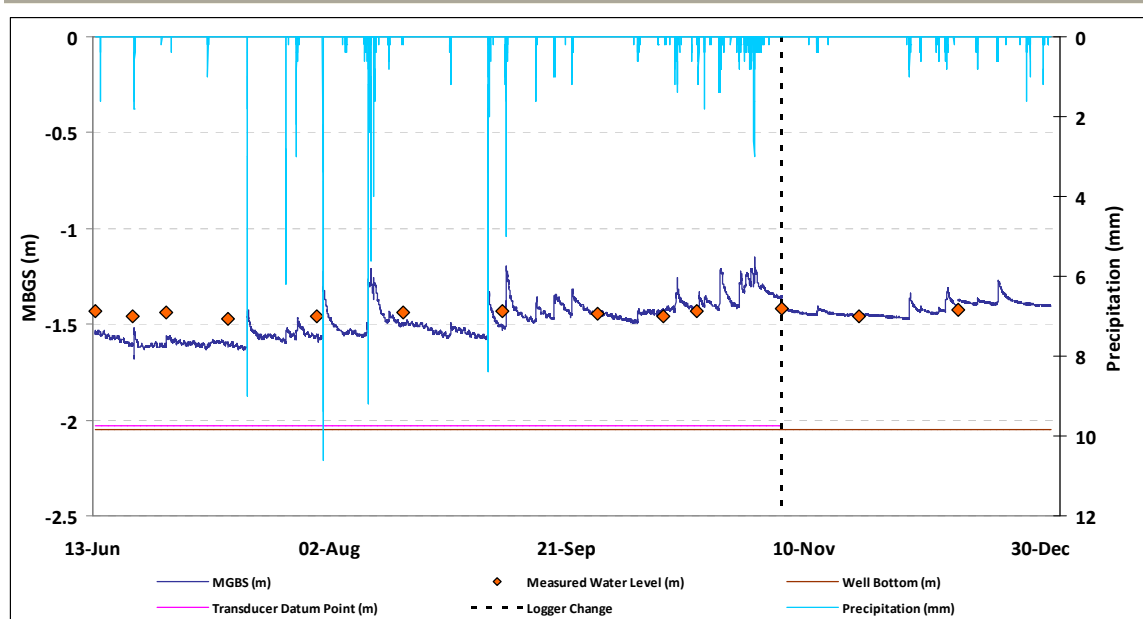
Figure 3. Elm Drive Water Level and Precipitation at Observation Point 3 from June to December 2012

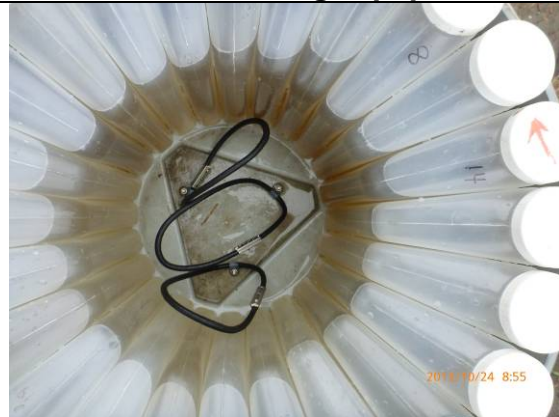
October 24, 2012 – Storm Event Samples

In May 2012 an automatic sampler was installed in the same manhole to collect water quality samples during storm events. To date, samples from 12 storm events have been collected.

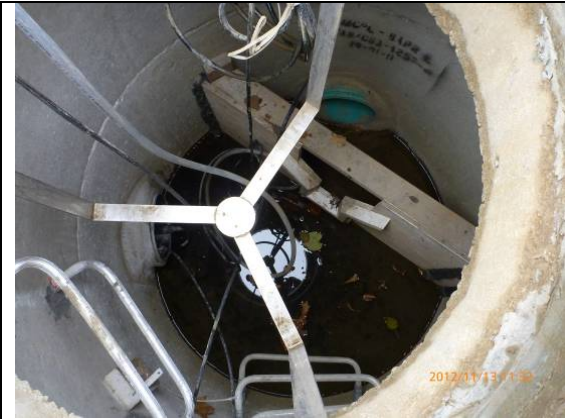
November 13, 2012 – Monitoring manhole

Water quantity (flow) monitoring started in July 2011. A weir and a continuous water flow logger were installed in the manhole downstream of the LID infrastructure and set to record water level at 10 minute intervals. The logger has been operating continuously since it was installed.

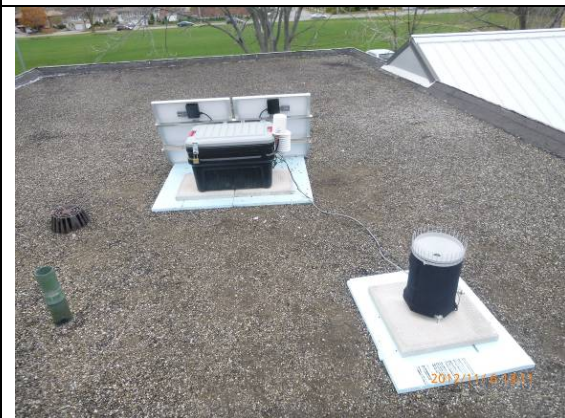
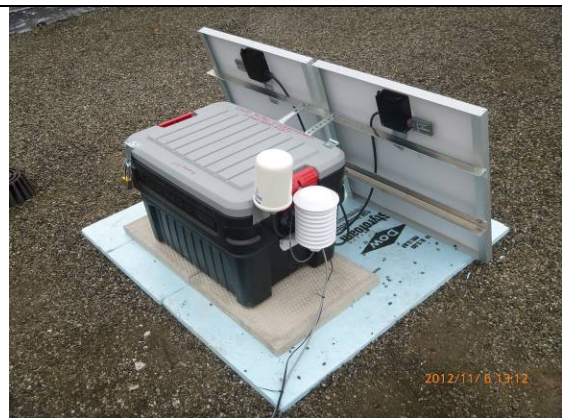
November 6, 2012 – Newly installed precipitation gauge on the roof of the Elm Drive Adult Education Centre

Prior to November 2012, a City of Mississauga precipitation gauge located approximately 1 kilometer away from the Elm Drive site provided precipitation data for this project. In November 2012 CVC staff installed a new rain gauge and air temperature logger on the roof of the Elm Drive Adult Education Centre. They are set to record precipitation and air temperature at 10 minute intervals to match the flow logger time steps. Going forward, data from this new gauge will be used for the Elm Drive monitoring program.
