**Showcasing Water Innovation
Elm Drive
Fall 2013 Monitoring Update**

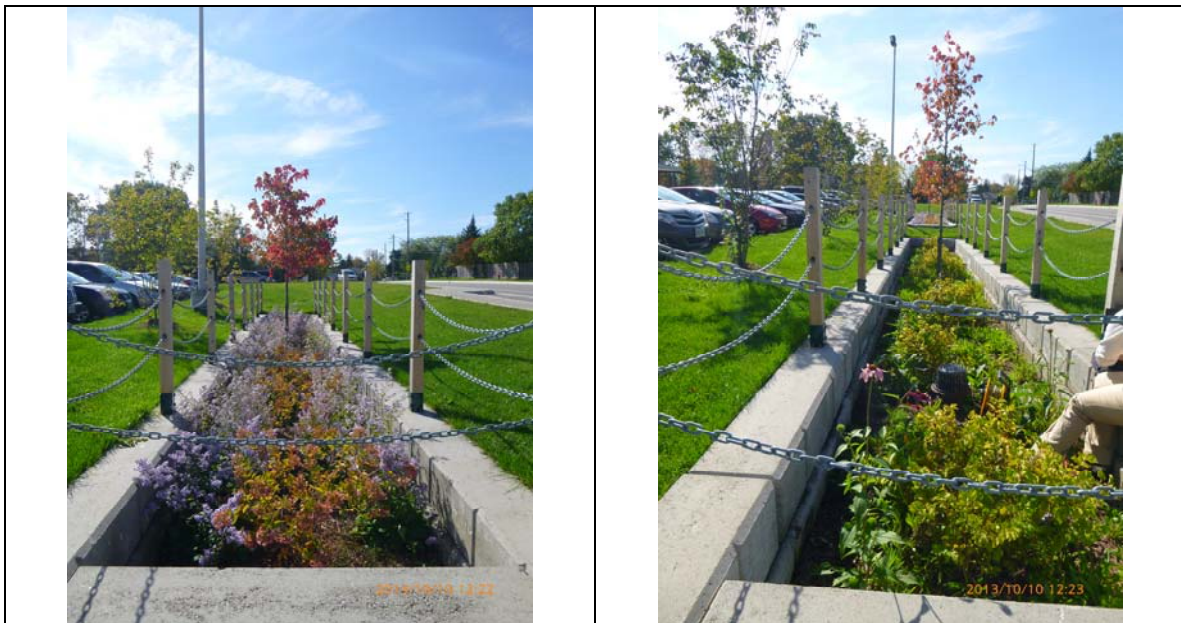
Fall 2013 photos of the Elm Drive Rain Garden planters

- **Landscaping** – The plants are doing well and most are now well established. Plants are beginning to die off slowly for the winter. CVC staff have performed litter removal and added a fresh layer of mulch to all of the cells this fall.

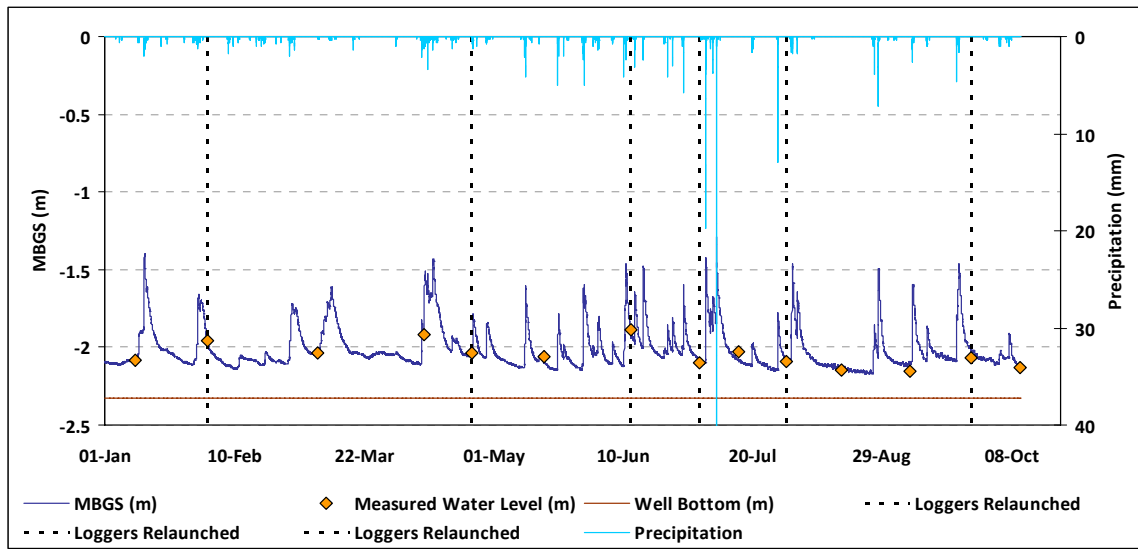
Figure 1 - Elm Drive Water Level and Precipitation at Observation Point 2 from January 2013 to early October.

- **Water Levels** – Initial results from the observation well level loggers have shown that the rain garden is operating properly. Surface water ponding has not been recorded since a shallow well was installed this fall. Monitoring of flows from the site has found that in 1 year, 1.9 million litres of stormwater (1.3 Olympic size pools) has been stored and infiltrated by the rain garden planters. For rain events up to 25 mm, no outflow from the rain garden planters was measured.

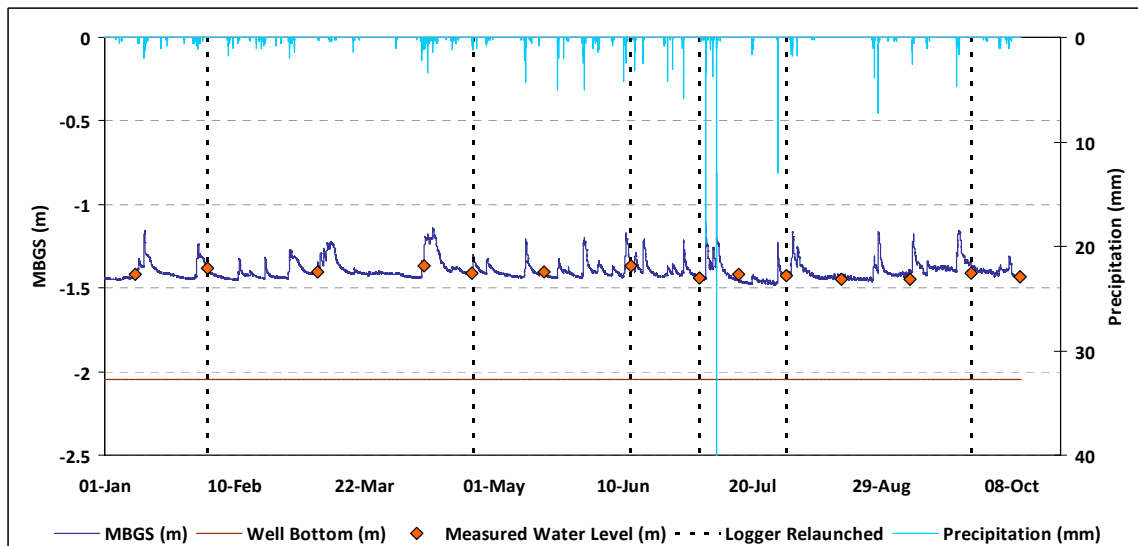
Figure 2 - Elm Drive Water Level and Precipitation at Observation Point 3 from January 2013 to early October.

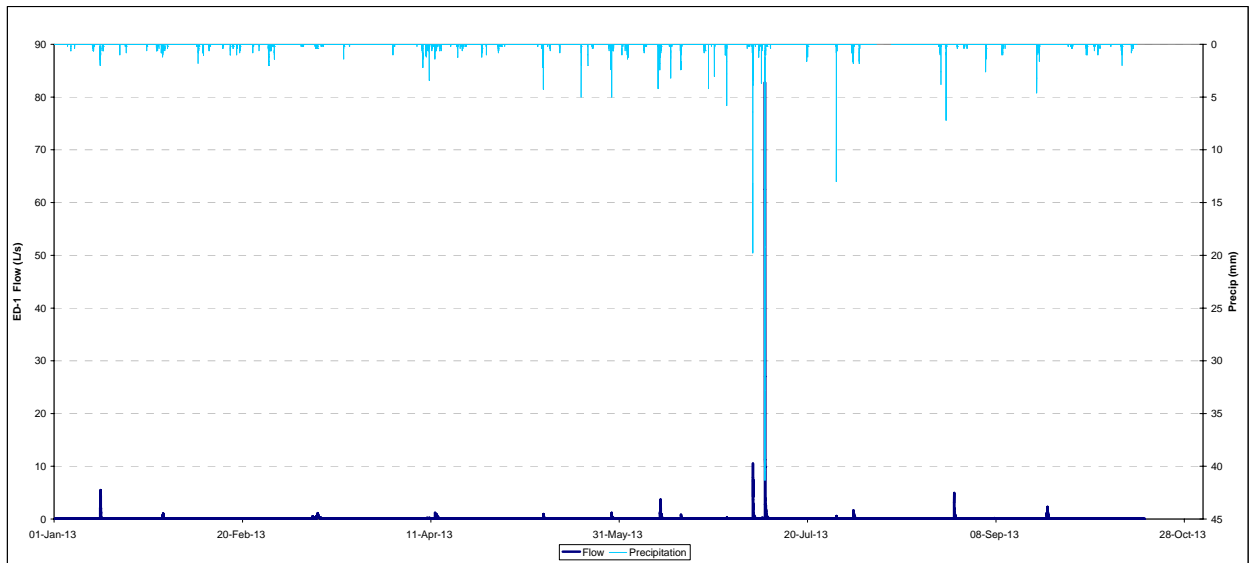
Figure 3 - Elm Drive Outlet Water Flow and Precipitation from January 2013 to mid October.

Since August 2011, for rain events not involving snow melt of up to 25 mm, no outflows have been observed leaving the LID infrastructure. Outflow has not been observed from Elm Drive since a 42mm event that took place on September 21st.

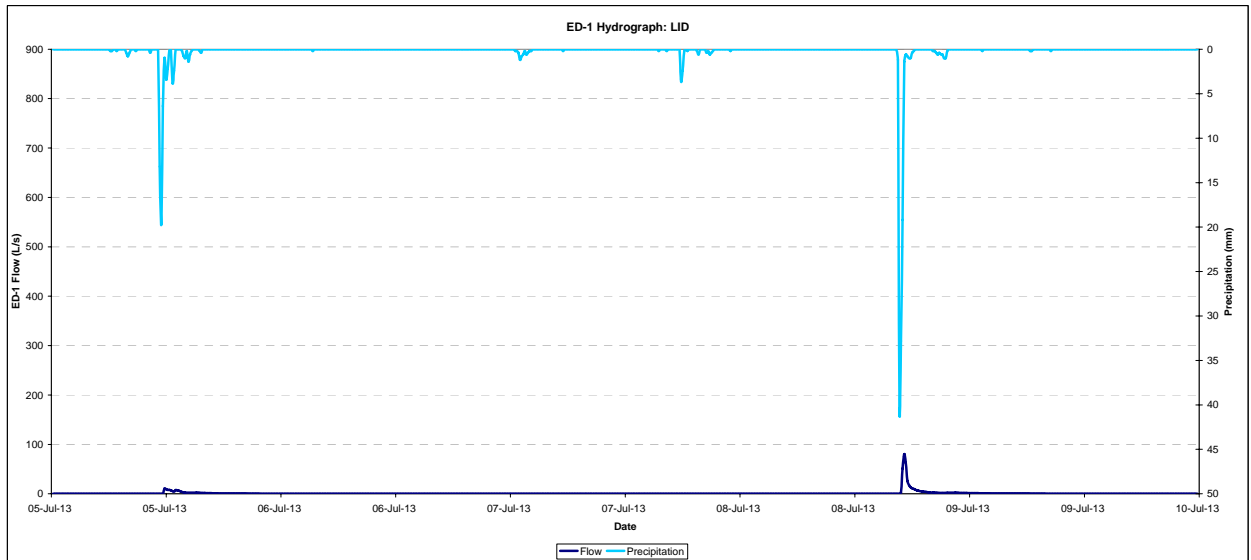
Figure 4 - Elm Drive Outlet Water Flow and Precipitation from the July 8th 2013 event totaling 104mm in one evening.

The largest precipitation event recorded to date happened July 8 2013, with a total of 104 mm of rainfall over one evening (larger than a 100 year design storm event).
