Ontario Ministry of Transportation Carpool Parking Lot (Beamsville)

Location: Beamsville

Constructed: 2010

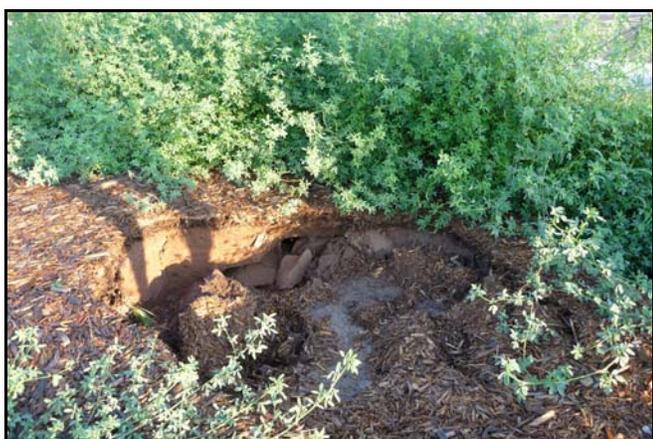
One issue identified following construction was development of large depressions within the bioretention soil media at the surface of the practice. One of these depressions is shown in the following photograph.

Image of a surface depression that formed within the bioretention cell shortly after construction

Performance monitoring at the site observed large amounts of fines exiting the practice through the underdrain. A field investigation and review of design drawings were undertaken to identify the source of this issue.

This investigation found that the fine filter media was seeping into the underdrain. Observation ports used for monitoring confirmed that visible clogging was present. The fine filter media was travelling through the clear stone bedding surrounding the underdrain and into the drain pipe.

To address this issue it is recommended that infiltrating LID practices include a transition layer to prevent fines from mobilizing. This transition layer can be a pea gravel 'coking course' or geotextile fabric.

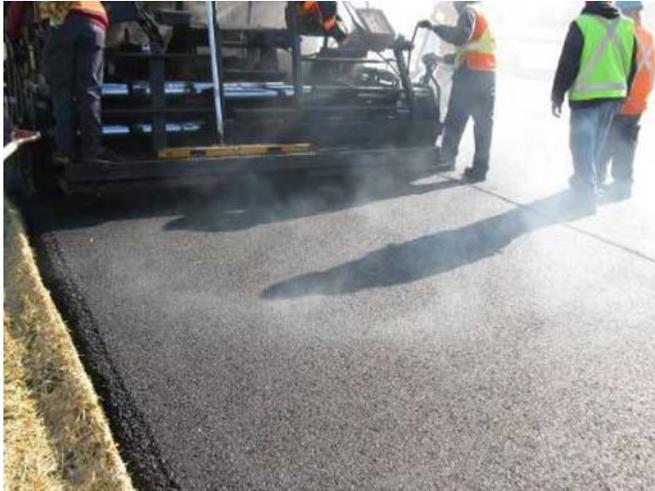
Unique rubber modified asphalt was used on a portion of this site. This material was made of ground scrap rubber tires and conventional hot mix asphalt. Using such material on a wide scale may potentially divert large quantities of used tires from stockpiles. It is estimated that 624 tires were diverted from landfill with this project. A photograph showing installation of this material is shown below.

Installation of rubber modified asphalt test strip

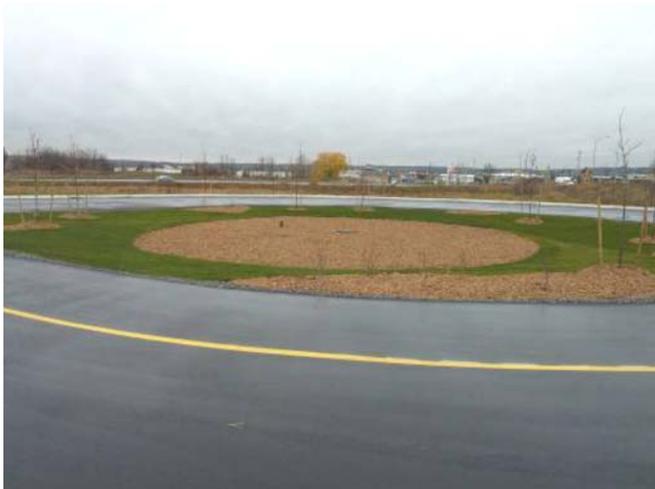
The engineered soil specified in the design was sourced locally. The sandy loam soil was mixed onsite and the cells were constructed during project grading. Landscaping was completed after the asphalt was laid. A photograph of the large central bioretention cell located within the bus loop showing the initial landscaping follows.

A large bioretention cell is located within the bus loop. This photograph shows the cell shortly after construction

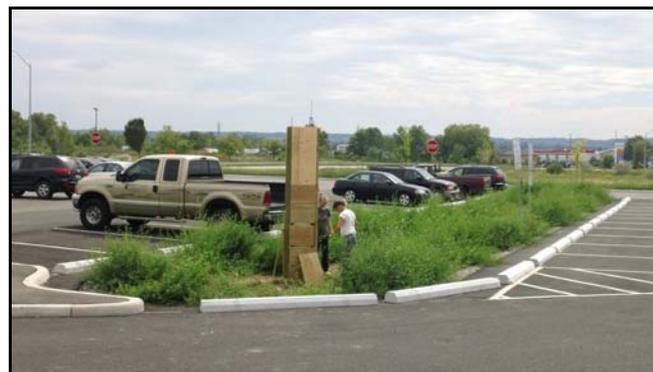
Flow discharged from the site is being continuously monitored. Overflow conditions are being noted as both the underdrain and overflow share the same outlet. Water quality samples are collected by hand during storm events. Soil and temperature probes are positioned at various depths and used to describe antecedent conditions. Equipment is housed in a temporary wooden structure as shown in the photo below.

University of Guelph students collecting data from the monitoring station

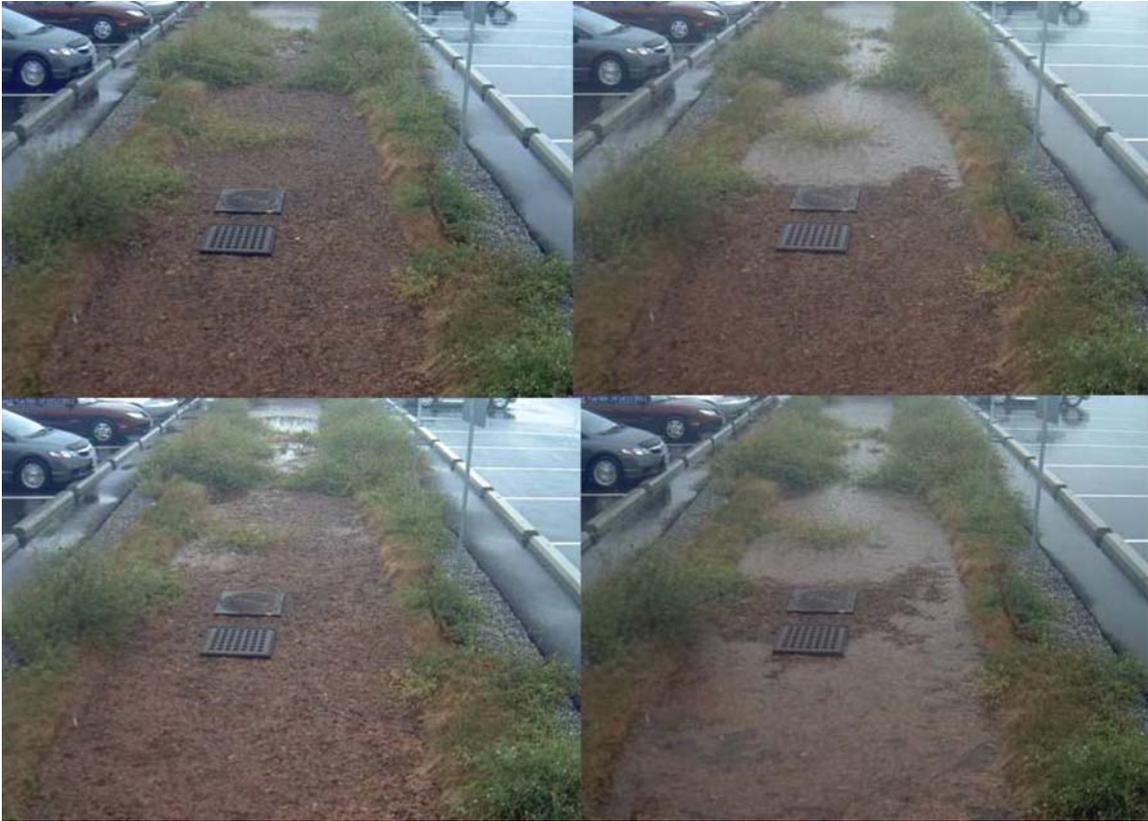
As part of the monitoring program a surveillance camera was installed to observe occasions where water ponding took place. This information was used to help determine when overflows through the surface catch basins occurred

A unique component of the monitoring program is highlighted in the above series of photographs. A surveillance camera was installed to monitor occurrences of surface ponding and overflows through the surface catch basins. Using low cost cameras is recommended as a potential tool for municipalities and/or landowners to observe performance of infiltrating LID practices during rainfall events. This method allows for easy detection of any issues with extended drainage periods, blocked (or poorly graded) flow route(s) into the practices, and monitoring plant health over time.
