Unitarian Congregation

Location: Mississauga
Constructed: 2011

Project Objectives, Design and Performance

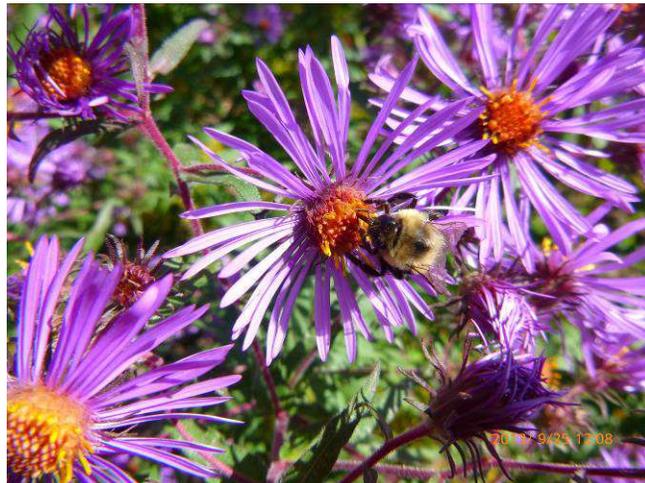
New England Aster does well in bioretention areas and can handle the salts and pollutants that may run off of roads and parking lots.

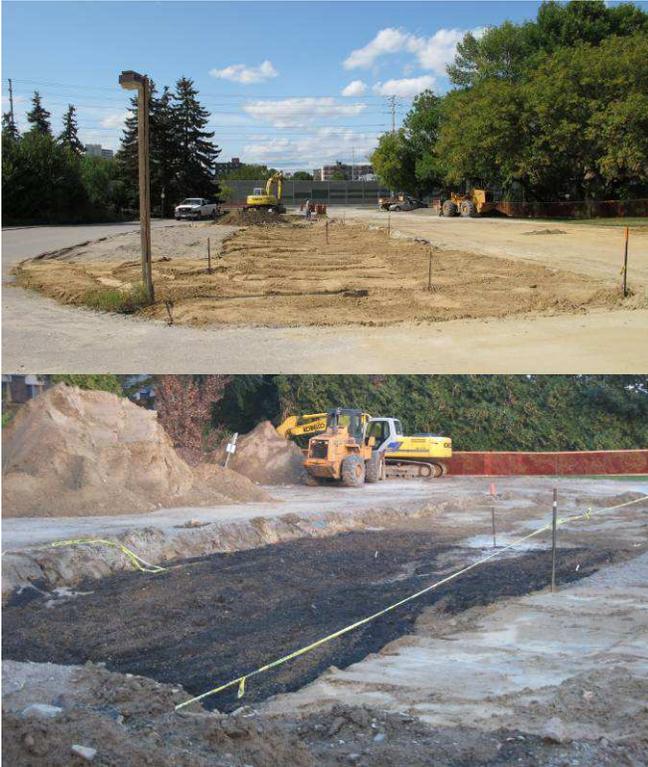
The top image shows the bioretention area staked out and the topsoil removed. The lower image shows the compost being spread and readied for mixing into the sand soil. (Source: Tafler Rylett Architects)

1. Removed the top 20 cm of topsoil and reused it along the perimeter of the parking lot.
2. Excavated the sandy soil to an additional depth of 60 cm and stockpiled it on the side of the excavation.
3. Used the tooth bucket to loosen and roughen the sandy soil at the bottom of the excavation to improve infiltration.
4. Returned stockpiled sand into the excavation in two 30 cm layers. The returned sand was broken up and loosened to improve its ability to store and infiltrate rainwater.
5. Thoroughly mixed in 10-15 cm of compost between each layer with a roto-tiller.
6. Finely graded the surface of the sand and compost mixture to about 20 cm below the top of the overflow.

These steps were completed with a professional contractor and backhoe operator. The contractor took care not to compact the bioretention area soils by keeping the heavy excavation equipment off to the side.

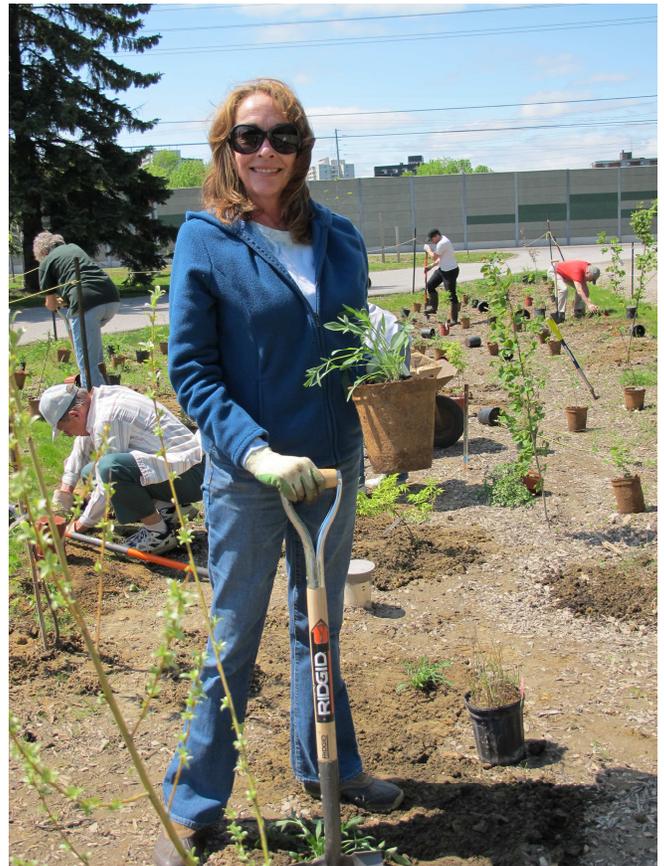
Volunteers planting for the first phase of planting in 2011.

With the soils in place, the remaining steps of planting and spreading the mulch could be done by volunteers from UCM and CVC. Due to available resources, the bioretention cell was planted in two phases: the south end was planted in 2011 and the north end in 2012.

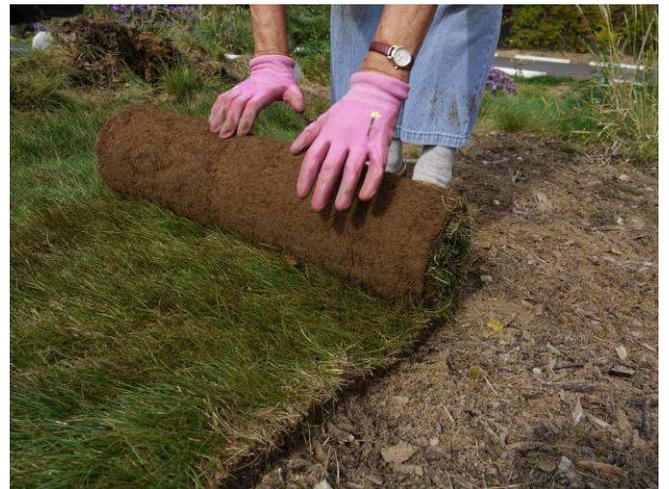
Installation of sod strips around perimeter of bioretention swale to reduce erosion and pretreat runoff entering the swale

A year after major construction, different pre-treatment options for the edge. There is no curb surrounding the parking lot so curb stops are used for the parking spaces. Rainwater running off the parking lot enters from all directions, often called sheet flow. There were a few locations where the flow concentrated, creating erosion problems. Grass or gravel filter strips are the two most common options for pretreating and slowing down sheet flow entering bioretention. A fescue grass sod from Green Horizons was donated to the church to use as a filter strip. The sod successfully stabilized the edge and eliminated most of the erosion issues, but the grass has created other maintenance issues that are noted in the maintenance section.

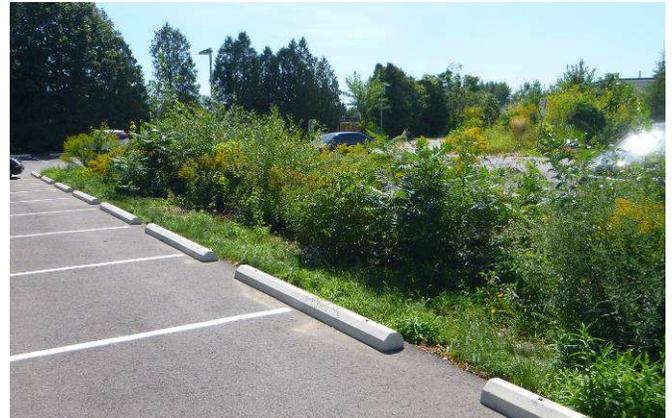
Vegetation grew rapidly in the 2013 growing season, leading to a very well established practice

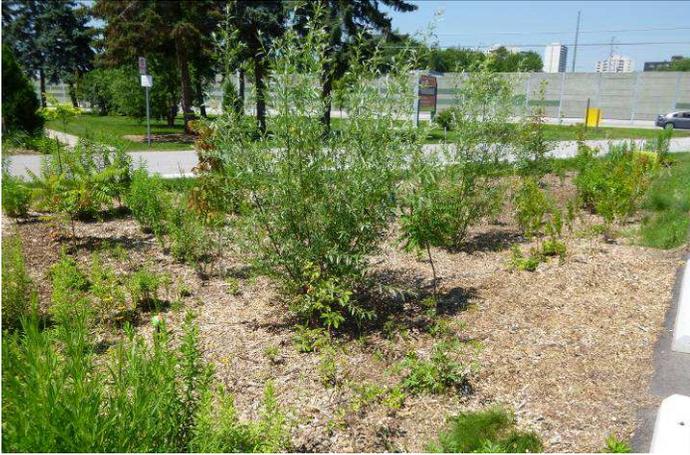
A hot dry summer in 2012 hindered the establishment of the landscape and many areas remained bare.

During this period, a few maintenance issues have been noted at the site. For example, in 2013, an excellent growing season reduced the need for establishment watering but created the need for more frequent weeding and pruning maintenance. Invasive species have also been aggressively taking over the planted native species but UCM has been weeding them on a weekly basis.

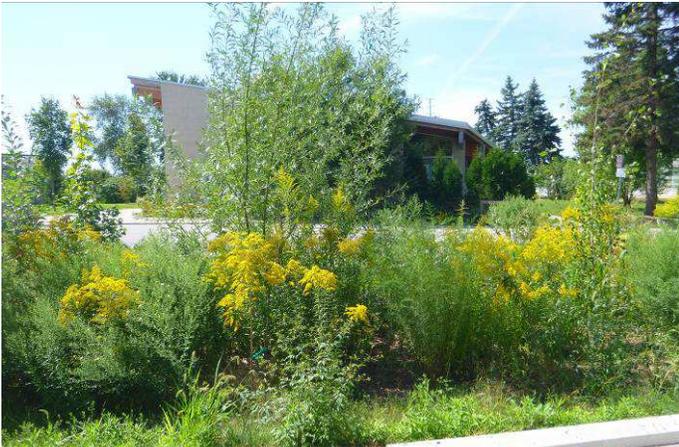
A wet growing season in 2013 was good for establishing desirable plants but it was also good for aggressive invasive plants.

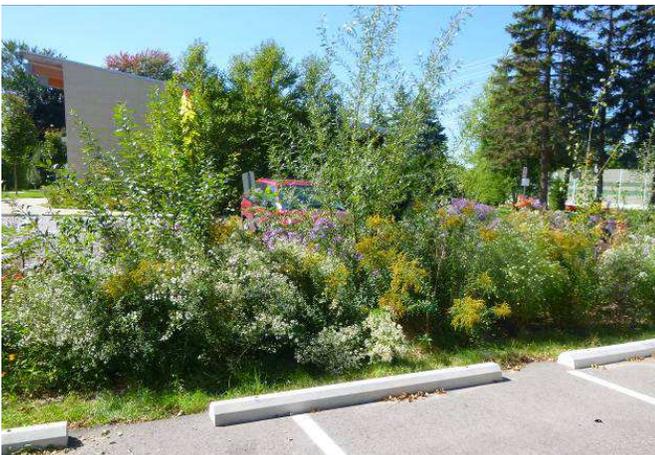
As of September 2013, 2 years after planting the site is fully vegetated and well established.

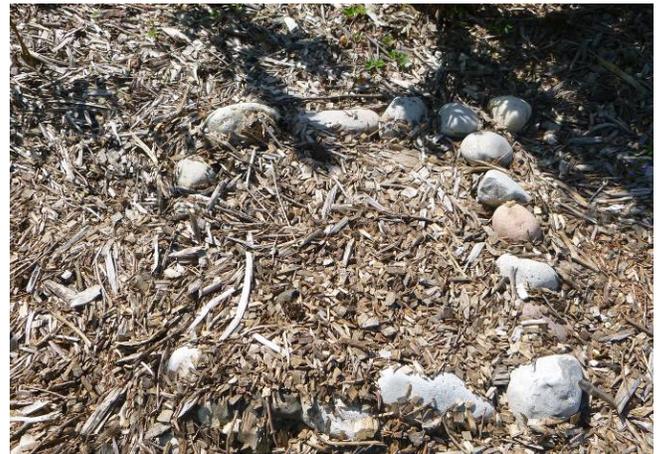
Mulch collects on the catchbasin overflow during large storm events.

CVC staff have also noted that water picks up and deposits the mulch on top of the catch basin during large storm events. The large pieces of mulch float easily and collect on and around the catchbasin overflow. This can impact the performance of the LID features, causing stormwater to backup into the parking

lot. To address this issue, the use of a better quality shredded mulch is recommended. Stacking stone up around the catchbasin or using a domed catchbasin will help to reduce mulch buildup on the grate.

A standard visual inspection of the drainage area, inlets, outlets, and bioretention bed was performed on October 29th, 2013. Overall, the facility passed the visual inspection protocol. However, the catchbasin which acts as an overflow was covered with geotextile cloth to prevent sediment and mulch from leaving the site. The cloth will need to be cleaned or replaced frequently to prevent extended or deep ponding problems. An alternative option like stacked stone or fencing is recommended for keeping mulch and debris out of the overflow. Shredded mulch and additional vegetation will also reduce the mulch that makes its way to the overflow.

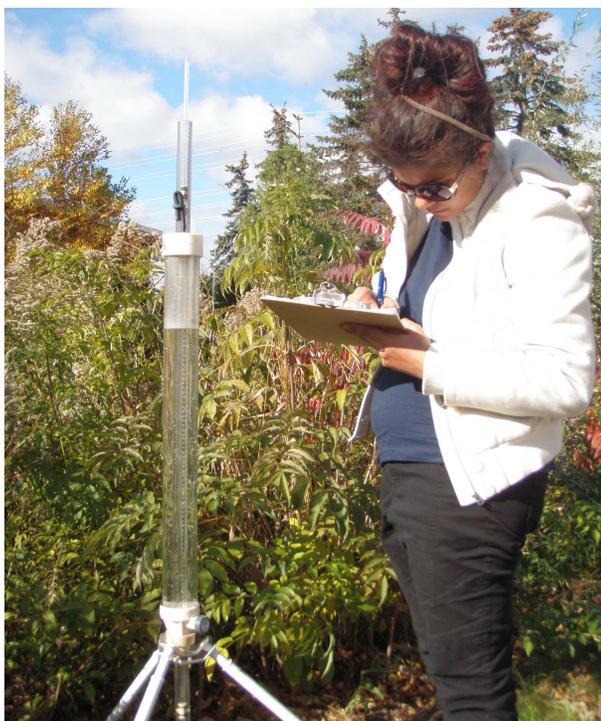
The Guelph Permeameter measure the hydraulic conductivity of the soil which can be converted to an infiltration rate.

The Guelph Permeameter method was used at the site on October 29, 2013. The Guelph Permeameter is one of several methods to measure the saturated hydraulic conductivity of soils which can then be translated into an infiltration rate. The bioretention facility passes the infiltration capacity protocol threshold of 25 mm/hr.

The tests were performed within a 24 hours dry period to ensure accurate infiltration results. A total of three tests for field saturated hydraulic conductivity were conducted and converted to an infiltration rate. The average infiltration rate of the three wells was 26 mm/hr which is higher than the 25mm/hr passing threshold.
