## Business and Multi-Residential

### Project Objectives, Design and Performance

The IMAX case study consists of the following sections:

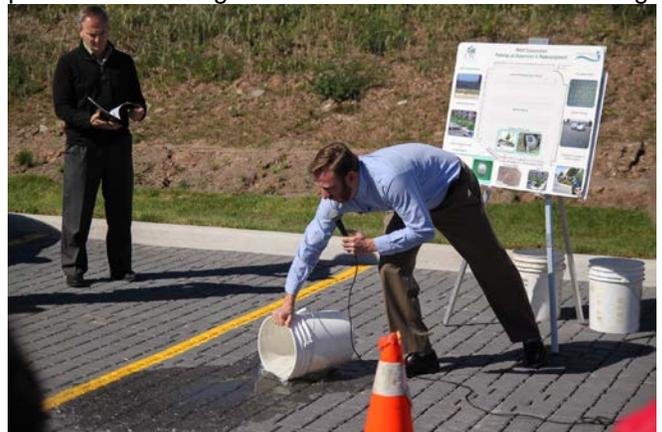
Figure 3: CVC staff demonstrating the effectiveness of the permeable pavers at infiltrating water

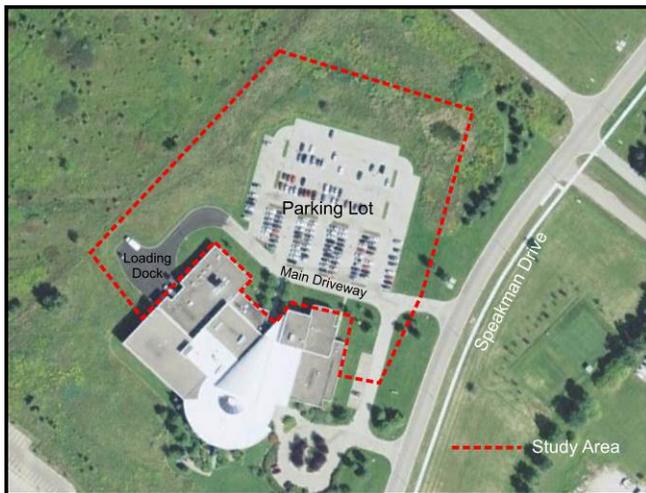
The IMAX retrofit site included the existing employee parking lot (0.62 hectares) and a portion of the main driveway (1370m<sup>2</sup>) which connects the main entrance from Speakman Drive to the loading docks located along the west side of the building (Figure 5). It also includes some of the surrounding natural area.

Figure 5: IMAX site – Pre-retrofit conditions

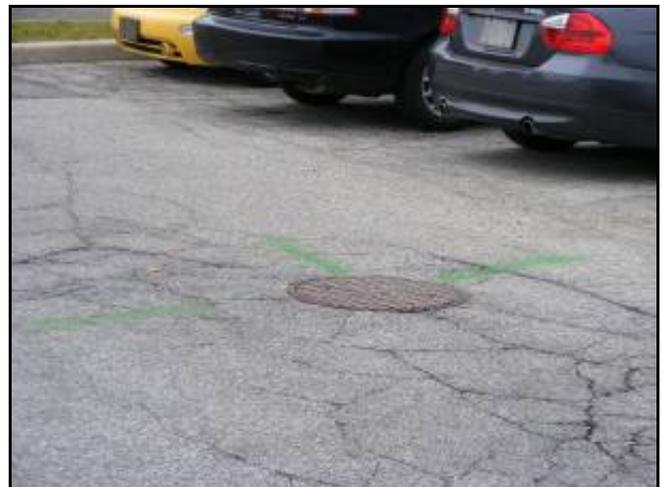
The pre-retrofit parking lot surface was in poor condition with signs of severe cracking, rutting, and spalling throughout the facility (Figure 6).

Figure 6: Pre-retrofit conditions - degraded asphalt

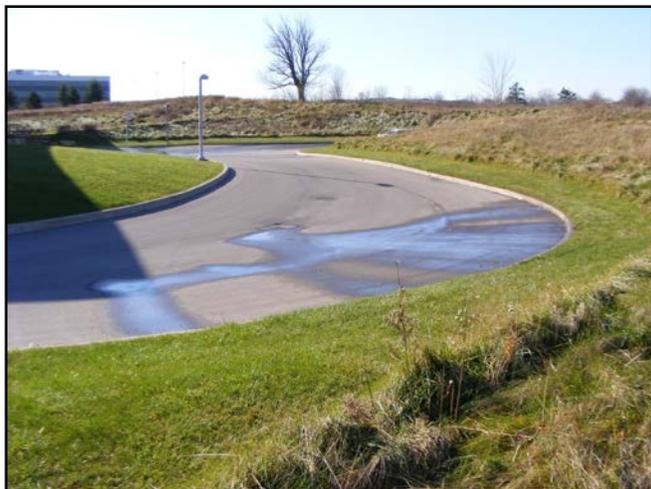
Wet weather events caused sustained standing water within pot holes and large cracks. Before it flowed overland to the nearest catch basins, groundwater from the high elevation areas pooled between the existing curb and asphalt surface (Figure 7).

**Figure 7: Pre-retrofit conditions: Groundwater seepage from surrounding high areas.**

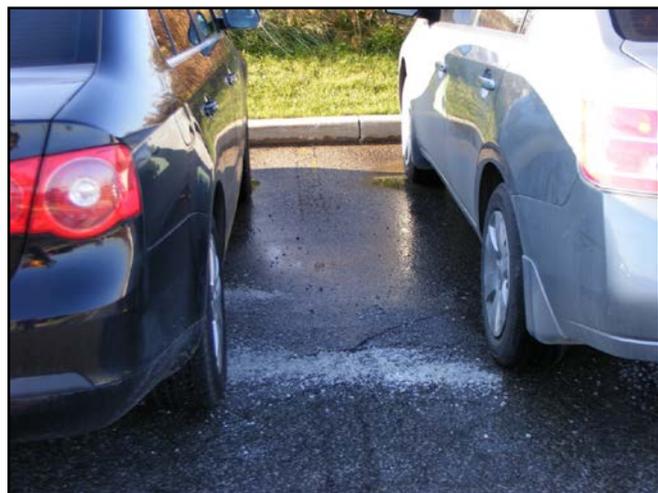
Poorly draining subsoils created saturated conditions that quickly degraded the asphalt surface, causing frequent ice build-up during winter months. Build-up resulted in increased salt application during de-icing operations (Figure 8). This salt negatively impacted the quality of stormwater runoff leaving the site.

**Figure 8: Pre-retrofit conditions - Excessive winter salt application**

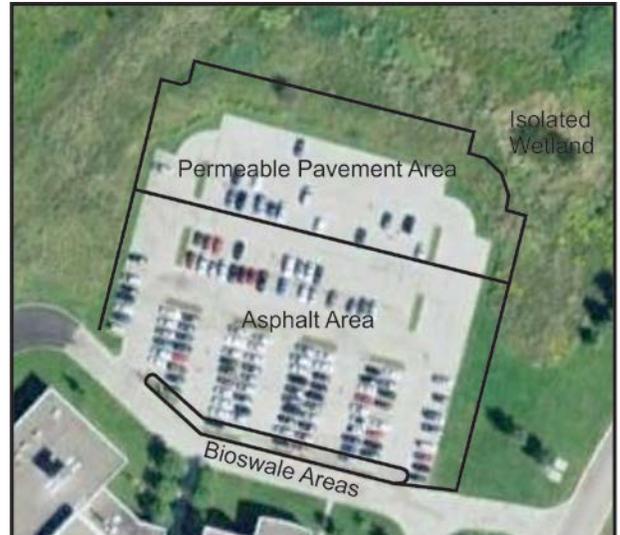
The parking lot surface was a combination of traditional asphalt and permeable pavement. The north part of the parking lot was set to be reconstructed using permeable pavement, whereas the south two thirds used asphalt paving. The proportion of permeable pavers to asphalt was a result of project budget and bedrock constraints. These constraints are described in subsequent sections (see *Pre-design Tasks* and *Detailed Design*). The stormwater runoff that infiltrated through the surface of the permeable pavement was designed to outlet to the isolated wetland where it can infiltrate and evaporate prior to discharging to the municipal storm sewer.

In addition to the bioswales and permeable pavers, the parking lot area incorporates various proprietary stormwater management technologies including Imbrium's Jellyfish® Filter and Sorbtive® Vault.

Figure 9: IMAX Retrofit Site – Retrofit Concept

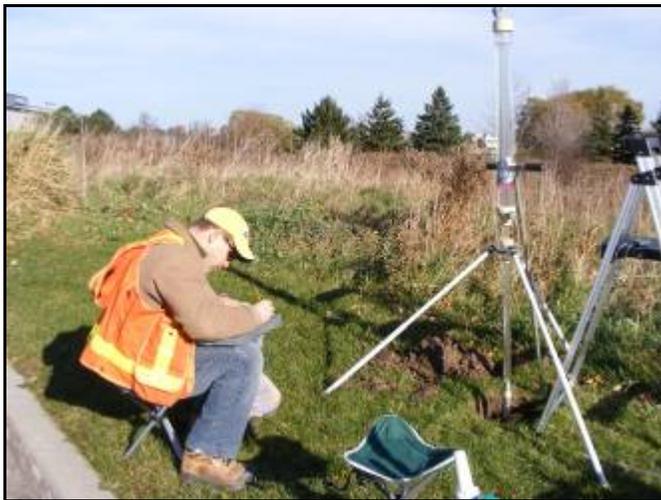
Guelph Permeameter testing was performed in December 2011 to determine the saturated hydraulic conductivity (Kfs) of the in-situ soils. The experimentally determined Kfs was converted to infiltration rate (mm/hr) and a factor of safety corresponding to the non-stratified soil condition was

**Figure 10: Infiltration testing conducted at IMAX.**

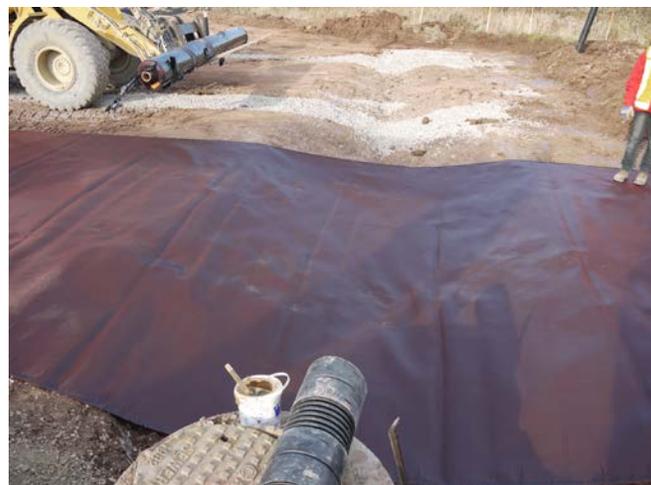
To augment the low soil stability of the sub-soils, the project team selected a high-strength woven monofilament geotextile (RS380i) to provide reinforcement strength and base course confinement, as well as high flow rates for infiltration and soil retention capabilities (Figure 12).

Figure 12: Tencate's Geotextile (RS390i).

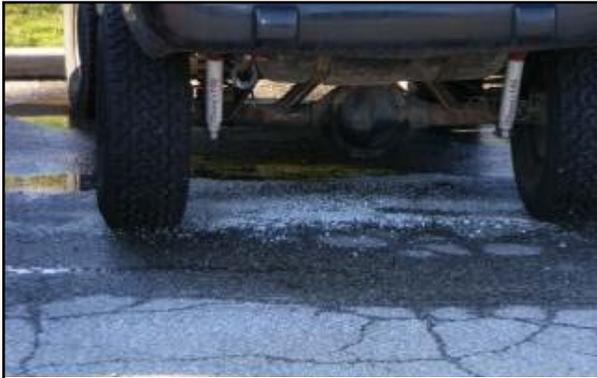
subsoils caused saturated conditions for days following wet weather events. The constant saturation of the subsoils weakened the supporting structure for the existing asphalt surface causing severe asphalt degradation. Throughout the winter, water would build up in the potholes and turn to ice which put employees at risk for slipping. Salt was extensively applied to eliminate the ice and risk of slipping (Figure 13).

Figure 13: Asphalt degradation at IMAX parking lot and extensive salt application.

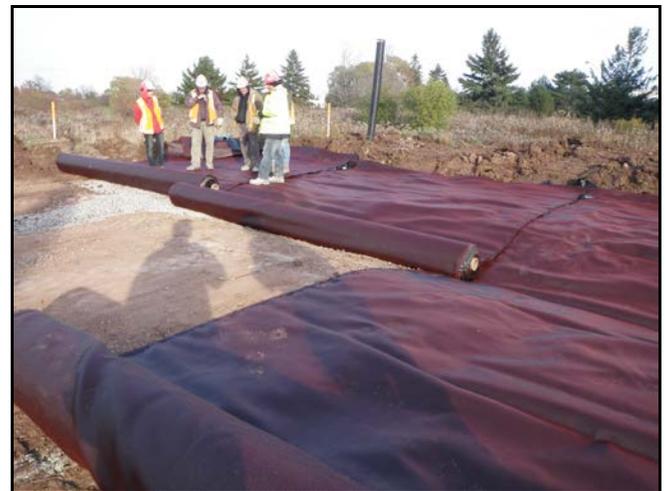
**Figure 17: Geogrid laid on subgrade.**

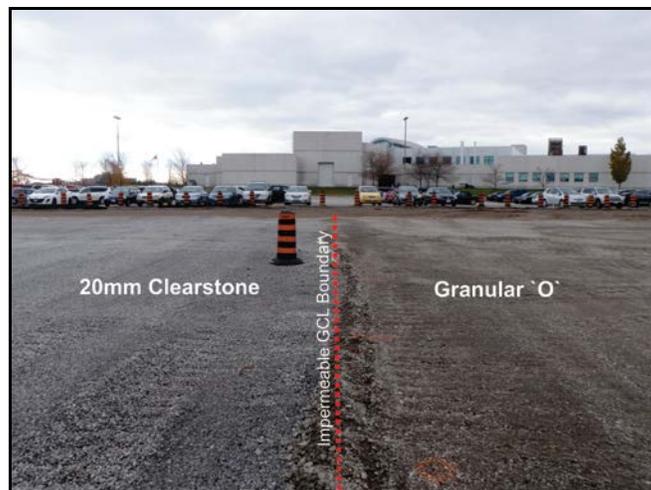
Granular "O" material was placed under the west half of the permeable pavement area while the 20 mm  $\emptyset$  clearstone was located on the east half. To effectively monitor the water quality and quantity performance of the two base materials, a Geosynthetic Clay Liner (GCL) spanned the boundary of the two base materials and permeable pavement to asphalt interface. The liner was keyed into the subgrade and sides of the excavation to ensure the base materials are fully separated, hydraulically. This configuration is shown in Figures 18 and 19.

**Figure 18: 20 mm  $\emptyset$  angular clearstone and Granular "O".**

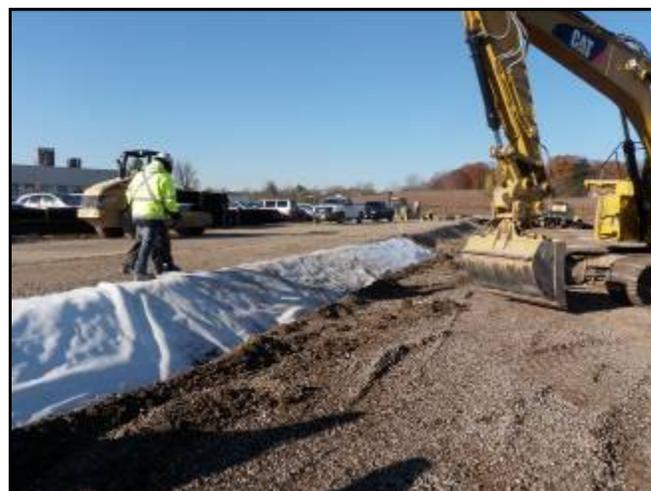
**Figure 19: Impermeable liner separating asphalt from permeable paver sections.**

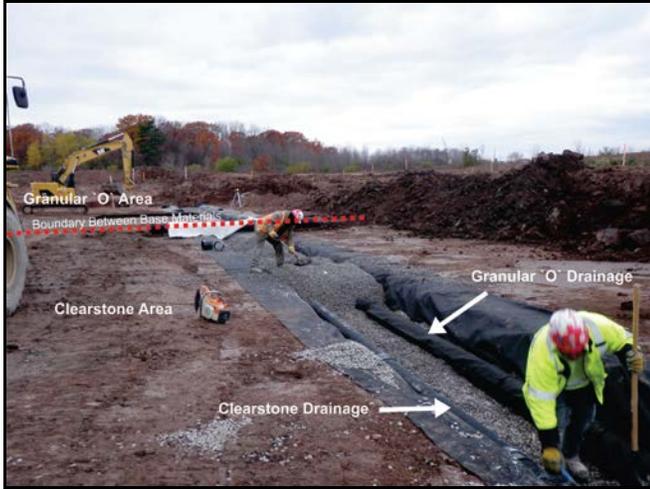
Each type of base material is underdrained by a separate network of piping and subsurface infrastructure as show in Figure 20. During the course of the monitoring program, samples collected from the underdrain below the Granular "O" area are separate from those collected from the 20 mm  $\emptyset$  clearstone areas. Depending on the results of the performance evaluation, the use of Granular "O" as an alternative base material for LID practices may prove beneficial from both a water quality and quantity perspective.

Figure 20: Underdrain configurations.

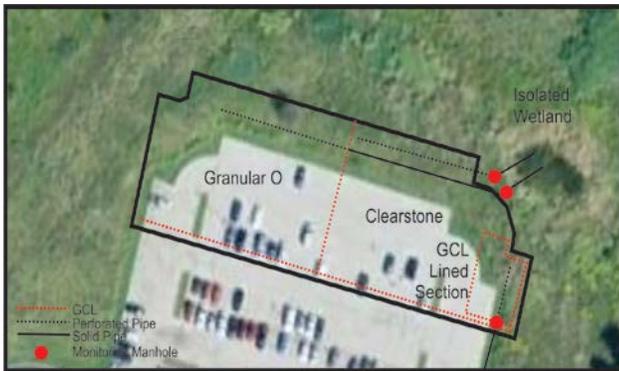
Figure 21 shows the layout of the underdrains and maintenance hole in which the water samples and flow monitoring are conducted.

Figure 21: Permeable pavement underdrain layout

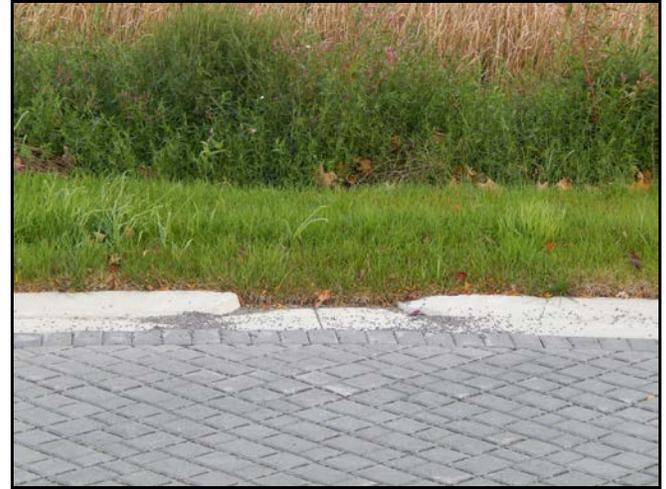
In the event runoff volumes exceed the capacity of the permeable pavers and underdrain system, excess flow discharge through a curb cut located at the northeast corner of the pavers (Figure 22) to an isolated wetland, and ultimately, enters the municipal storm sewer.

Figure 22: Overflow curb cut to wetland.

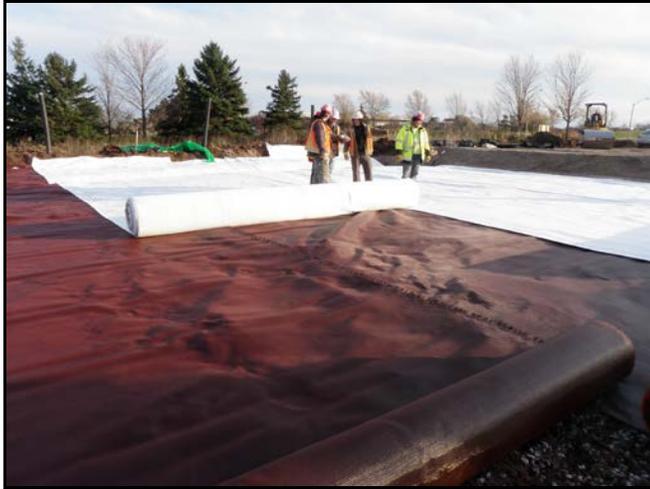
An area of permeable pavement and the entire base structure beneath it was isolated using the GCLs. The GCL was installed on top of the geotextile and wrapped up the sides of the excavation and the boundary between adjacent base materials and terminated just below the permeable paver surface (Figures 23 and 24). The overlapping seams were sealed with bentonite.

Figure 23: GCL installed along base material on top of the geotextile.

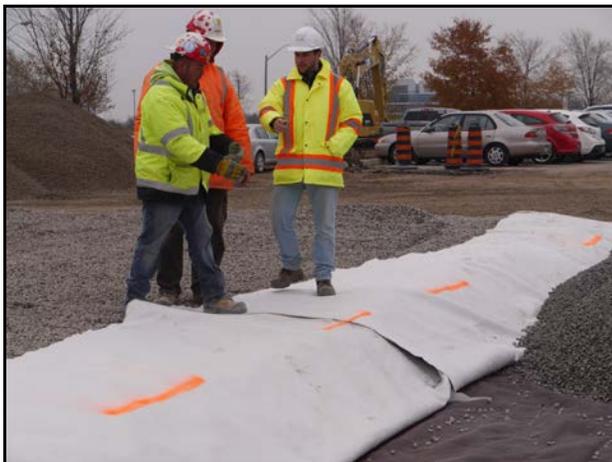
Figure 24: 20 mm Ø clearstone being wrapped with GCL.

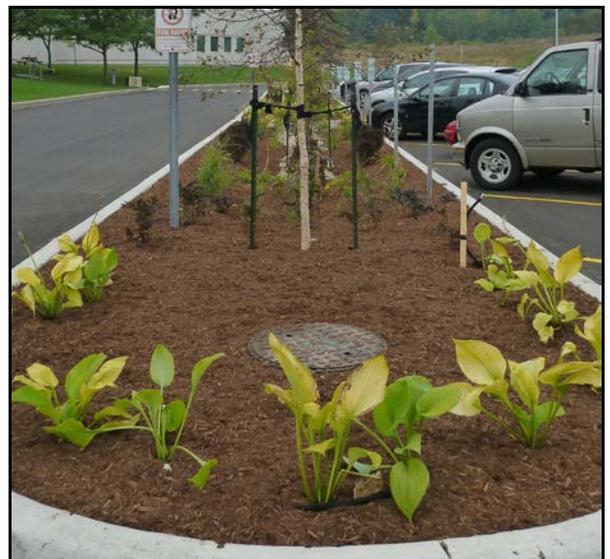
- Bioswale #1 (IX-2): West end, upstream of the Sorbtive® Vault polishing unit.
- Bioswale #2 (IX-3): Between the other bioswales and downstream of the Jellyfish® Filter pre-treatment system.
- Bioswale #3 (IX-4): Furthest east within the median, closest to the driveway entrance from Speakman Drive. Figure 25 is an example of a completed bioswale.

Figure 25: Bioswale after construction and landscaping.

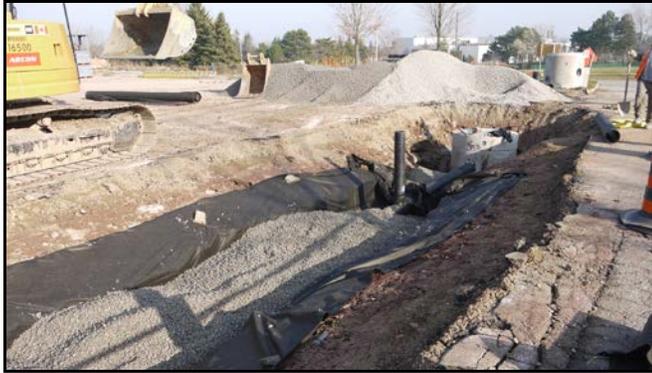
The bioswale underdrain system consists of an excavated trench lined with non-woven geotextile and filled with an open void 20 mm Ø clearstone. 200 mm Ø HDPE perforated pipes situated within the clearstone bedding underdrain the entire length of each bioswale. The 20 mm Ø clearstone bedding material is fully wrapped with non-woven geotextile so that it overlaps. This covers the top of the clearstone bedding material. Figure 26 shows the lining of the bioswale.

**Figure 26: Bioswale with non woven geotextile, 20 mm Ø clearstone with a 200 mm Ø HDPE perforated pipe.**

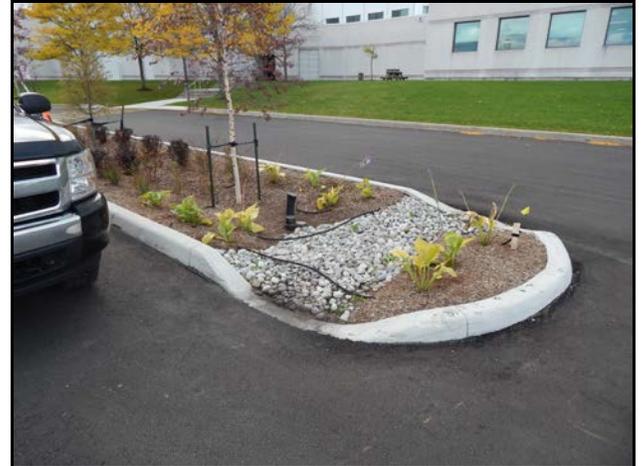
Inlets to each of the three bioswales consist of a simple curb cut in the barrier curb separating the parking lot and driveway areas from the bioswales. Following the inlets, a 150 – 300mm thick layer of 100 – 150 mm Ø round stone was embedded into the media acting as a flow dissipater and spreader for inflows.

**Figure 27: Completed bioretention cells, showing flow dissipater and curb cuts.**

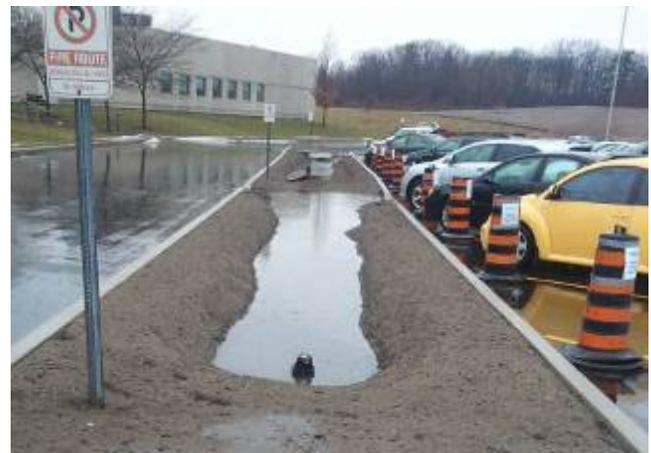
Runoff volumes that exceed the capacity of the bioswales are conveyed through overflows situated at the downstream limits/low point of the bioswales.

**Figure 28: Completed bioretention cell showing ponding. The overflow bypass is conveyed through a riser stand pipe connecting to the underdrain.**

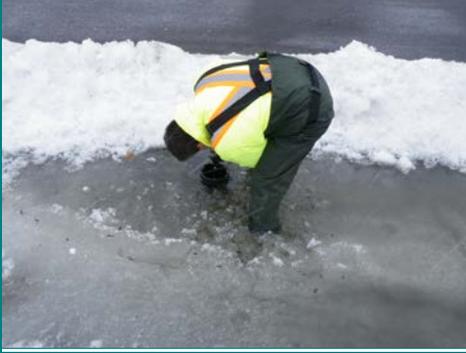
- During the 2013 winter, mild weather produced significant melt events. Slush and ice buildup around overflows limited flow capacity and backwatered runoff into the parking lot.

- Overflows were temporarily lowered to encourage flow and reinstated the following spring
- Secondary overflow was installed upstream near the curb cut inlets to the bioswales to act as a “fail safe” in the event downstream overflows suffer blockages.

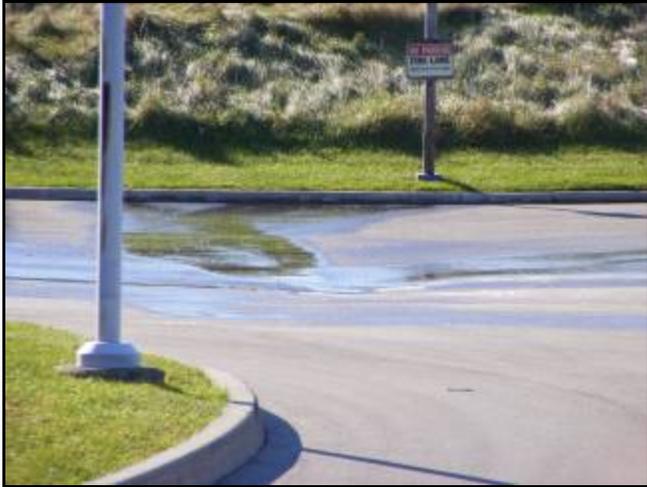
atop the bioretention soil media is manicured sod. The primary function of the swale is to intercept groundwater seepage before upwelling to the asphalt surface (Figure 29).

Figure 29: Groundwater seeping onto asphalt parking lot at IMAX prior to retrofit.

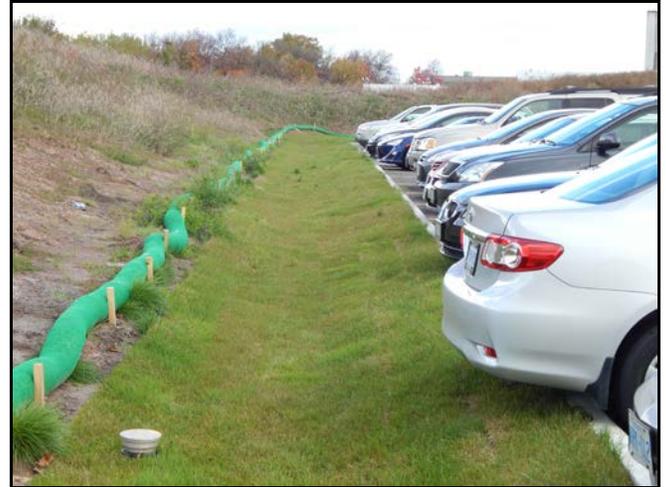
Figure 30: Grassed swale/sodded covered bioswale located along the west edge of the parking lot

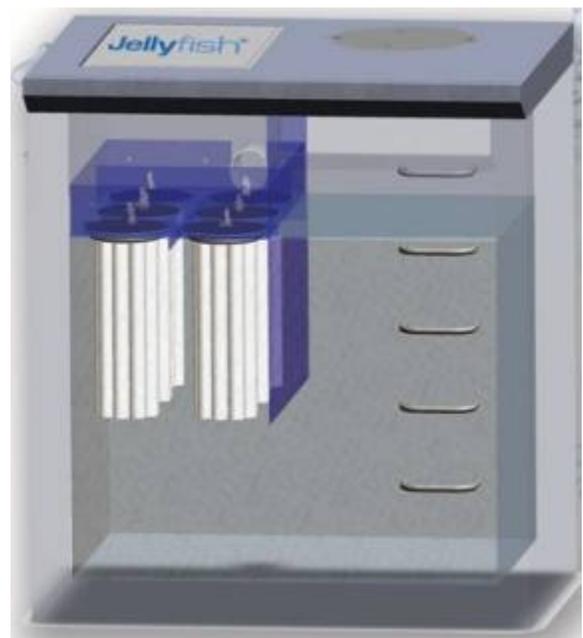
The Jellyfish® Filter is an engineered stormwater quality treatment technology featuring pre-treatment and membrane filtration in a compact stand-alone treatment system that removes a high level and wide variety of stormwater pollutants. Pollutant removal is achieved at high treatment flow rates with minimal head loss and low maintenance costs. Each lightweight Jellyfish® Filter cartridge contains an extraordinarily large amount of membrane surface area, resulting in high flow and pollutant removal capacity.

Figure 31: Jellyfish® Filter conceptual. (Source: Imbrium Systems)

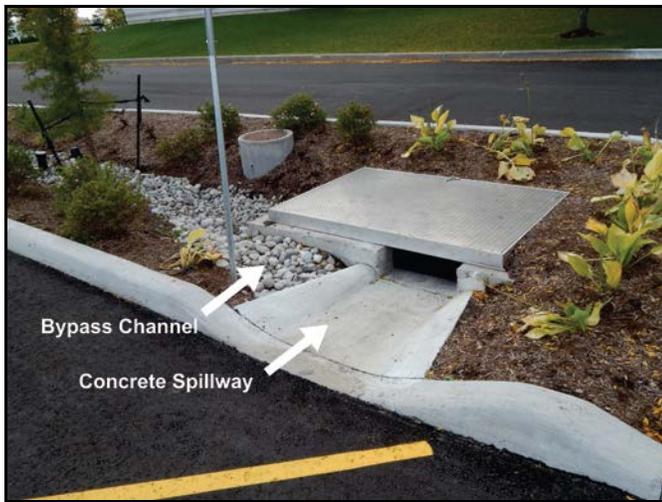
The unit installed at IMAX is situated upstream of Bioswale #2. It acts as a pre-treatment measure for stormwater runoff. Flows from the parking lot area enter a curb cut, flow down a concrete channel, and inlet the sump half of the Jellyfish® Filter unit.

Figure 32: Jellyfish® Filter installed at IMAX.

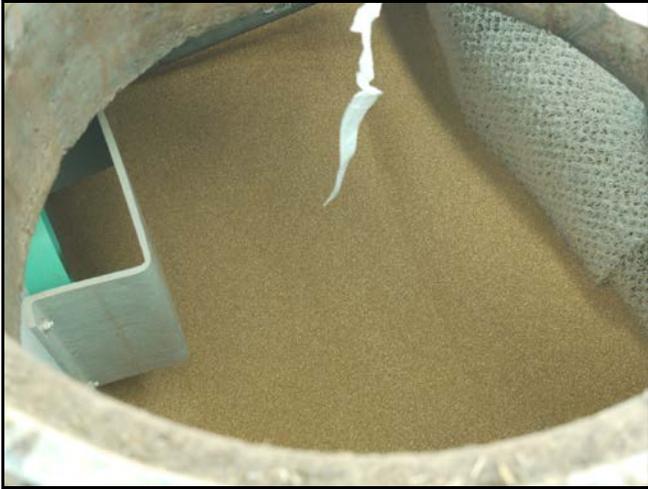
Sorbitive® Media is an oxide-coated high surface area reactive engineered media that sorbs and retains large phosphorus dissolved loads with a removal efficiency of 90%. Sorbtive® Media provides between 100 and 1,000 times more pollutant removal capability compared to conventional filtration media; and unlike other media, it does not desorb (leach) pollutants.

Figure 34: Sorbtive® Vault interior

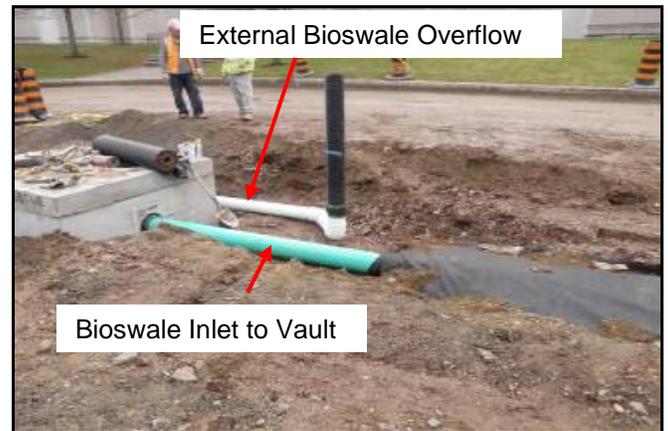
Figure 36: Sorbtive® Vault installed at IMAX and upstream bioswale.

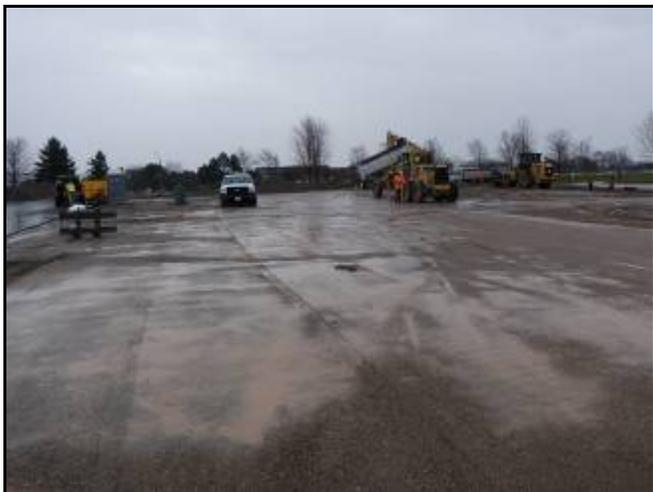
Figure 37: Wet conditions during construction due to severe weather.

Within the first several weeks of construction, five days of adverse weather delayed construction activities. To advance the project schedule, weekend work and extended work hours were required.

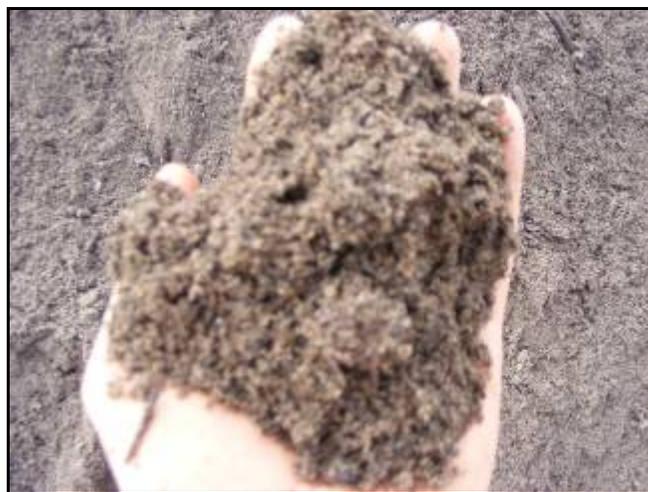
Filter media manufactured for the bioswale were analyzed to verify that the mixtures met the standards outlined in the Low Impact Development Planning and Design Guide.

Figure 38: Bioretention soil media consisting primarily of sand and organic material.

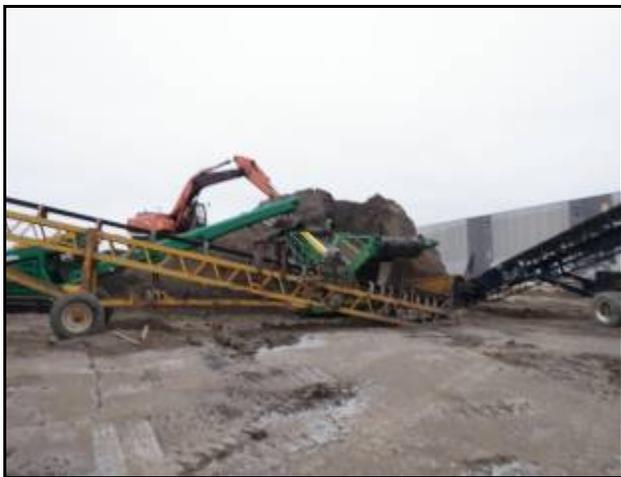
A two-point hydrometer test determined the soil textures of the sampled bioretention soil media and categorized the sample into percentages of sand, silt and clay. The test has a minimum detection limited of 2% for each particle size analyzed. The first samples submitted demonstrated 12% clay material and <2% silts which bordered on failure. A second sample was requested to verify manufacturing consistency and determine if the percentage of fines can be reduced. It is preferable to have bioretention soil media samples that demonstrate fine percentages closer to the low end of the acceptable range. The processes of loading, transporting and handling bioretention soil media material can often result in an increase in percent fines by the time the bioretention soil media is installed. Soils high in fines can be easily clog and reduce drawdown times. Clogging will negatively impact the effectiveness of the LID practice.

**Figure 39: Mechanically mixing process for bioretention soil media manufacturing.**

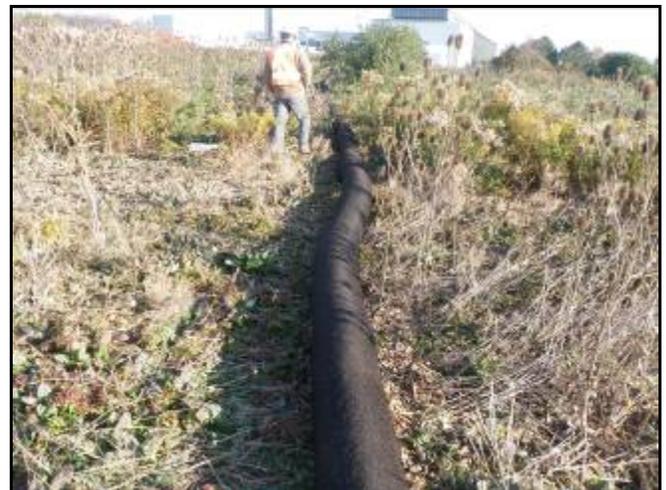
A typical erosion and sedimentation control plan was included with the design drawing. It consisted of catch basin inlet controls and filter socks. No excavated material had to leave the site, so road cleaning operations were limited.

**Figure 40: Filter sock installed to protect wetland.**

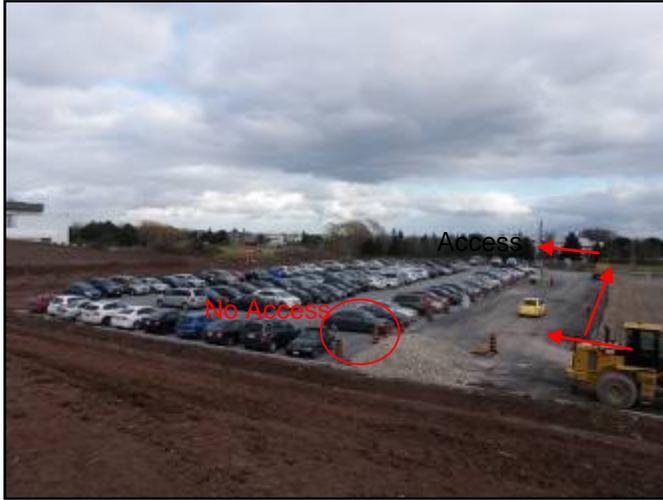
The most difficult ESC operation was controlling the amount of sediment deposited on the permeable pavers once they were designated as the primary parking area. During the construction of the asphalt areas, vehicular traffic had to travel over open aggregate to access the permeable pavers for parking. Through discussions between CVC, the contractor, and construction supervisor, it was decided vehicles would be diverted over washed clearstone and a temporary asphalt access strip prior to accessing the permeable pavers. Access to the permeable pavers was limited to a single

location so that the degree of contamination could be managed, monitored, and maintained more efficiently.

Figure 41: Access route to permeable pavement.

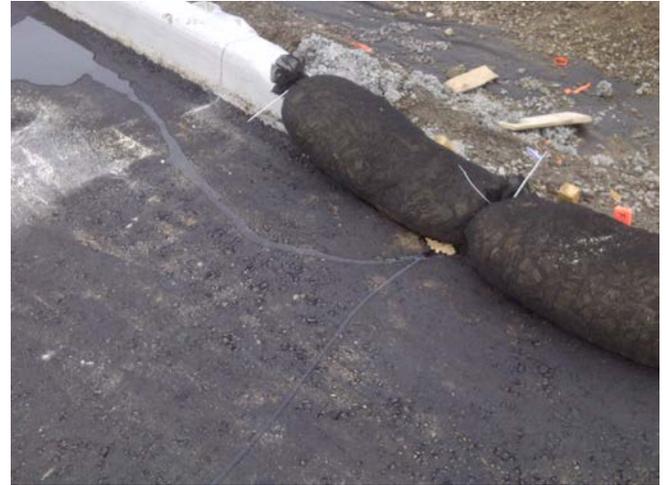
Filter socks were staked in place at the bioswale curb cut to prevent sediment laden runoff from entering the bioswales. These measures were removed once the bioretention soil media was installed and asphalt areas were stabilized.

Figure 43: Sediment socks installed at bioswale curb cuts.

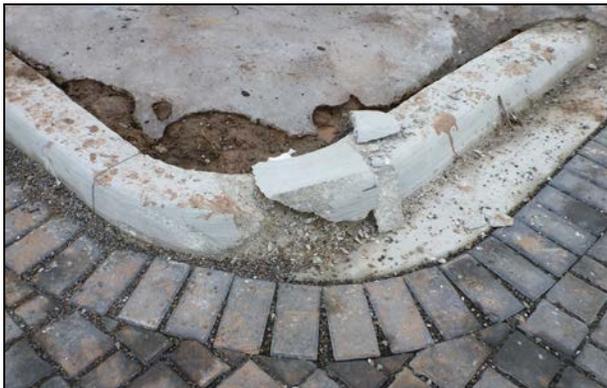
Figure 44: Curb damage due to snow ploughing.

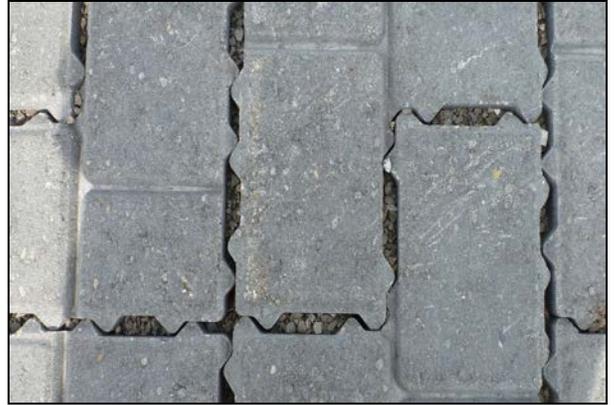
The steel plough used by the contractor scraped the surface of the permeable pavement (Figure 45). Rubber edging was installed on the steel plough to prevent further damage.

Figure 45: Paver scraped by winter plough.

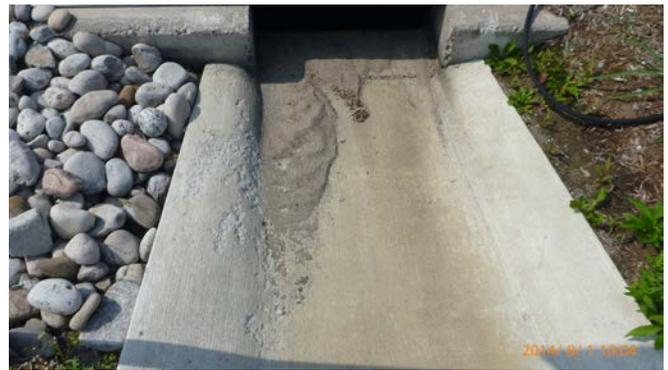
Figure 46: Sediment Accumulation in Jellyfish Filter Inlet

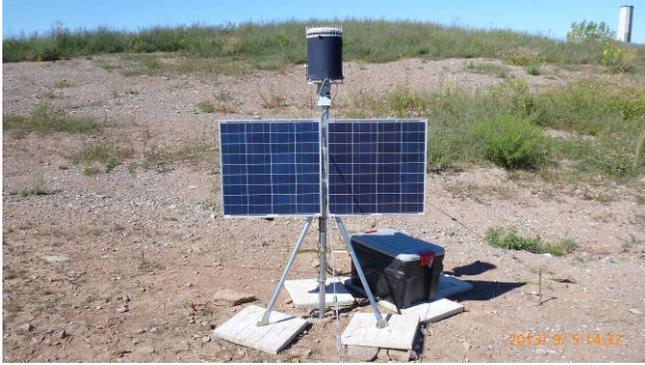
Figure 47: Heated rain gauge installed on-site.

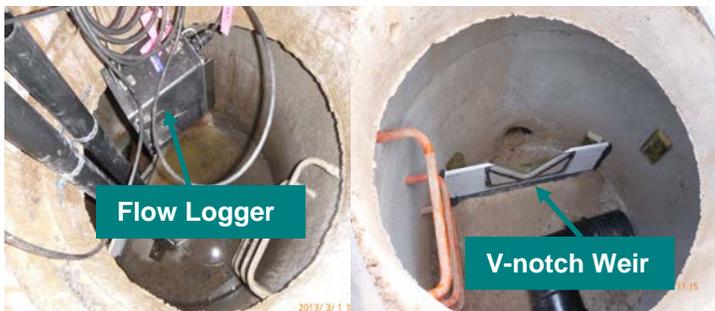
Figure 48: Water quantity monitoring set-up.

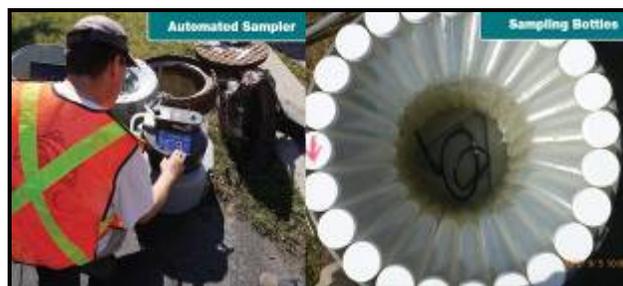
Figure 50: Water quality sampling.

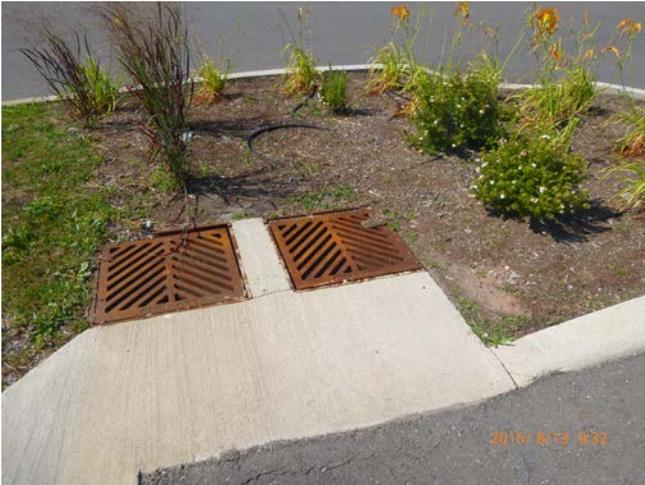
Figure 52: Control Site Receiver– Twin Catch Basin

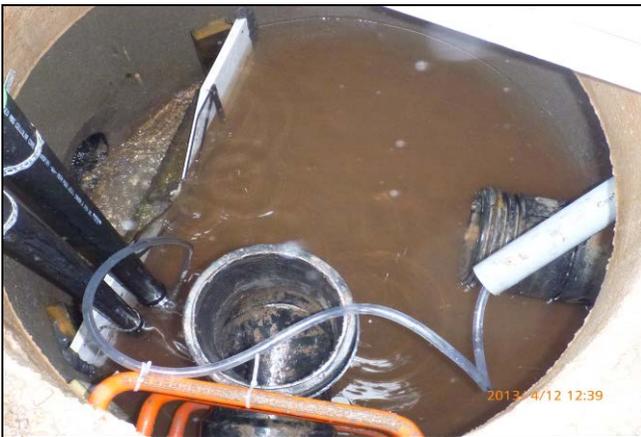
Figure 60: IX-5 – weir structure.

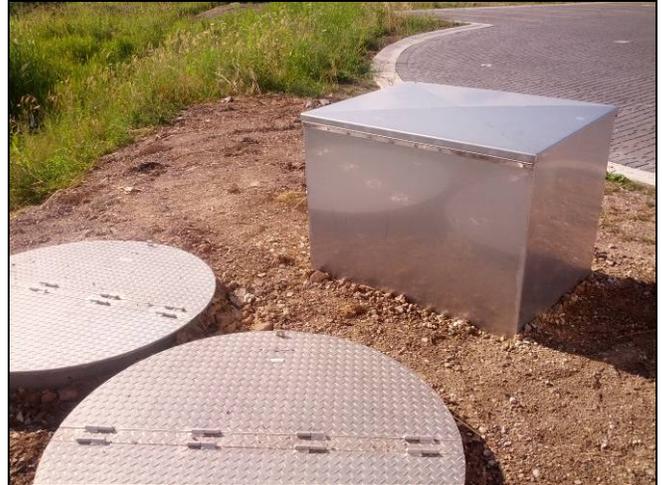
Figure 61: Steel box to accommodate Autosamplers.
