Portico: A Community Church

Location: Mississauga
 Constructed: 2011

Project Overview

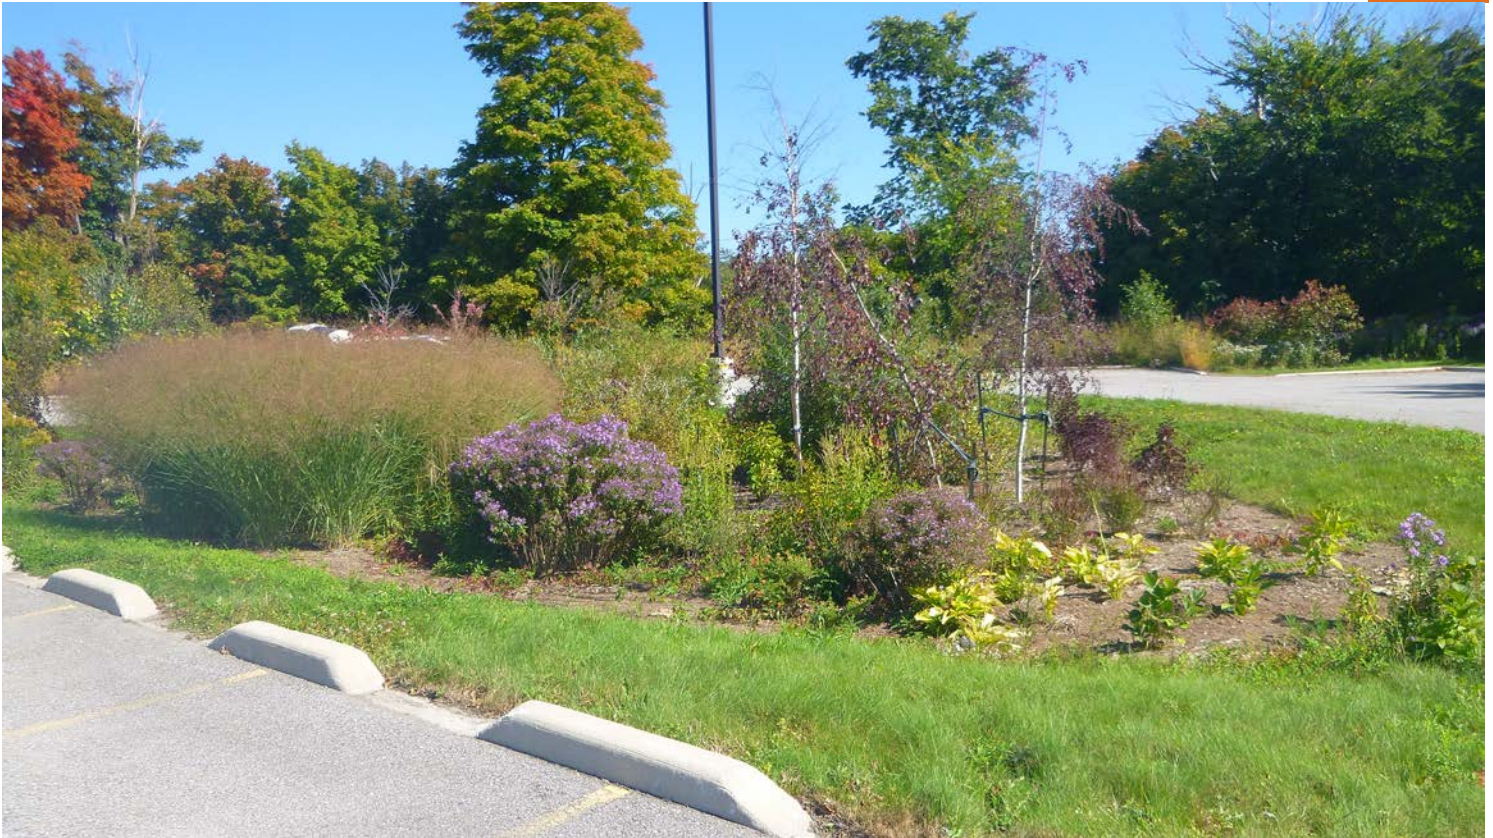
The bioswale (rain garden) at Portico Church absorbs and filters runoff from a parking lot that would have otherwise drained directly into the Credit River. The parking lot bioswale was added to the parking lot island in 2011.

The bioswale collects stormwater run-off from the parking lot and cleans the water through an engineered soil mixture and selected vegetation. In the bioswale, the interaction of plants, soil and natural microbes remove pollutants to improve the quality of water flowing back into the Credit River.

The design has curb-cuts to promote inflow of stormwater runoff. The parking lot runoff enters the rain garden as sheet flow.

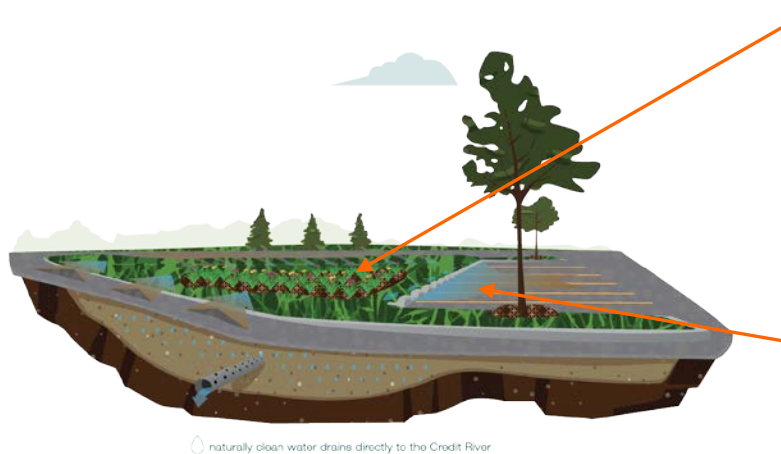
naturally clean water drains directly to the Credit River

Bioswale

Sheet Flow

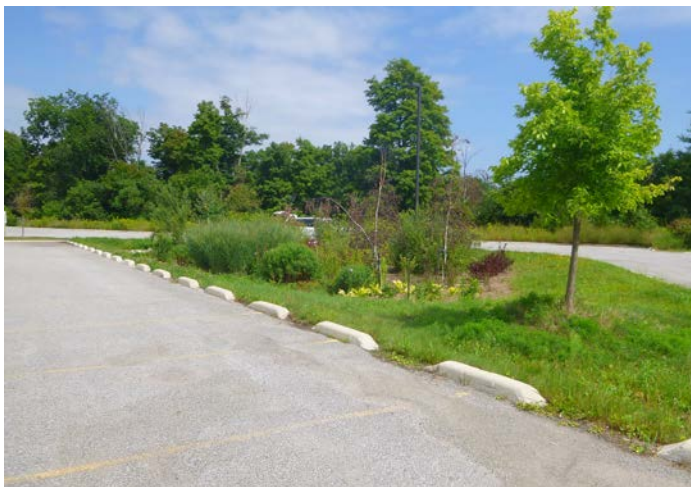
Photo taken during an LID Inspection in July 2014

Landscaping – The bioswale landscaping consists of a variety of trees, shrubs, and flowering perennials. The plants have had four years to establish and have been found to thrive.

Maintenance – Portico Church has been performing maintenance including litter pickup and weeding.

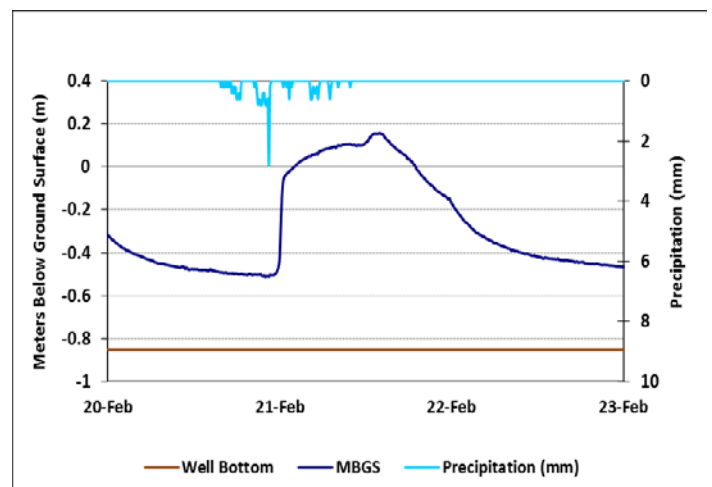
Performance – Analysis of water level data collected from 2013 to 2014 indicate that the bioswale is performing well and functions within the design parameters. Any ponding of water that occurs on the surface is able to soak into the bioswale within 24 hours. The bioswale is also able to function in the winter when the ground is frozen as melt events are able to infiltrate through the engineered soil mix. The figure below shows a rain event in February 2014, where infiltration into the bioswale occurred after a short period of surface ponding.

Precipitation event and measured water level in February 2014
