Low Impact Development Infrastructure
Performance and Risk Assessment
July 2015

Technical
Report

LOW IMPACT DEVELOPMENT INFRASTRUCTURE PERFORMANCE AND RISK ASSESSMENT

TECHNICAL REPORT (2012 – 2013)

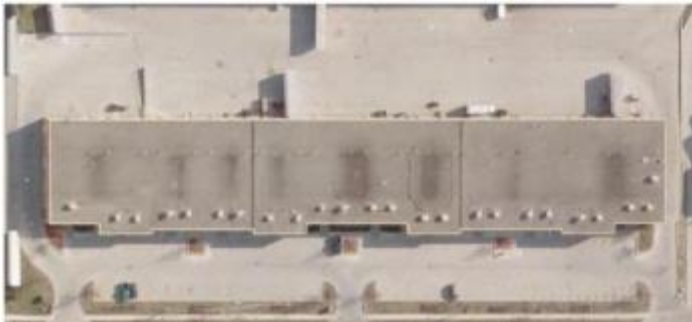
Figure 1-2: Large roof area and asphalt pavement that account towards impervious area in a typical industrial/commercial setting.

SWM Guidelines. Commercial and industrial land uses often have high percentage of impermeable surfaces including rooftops, parking lots, laneways and roads. These surfaces generate large amounts of runoff that need to be collected and managed by costly stormwater infrastructure. The runoff contains pollutants that enter downstream ponds, creeks and streams. Poor SWM can put the environment, infrastructure and human safety at risk.

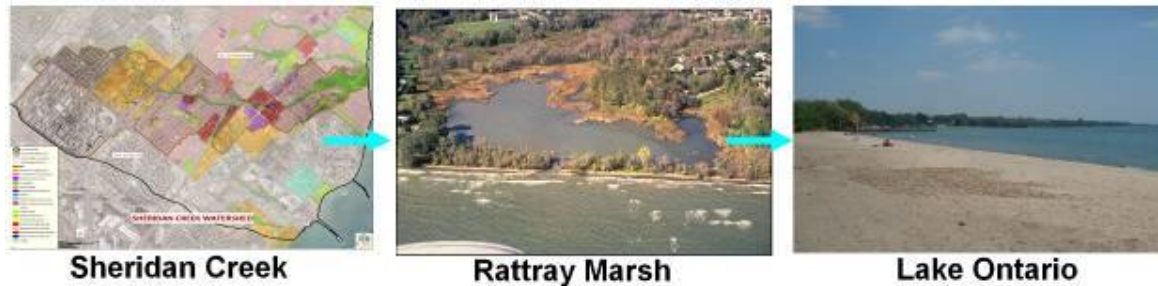
Figure 1-3: Sheridan Creek, Rattray marsh and Lake Ontario

The IMAX Headquarters head office is located at 2525 Speakman Drive, Mississauga. This location is at the headwaters of the Sheridan Creek Subwatershed as shown in Figure 1-3. The Sheridan Creek Watershed is a long, narrow, fully urbanized watershed located on the west side of the City of Mississauga. The subwatershed drains an area of approximately 1,035 hectares (ha) and outlets to Rattray Marsh. Rattray Marsh is a Provincially Significant Wetland (PSW) and Provincial Area of Natural and Scientific Interest (ANSI). The water then flows into Lake Ontario which is the drinking water supply for millions of Canadians (see Figure1- 3).

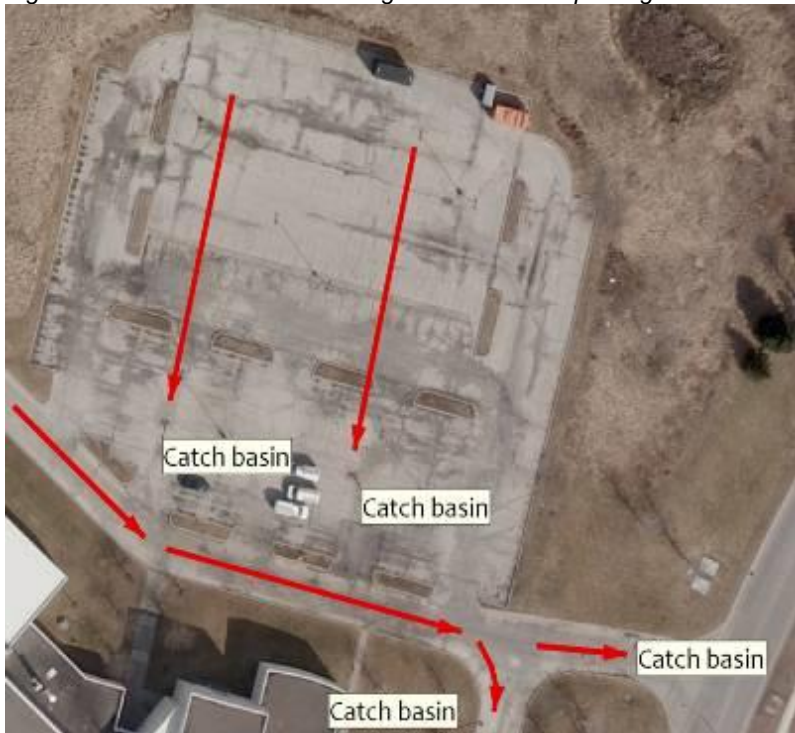
Figure 1-5: Before Retrofit – Drainage from the IMAX parking lot

These innovative practices store and filter stormwater before it enters the Sheridan Creek and Lake Ontario. **Figure 1-5** and **Figure 1-6** show the drainage patterns of the parking lot before and after construction.

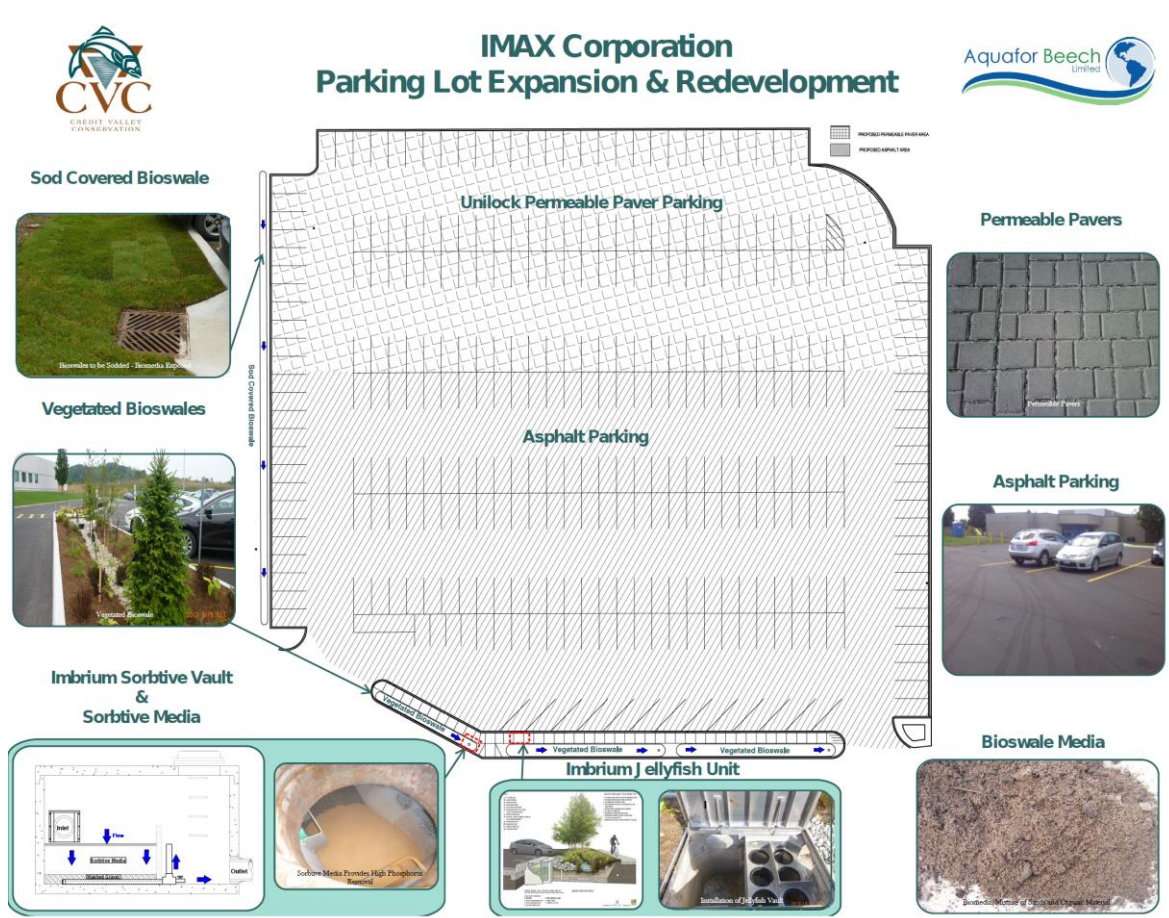
Figure 3-1: IMAX retrofit design concept

The total drainage area for the site is 0.93 ha (9,268 m²) based on 2013 as-built survey results, see Appendix E for details. The IMAX parking lot retrofit applies LID designs to a SWM system that is customized to suit local hydrology and geology conditions. The layout of the parking lot is shown in **Figure 3-1** below which outlines the locations of the different SWM technologies. The main source of runoff to the LID systems is from the parking lot and entrance driveways. The parking lot has been divided through the upper third with permeable pavement on the north end and asphalt draining into a series of LID treatment trains on the south end.

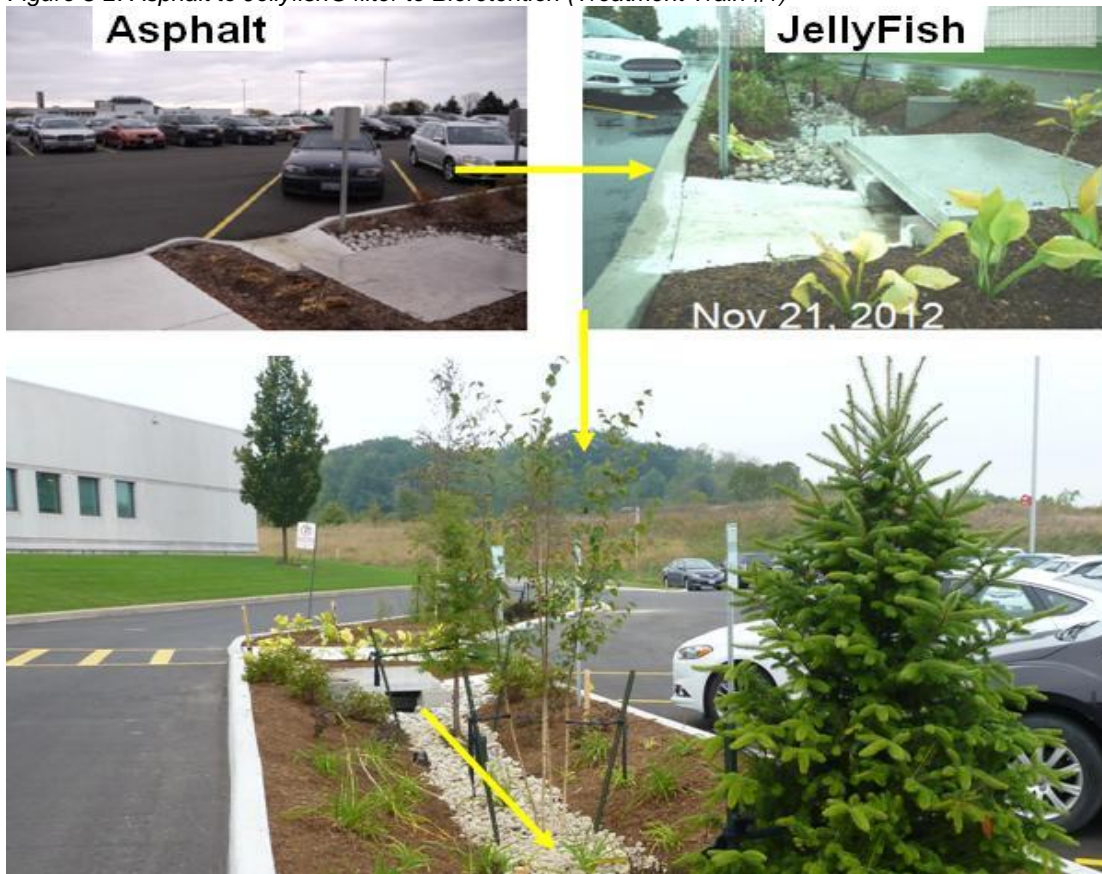
Figure 3-2: Asphalt to Jellyfish® filter to Bioretention (Treatment Train #1)

large intensity occurs producing flow rates that overwhelm the Jellyfish® filter, the bioswale downstream will still provide some level of effluent treatment. Similarly, for the other treatment train, if the bioswale is overwhelmed during an intense storm, the overflow/bypass will receive some level of treatment through the Sorbtive® Vault unit. These in-series LID combinations are the first of their kind in Ontario. The treatment trains implemented at IMAX and the components of the design are shown in **Figure 3-2** and **Figure 3-3** below. Treatment train #1 drains asphalt generated runoff to a Jellyfish® Filter for pre-treatment and then outlets to a bioretention for secondary treatment. Treatment train #2 drains asphalt generated runoff to a bioretention for pre-treatment and then to a Sorbtive® Vault for further polishing and secondary treatment. As shown in **Table 3-1** under Section 3.3, treatment train #1 drains 1256 m² of contributing drainage and treatment train #2 drains 1110 m².

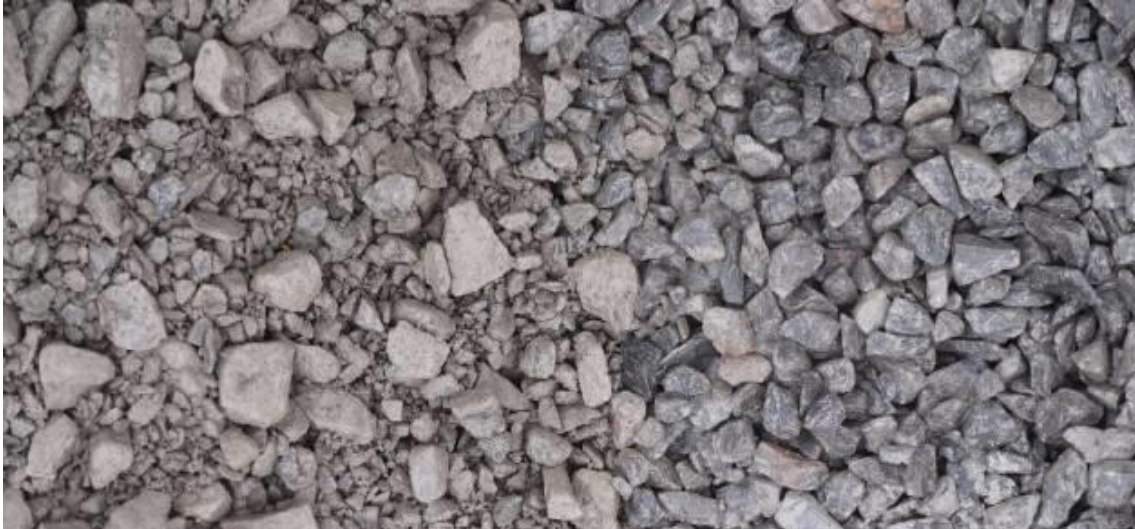
Figure 3-4: Granular "0" (left) and 3/4" Clearstone (right)

As part of the experimental design, the permeable pavement parking lot was separated into two sections to include different aggregate materials to investigate permeable pavement design. These sections are hydraulically separated with an impermeable liner. Each section is designed to have an independent underdrain system so performance comparisons are possible. **Figure 3-7** shows the permeable pavement lot has three distinct catchments; Area 5, Area 6 and Area 7. Area 5 has been constructed with a granular “O” base. Areas 6 and 7 have been constructed with a 20 mm clear stone base. Infiltrating stormwater from these catchments will be routed to manholes IX-5, IX-6 and IX-7, respectively. Stormwater from IX-5 and IX-6 discharge to the constructed wetland that is adjacent to the IMAX property. IX-7 drains to the municipal sewer. As outlined in **Table 3-1** under section 3.3, the contributing drainage areas for IX-5 and IX-6 are 1915 m² and 1328 m², respectively.

Clear stone is recommended for permeable pavement systems because it does not include fines and has large void spaces that provide storage for infiltrating stormwater. The lack of fines means that larger aggregate depth is required to meet structural requirements for traffic loadings. Aggregate ‘O’ is readily available in Southern Ontario and requires less aggregate depth to meet structural requirements. This study tests Aggregate ‘O’ as an alternative base material which may offer better balance between structural and environmental objectives.

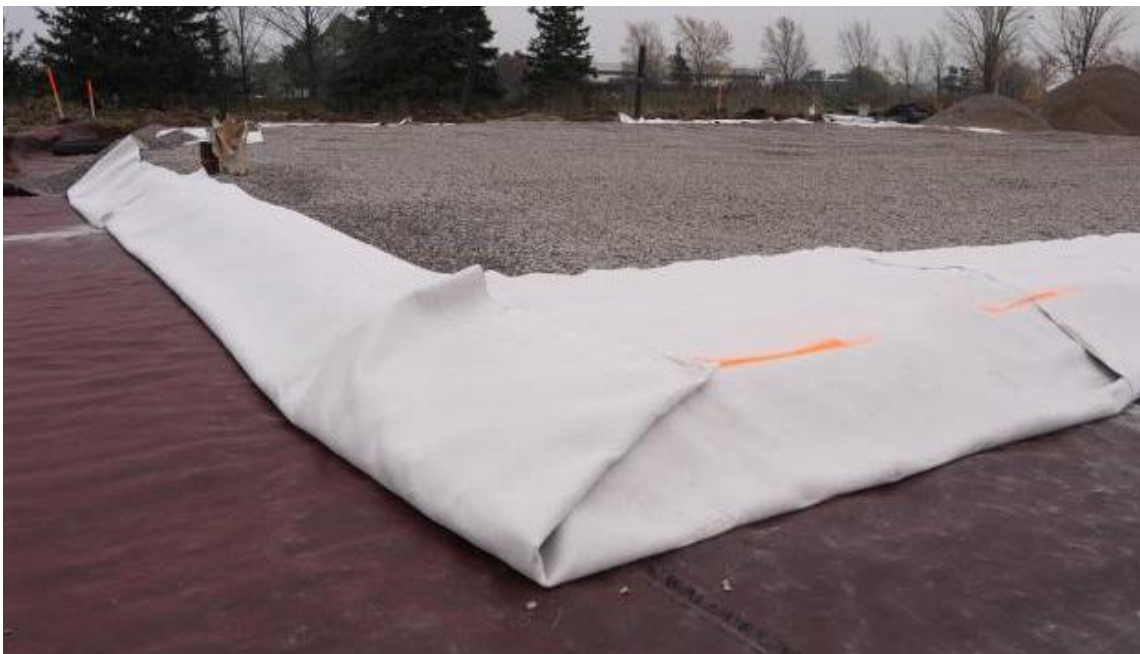
Figure 3-5: Geosynthetic Clay Liner

The risk to groundwater systems from LID is unknown. Fully lined and underdrained permeable pavements are not anticipated to pose a significant risk if all infiltrating stormwater is routed to a conventional storm sewer system (Area 7). The IMAX property is a good location to test and monitor a lined permeable pavement system as it is not an area of groundwater sensitivity. The monitoring data can be used to assess lined infiltration systems in groundwater sensitive areas such as CVC's upper watershed and across Southern Ontario. The subcatchment has sampling ports beneath the liner that connects to an observation well. This well can be used to check for leakage when performing an annual dye test. As outlined in **Table 3-1** under section 3.3, the contributing drainage area for IX-7 is 478 m².

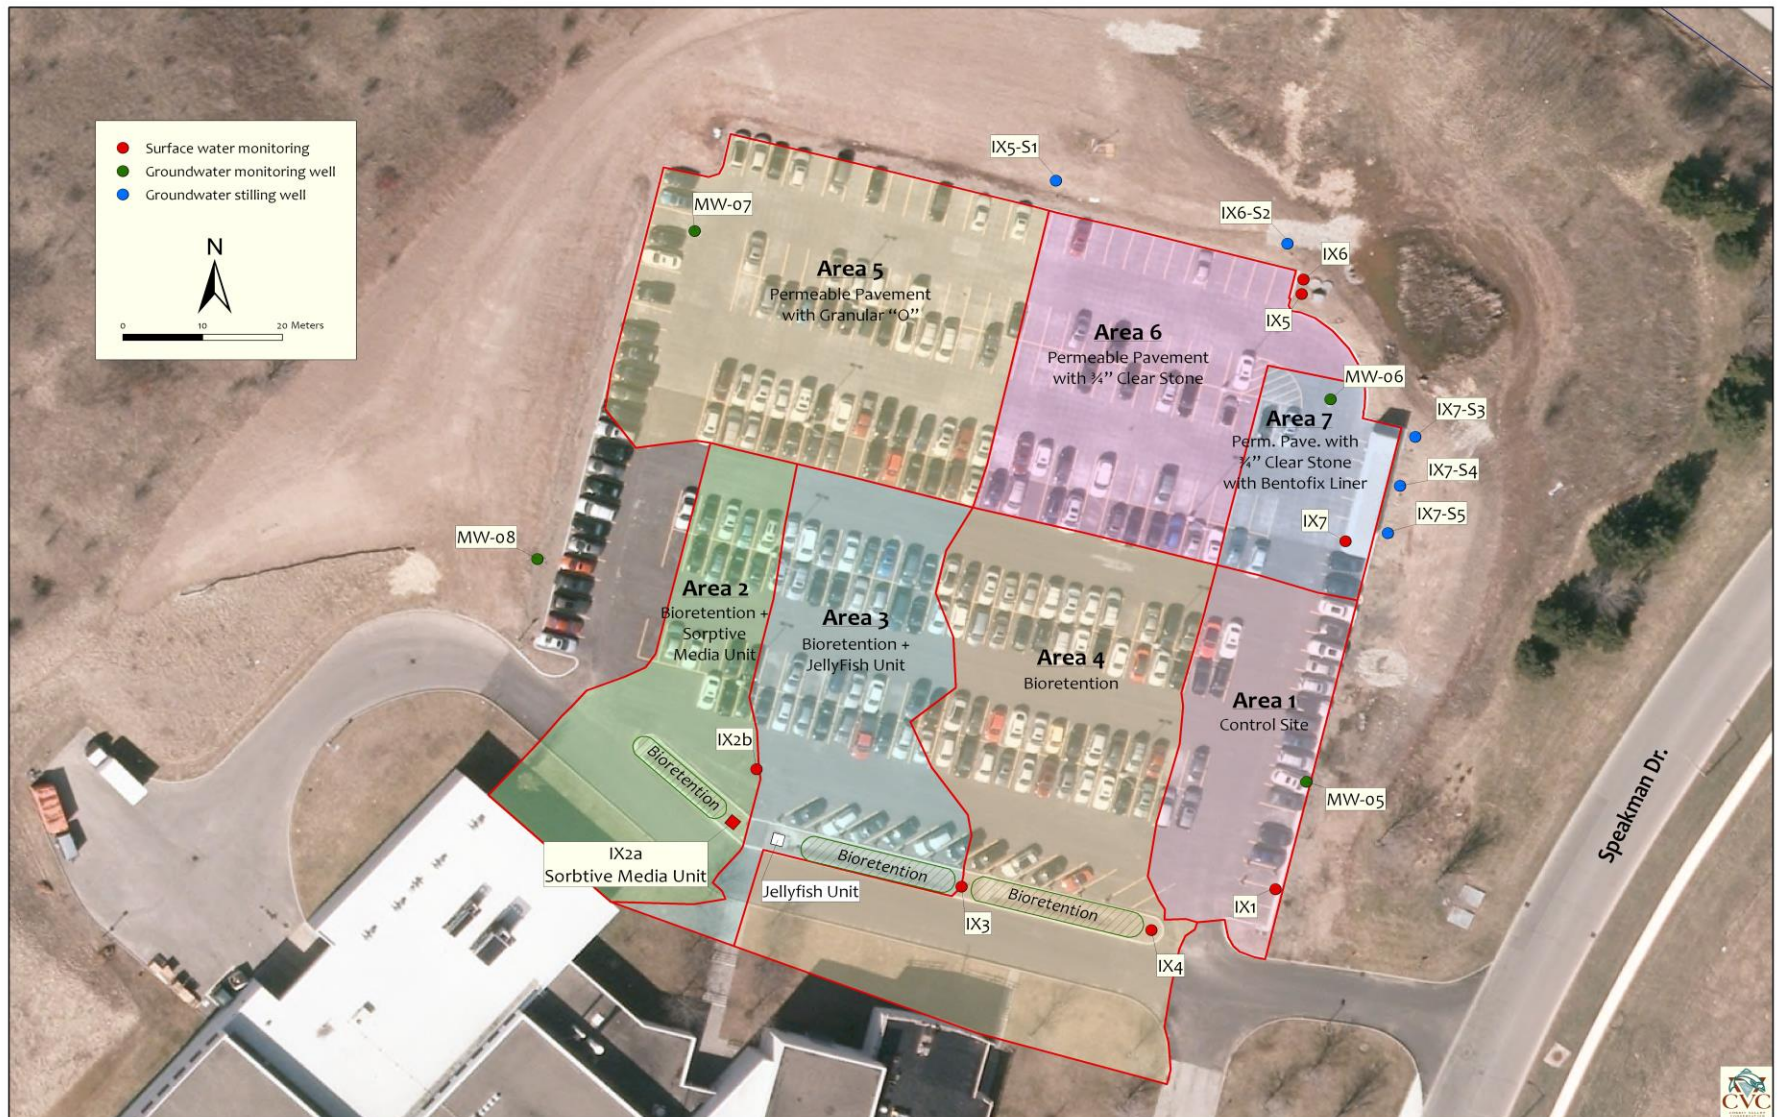
Figure 3-7: Catchment Areas and monitoring stations

The parking lot has been divided into seven subcatchments, defined by the drainage area entering each SWM system. There are seven monitoring stations where stormwater flows are monitored and sampled. Soil conditions are unsuitable for complete stormwater infiltration so the bioretention cells and permeable pavements are designed as underdrained systems. This means that infiltrated stormwater will be collected through buried perforated pipes. The underdrains are dual purpose, providing access points to measure and sample infiltrated stormwater while simultaneously conveying excess stormwater to the receiving municipal stormwater system.

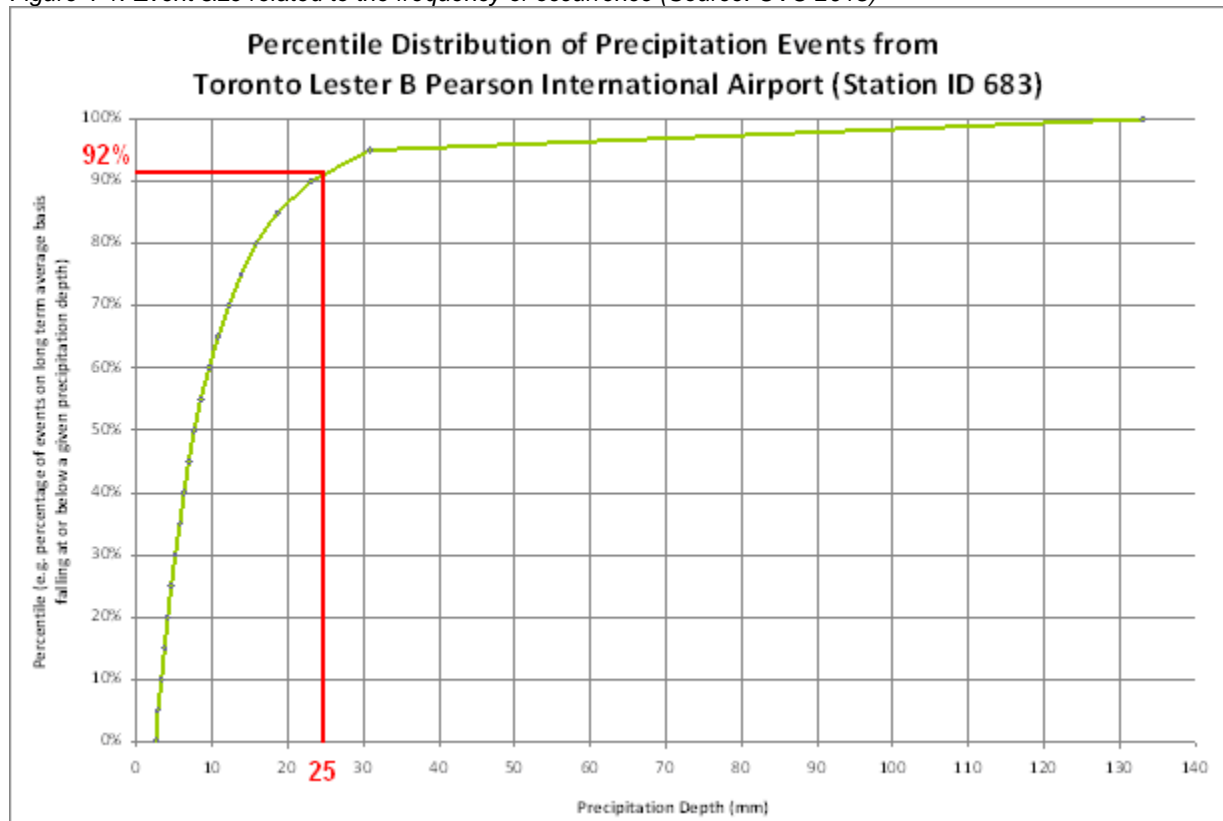
Figure 4-1: Event size related to the frequency of occurrence (Source: CVC 2013)

Toronto Lester B. Pearson International Airport weather station. The analysis was completed using WQ-COSM, software which is designed for modeling water quality (CVC 2013). The analysis indicates that 92% of all precipitation events were 25 mm or smaller. **Figure 4-2** below indicates the number rainfall events that were recorded at IMAX from February to December 2013. Precipitation events are defined as periods of precipitation with a depth of 2 mm or greater. Sixty-two (62) events were observed during this monitoring period (February to December 2013); of these, fifty-five (55) had a precipitation depth smaller than 25 mm. This is equivalent to 89% of the total precipitation events observed during the monitoring period, which is consistent with the average precipitation patterns observed in Southern Ontario.

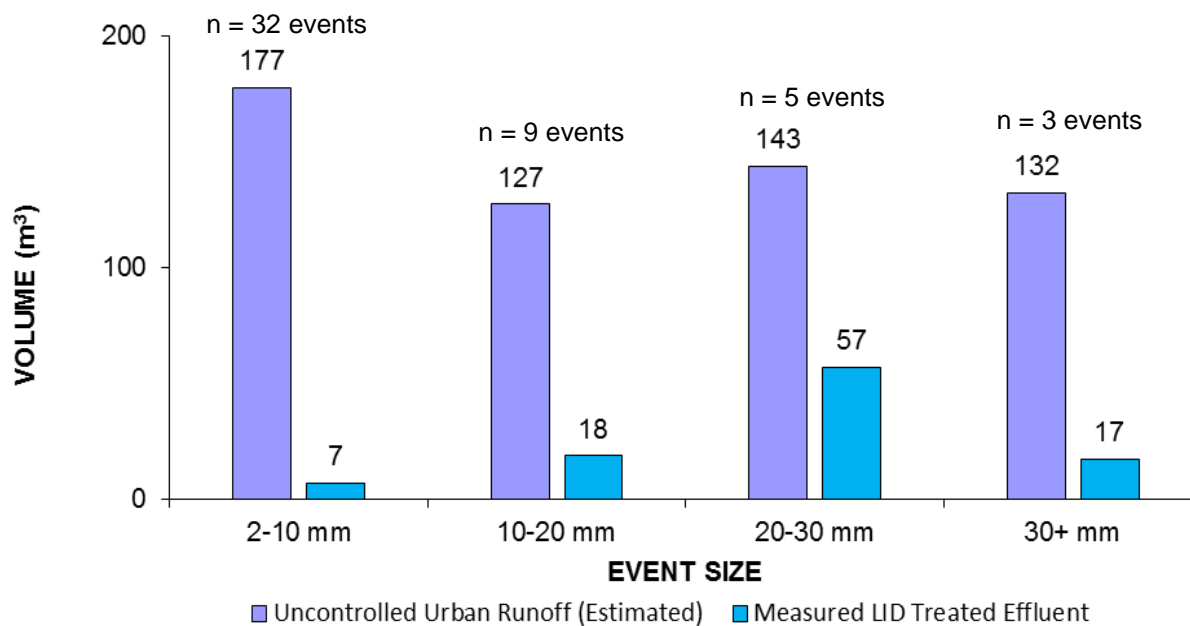
Figure 4-3: Runoff volume reduction from IX-2b for different event ranges

Summaries of the overall runoff volume reduction achieved by IX-2b, IX-3, and IX-5 are provided below in Figure 4-3, Figure 4-4, and Figure 4-5, respectively.

IX-2b achieved an average volume reduction of 91% for the forty-nine (49) precipitation events observed at this location during the 2013 monitoring period. 100% volume reduction was observed at IX-2b for nineteen (19) precipitation events, the largest of which had a total precipitation depth of 10.6 mm. This event (the IX-2b “no flow” event) occurred on June 2, 2013.

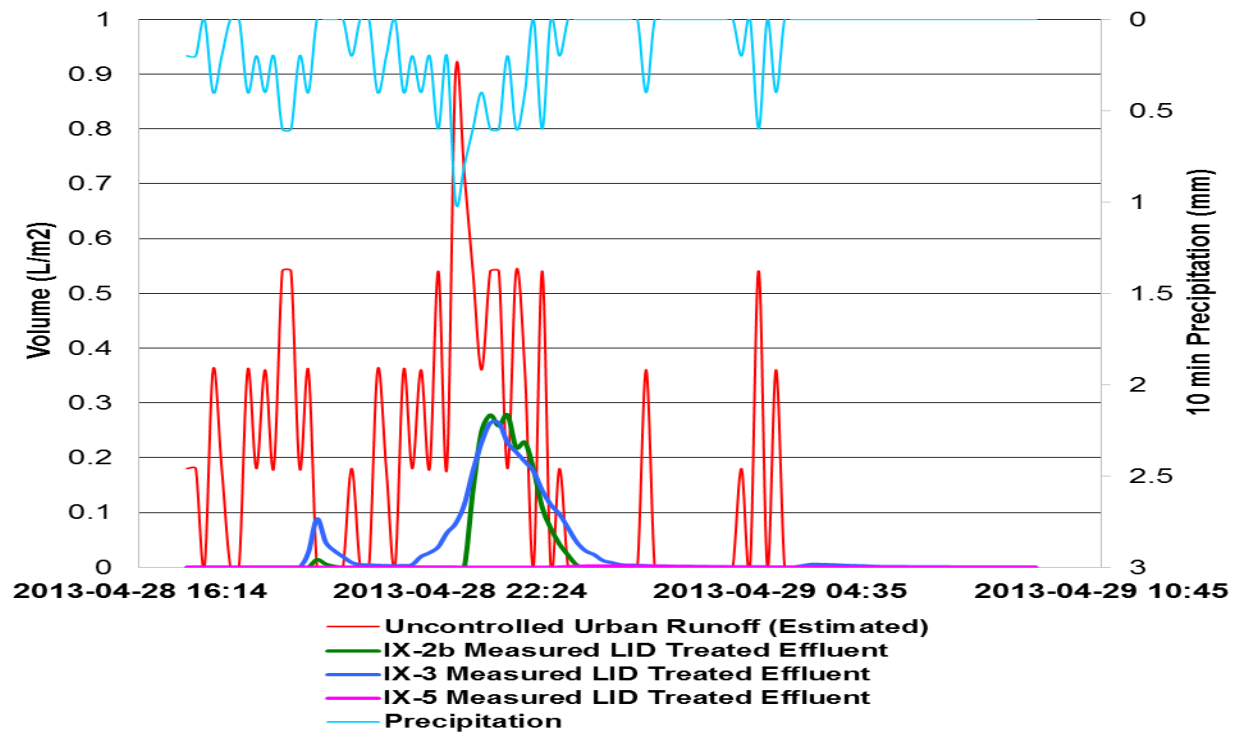
Figure 4-6: Normalized hydrograph for low intensity event – April 28, 2013

Hydrographs for a low and high intensity precipitation event during which IX-2b, IX-3, and IX-5 were monitored are provided below in **Figure 4-6** and **Figure 4-7**, respectively. As hydrological data is not available at this time for the control site (IX-1) the runoff hydrograph was estimated using the Rational Method, assuming a runoff coefficient of 0.9. Additionally, the hydrographs for the control site, IX-2b, IX-3, and IX-5 were normalized by dividing the hydrograph volumes by the contributing catchment areas.

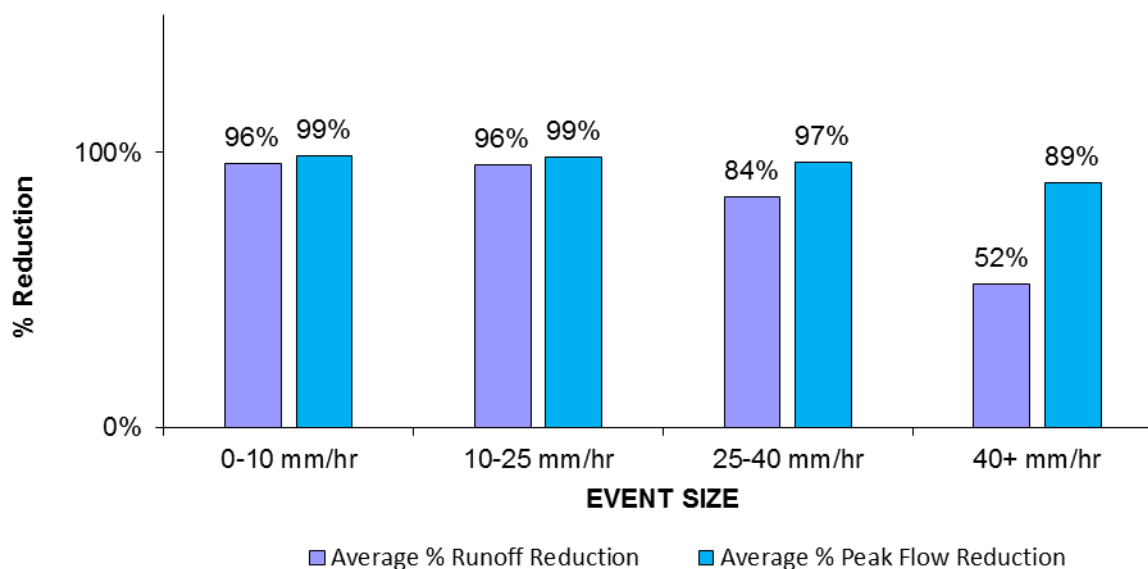
Figure 4-8: IX-5 performance based on peak precipitation intensity

The performance of IX-5 based on peak precipitation intensity is provided in **Figure 4-8** below:

IX-5 achieved an average peak flow reduction of 98%. The lowest peak flow reduction observed at IX-5 of 77% occurred during a storm on July 5, 2013. This precipitation event had a total precipitation depth of 23.4 mm and a peak rainfall intensity of 37.2 mm/hr; however, IX-5 was able to achieve a greater peak flow reduction for precipitation events of both greater intensity and total depth. During the September 20, 2013 storm (precipitation depth of 43 mm and a peak rainfall intensity of 30 mm/hr), for example, a 94% peak flow reduction was observed at IX-5. It is suspected that the shorter antecedent dry period of 21.6 hours was responsible for the low peak flow reduction on July 5, 2013 when compared to the larger precipitation event on September 20, 2013, which had an antecedent dry period of 5 days.

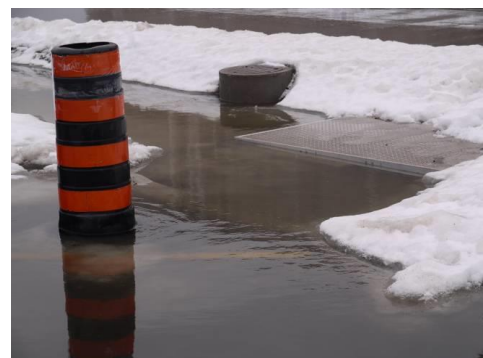
As with traditional stormwater management ponds, determining adequate ponding depth can be critical to the success of the practice. Similarly, it is also important with LID design to consider ponding depth to capture maximum runoff volumes and provide enough contact time for infiltration. Pond depth errors documented by CVC for LID project sites cause major issues as illustrated in the following photo. The second coat of asphalt was delayed due to winter weather and the heights of the overflow pipes set too high. Subsequent snowfall followed by heavy rain led to large runoff volumes and backflow into the parking lot. The heights of the overflow pipes were temporarily reduced just below

Ponding depth within LID with overflow not cut to proper grade

inlet grade to stop backflow onto parking lot and reinstated when the asphalt paving was completed the following spring. When designing, ensure LID pond depth accounts for the grades of inlets, outlets, overflow pipe, and ground surface to avoid issues backflow or insufficient ponding depth.

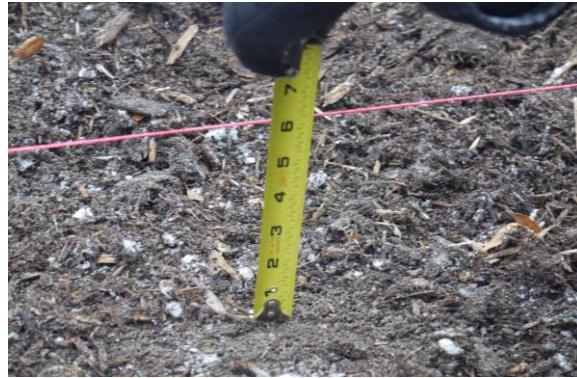
Related to grading, the bioswales were fine graded to the final elevations prior to the bioretention mix, plant and mulch material being installed. This resulted in a higher final grade of the ground surface limiting surface ponding capacity. This was identified through visual inspections and flow monitoring which indicated that the LID system had outflow for events as small as 4 mm. As a result, the bioswale grades were adjusted to increase surface ponding capacity and the excess bioretention mix was reapplied elsewhere on site.

Surface ponding capacity increased
