Overview

The Credit Valley Conservation head office is located on Old Derry Road in the Meadowvale Conservation Area in Mississauga, Ontario.

The CVC head office addition is located at 1255 Old Derry Road, Mississauga, Ontario

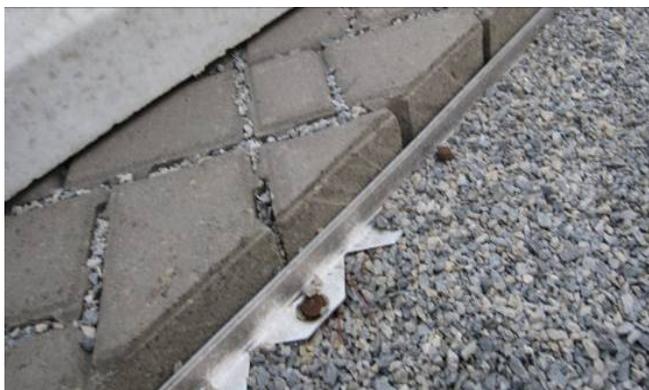
Close-up photograph of permeable paver edging restraint

The purpose of the edging restraint is to ensure that optimal spacing between pavers is maintained throughout the lifespan of the parking lot (i.e., prevent the pavers from spreading). In practice, however, a majority of permeable paver installations have a concrete curb rather than an edging restraint to retain pavers.

Installing an edging restraint is typically done because they are cheaper than curbs. These capital savings may be outweighed by operation and maintenance expenses incurred if the restraints fail and the paver spacing must be corrected in future installations.

Edge restraints can be displaced by cars and winter maintenance. The stability of an edging restraint compared to a standard concrete curb will be tested at the CVC head office because an additional permeable pavement expansion lot was constructed on the property.

In the case of the permeable parking lot, there is initial evidence that the edging restraints are not providing the necessary support for the pavers in certain sections of the lot. Some spreading of the pavers at the edge of the lot was observed. As part of the one-year construction warranty between the contractor and CVC, the pavers that had moved out of alignment were adjusted by the contractor. CVC has now taken over management of the parking lot and is monitoring the status of the pavers for any further issues. These initial issues with the edging restraint were one of the factors influencing CVC to specify a concrete curb for the expansion lot constructed approximately one year after the first lot.

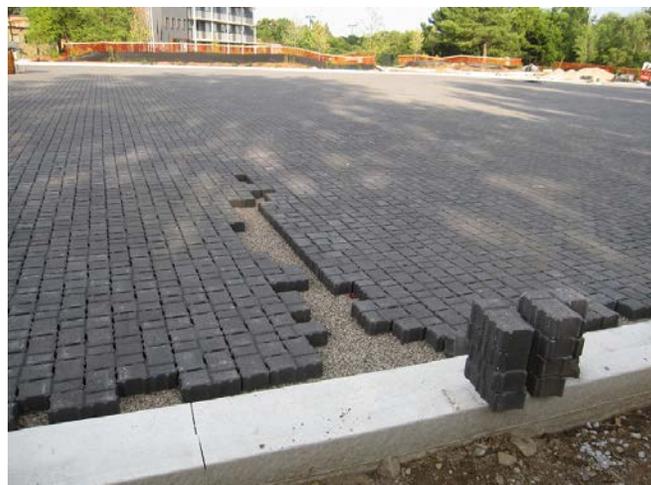
Permeable pavement expansion parking lot during construction

The design of the expansion parking lot differs from the original permeable lot in two ways. First, the expansion lot uses a conventional concrete curb for edge restraint. Second, it uses a darker-coloured stone. The differences between the two permeable lots will allow CVC to monitor any differences in the operation and maintenance between the two lots.

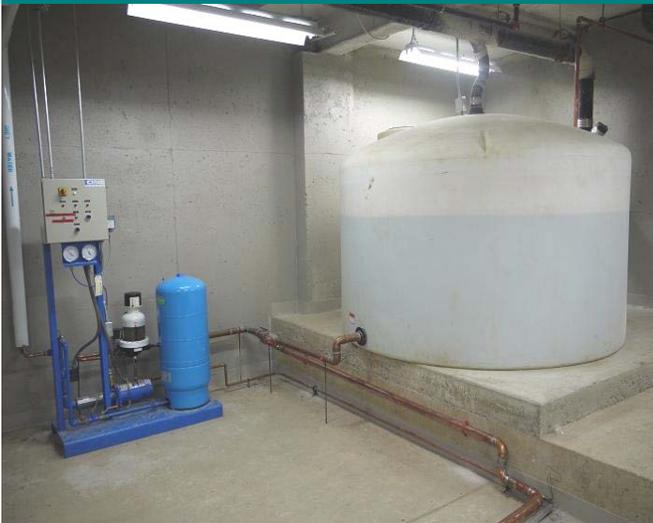
The RWH system uses a 5,000 litre rainwater storage tank located the basement of the building. Rainwater from the roof is directed through interior rain leaders to a central mechanical room. The roof runoff is directed through 75 mm diameter ABS piping to the tank. The same size pipe is used to convey excess rainwater from the tank when there is too much volume in the storage tank. All excess rainwater is discharged through the building's 150 mm diameter storm drain, connected to an on-site wetland. The tank is also periodically filled with water that was collected in the building's sump pump, as a high water table surrounds the building.

The rainwater and groundwater collected via the sump pump is used to supply non-potable water to toilets and urinals in the building addition and also supplies water to outdoor hose taps. To supply this water to the connected fixtures, the system uses a standard constant-speed style pump and pressure tank. The multi-stage pump provides a flow rate of 40 litres per minute (LPM), while the pressure tank stores 100 litres.

Indoor rainwater storage tank, located in the basement

Rainwater is treated by a 100-micron particle filter (model JUDO JFXL-T). Maintenance of the filtration system is minimized by using this type of filter because it includes an automatic timer-based self-cleaning backwash system. One potential long-term performance issue associated with the design of the treatment system is the filter location. The filter is located upstream of the pump (on the suction line), which tends to increase the amount of wear on the pump. When designing RWH systems, it is recommended that all treatment components (filters, Ultraviolet lamps, etc.) be installed downstream of the pump, on the discharge line of piping. If intake of debris into the pump is a concern, a line strainer filter can be used to protect the pump from large debris while minimizing wear.

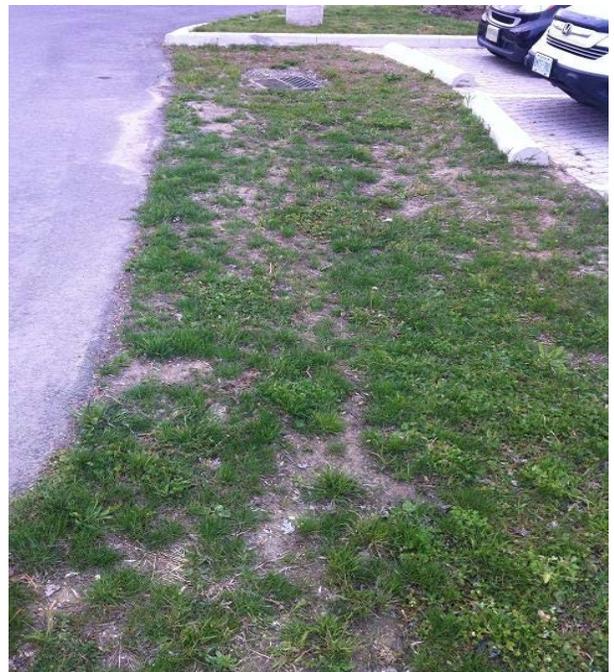
One issue that arose during construction was that the grass swales were seeded but weren't kept offline to permit the grass seed to grow and become established along the swale. Without a proper establishment period, the seed did not have the right conditions to grow. As a result, weed species grew in the swales, and there was poor overall grass cover. This led to the formation of rills (erosion channels) along the length of the swale.

Grass swales, with erosion channels (rills)

To prevent issues with grass swales during or following construction, they should either be: seeded and left offline to permit establishment (preferred), or sodded, if it is not possible to leave the swale offline for a period of time.

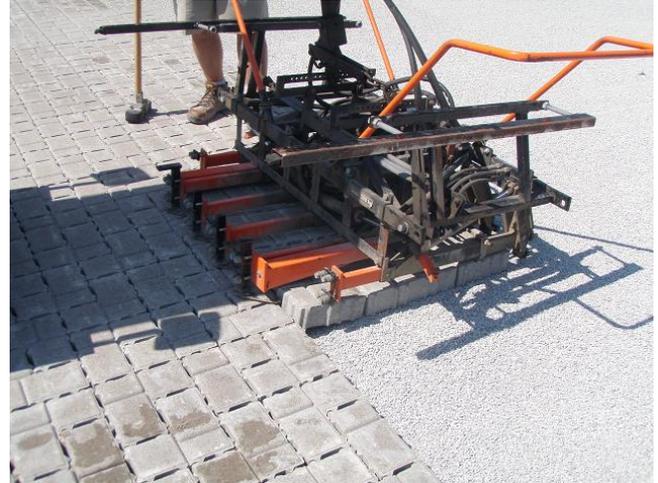
Unilock Eco-Optilock pavers were placed overtop of the bedding layer. This sped up installation of the pavers because this particular paver has an 'L-shape' and includes nubs that surround the outer perimeter of each stone. This design permits multiple pavers to be placed simultaneously using mechanized equipment, shown in the following picture:

Mechanized equipment used to place multiple pavers

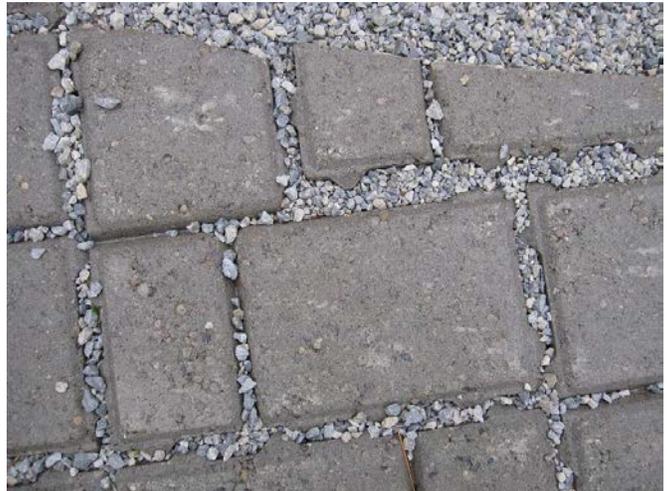
Once the pavers were installed and compacted, the 1cm spacing between the pavers was filled with washed chip stone.

Close-up view of the chip stone used in-between pavers

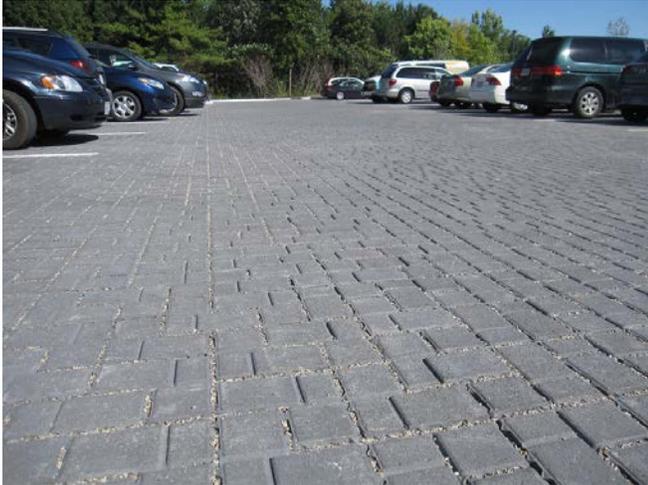
The expansion lot constructed following the first paver lot also used Unilock Eco-Optilock, but a dark grey (rather than light grey) colour was selected. Unlike the first lot, the expansion lot was installed without using the mechanized stone placement equipment. As such, it required more man-hours to complete the second lot.

Photograph of the expansion parking lot, following construction

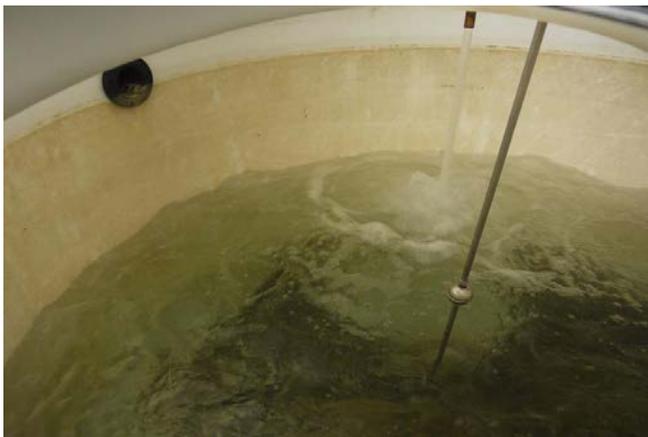
As discussed in the design section, the RWH system uses a top-up system to supply municipal water in times when the tank is dry. The system was originally designed to use a different method, known as a 'bypass system.' The bypass system would bypass all of the RWH components (tank, pump and filtration system) and supply municipal water directly to the connected fixtures.

During commissioning of the building, there were challenges associated with getting the bypass system to operate as intended. The RWH system control panel would not re-set the bypass system once sufficient rainwater was in the tank (i.e., potable water would be used to meet demands in the event of a low tank level, but the system would not automatically reset to rainwater once there was sufficient supply back inside the tank).

Interior view of rainwater storage tank during top-up filling process

Given the complexities of modifying the control panel, the partners involved with the RWH system design and commissioning worked together to implement the top-up system now being used.

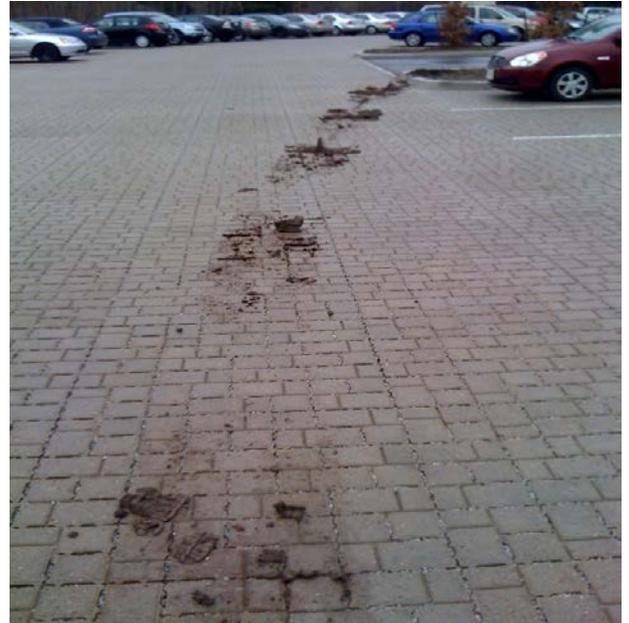
To facilitate staff parking prior to completion of the addition, it was necessary to park vehicles on the permeable pavement lot during construction. To minimize sediment in the facility, construction fencing was erected around the lot and construction vehicles were instructed not to enter the permeable lot. However, despite these measures, there were some instances where construction vehicles tracked mud onto the lot.

Picture showing mud tracking from construction vehicles

Another challenging issue was that the contractor did not budget for maintenance of the sediment and erosion control measures. For instance, the tracking pad at the entrance to the construction site was not properly maintained (i.e., aggregate was not replenished) which led to the tracking of mud on the asphalt roadway used by the construction vehicles. This same roadway was also used by CVC staff en route to the permeable pavement lot, and mud was transferred to these vehicles, ultimately tracking onto the permeable lot.

To ensure the long-term performance of LID practices, it is important that construction contracts provide for maintenance of erosion and sediment control structures. Furthermore, it is critical that a construction site supervisor provide instructions to all contractors and sub-contractors on site about how to act appropriately to protect the LID practices.

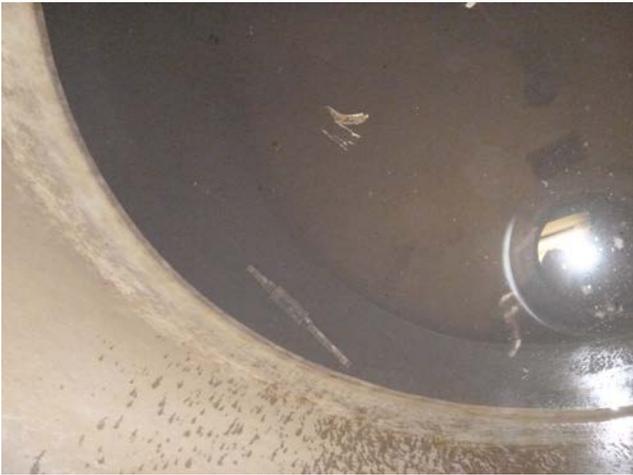
In the summer of 2015, the raintank was cleaned for the first time in several years. Sediment and some larger debris had accumulated in the tank. It is suspected that the sediment is largely from the sump pump and the large debris from the roof. This cleaning was done in-house, using a wet/dry shop-vac and a pressure washer. It took about 2 hours, and required two staff members. Due to a sump pump failure in the fall of 2015, the raintank required additional cleaning. An outside contractor was used at a cost of about \$200 for half a day of work. Moving forward, the use of an outside contractor is considered preferable to using CVC staff as the tank is cleaned much more

Accumulated sediment and debris in the rain tank.

thoroughly for a competitive price. Starting in 2016, the raintank is expected to be cleaned in this manner once per year.

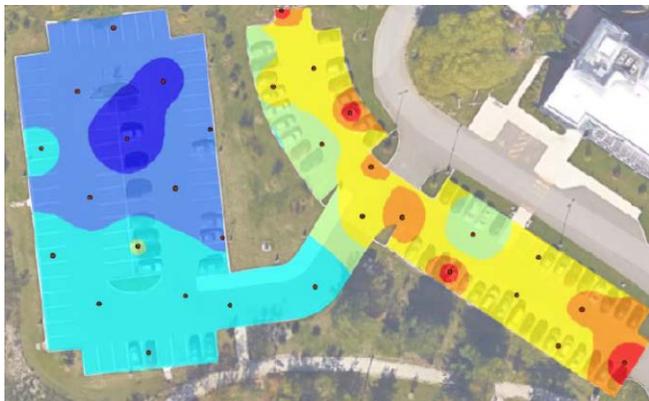
At the end of 2015, the older permeable lot had been vacuumed once, in 2012. There has been no maintenance on the new permeable lot. Infiltration tests were completed for both permeable parking lots in November 2015. On average, the newer lot had higher infiltration rates, and there is evidence of clogging in some areas of the older lot. Vacuuming is being planned for the older lot in spring/summer 2016, followed by another round of infiltration tests. Further maintenance may be completed based on the requirements of CVC's application for Mississauga's Stormwater Charge Credit Program.

Infiltration Rate (mm/h)

0 - 63	459 - 1006
63 - 193	1006 - 2182
193 - 459	2182 - 4433
	4433 - 9167

● Infiltration Test Locations

Contour map of infiltration test results

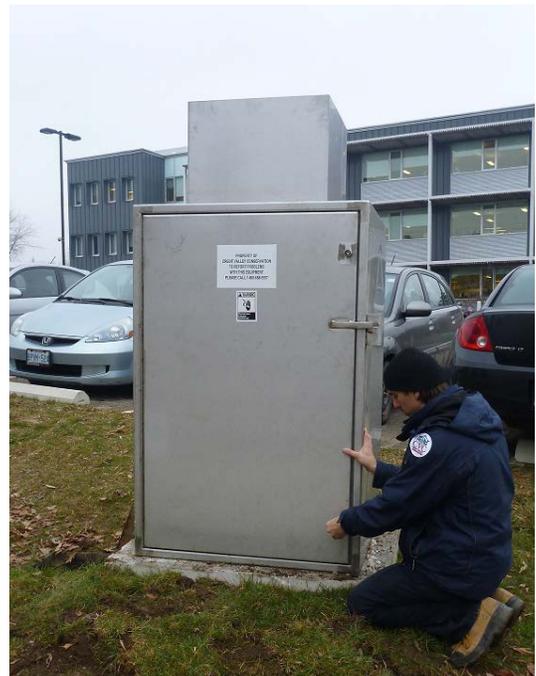
In addition to keeping records of the operations and maintenance work that is performed on the LID features, CVC is also conducting more extensive performance assessments on the LID infrastructure. Monitoring at the CVC Head Office site began in summer 2014. This monitoring program encompasses the older permeable parking lot, the adjacent swales and the rainwater harvesting tank.

Installation of exterior housing for performance assessment equipment
