# O'Connor Park

Location: Mississauga  
Constructed: 2011

### Project Objectives, Design and Performance

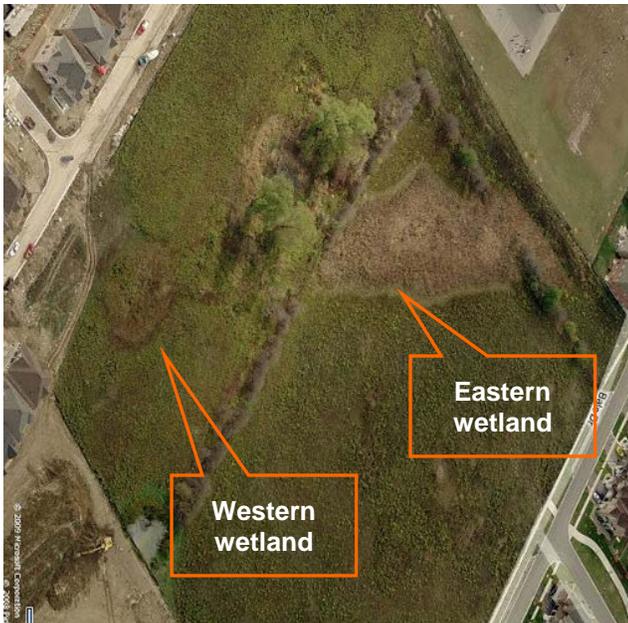
Two cattail mineral shallow marshes were identified on the property, a large marsh approximately 0.45 ha on the western portion of the property, and a smaller 0.25 ha marsh on the eastern portion of the property. The location and size of the wetlands on the remnant property are shown in the following aerial photograph.

Oblique air photograph of site prior to park construction

Through the planning process it was determined that the eastern wetland would be filled to permit the construction of soccer fields and the west wetland would be expanded and improved to provide an ecological net gain. In the end, the total wetland area was increased by 3.5 times. Species from the eastern wetland were relocated to the enhanced western wetland.

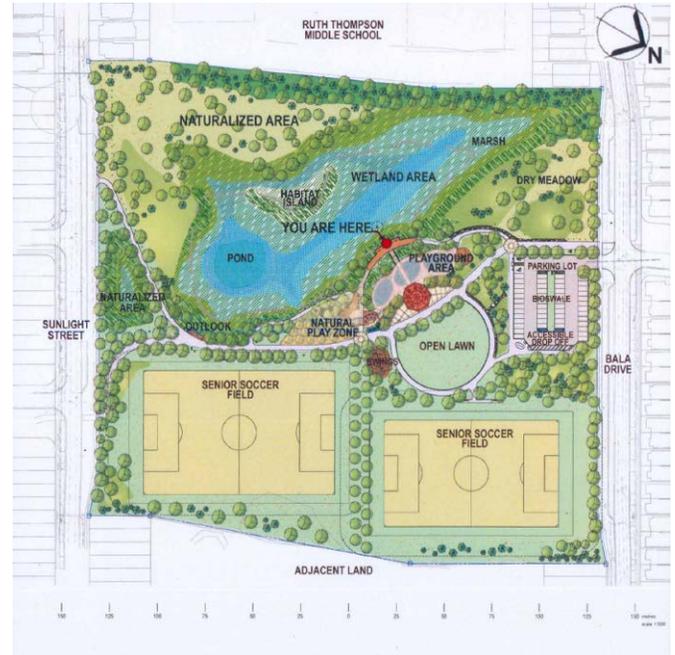
Illustrated rendering of O'Connor Park (Drawing prepared by PMA Landscape Architects for the City of Mississauga)

The features of the park include: two soccer fields, wetland with a habitat island, naturalized areas, playground, walkway adjacent to the wetland and parking lot with innovative LID features.

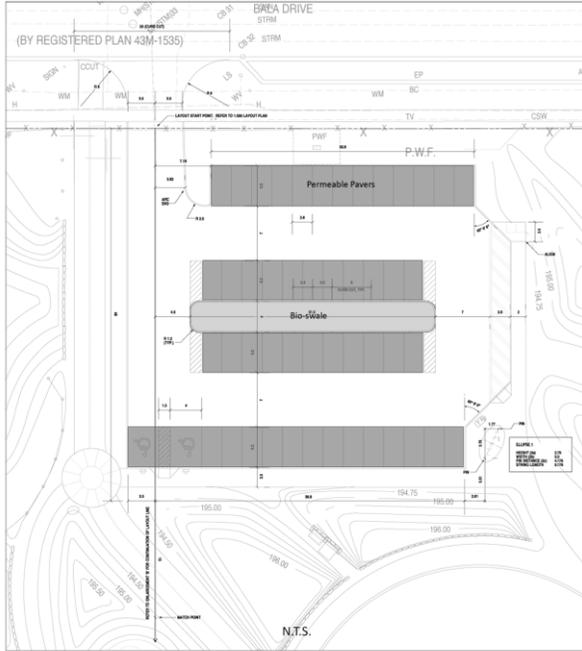
**Parking Lot with permeable pavement and bioretention areas labeled (Drawing prepared by PMA Landscape Architects for the City of Mississauga)**

LID features are primarily located within the parking lot of the park, however additional infiltration practices were installed throughout the soccer fields.

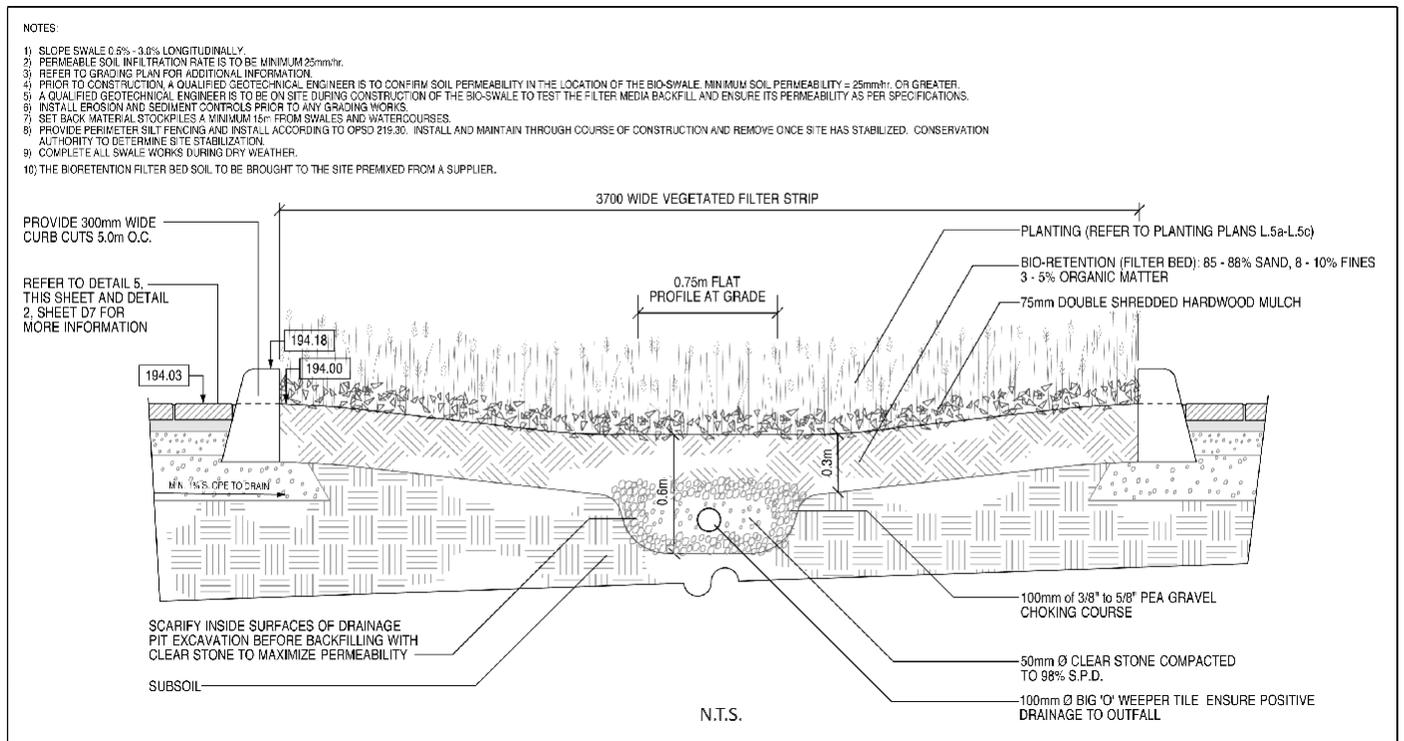
**Bioswale section drawing (Drawing prepared by PMA Landscape Architects for the City of Mississauga)**

The bioretention cell is 24 m by 3.7 m and is located in the center of the parking lot. It is graded at 2% to allow the runoff to be directed towards it more effectively. Around the perimeter of the bioretention cell is a small retaining curb, with 30 cm cut-outs at 5 m intervals, to allow for the surface runoff to enter the cell. This curb

design prevents cars from driving into or parking on the swale while allowing low concentrations of flow to enter at multiple locations. At the curb cut inlets are 100mm clear stone pads that help to slow and spread flow while providing erosion control. The base of the bioretention cell contains a subdrain, which is sloped towards the catch basin leading to the open lawn area at 0.4%. The subdrain is surrounded by 50 mm clear stone, which is then surrounded by 100 mm pea gravel. This was done to replace the need for geotextile fabric, which can become clogged.

An engineering cross-section detail for the bioretention cell is reproduced below.

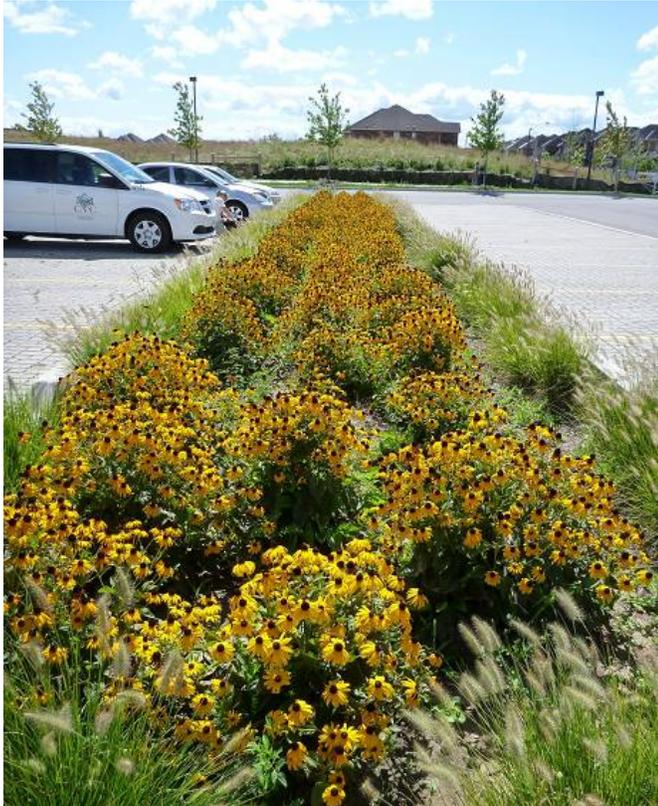
**Black Eyed Susan and Foxtail Grass planted in bioretention cell**

For ease of maintenance, landscaping was kept simple within the bioretention cell; only two plant varieties were used. The O'Connor Park bioswale has a decorative dwarf fountain grass border with rows of black-eyed Susan in the middle, creating a landscape with clean lines and colour. For more recommendations on LID planting plans see CVC's [LID Landscape Design Guide](#) (available for download at [bealeader.ca](#)).

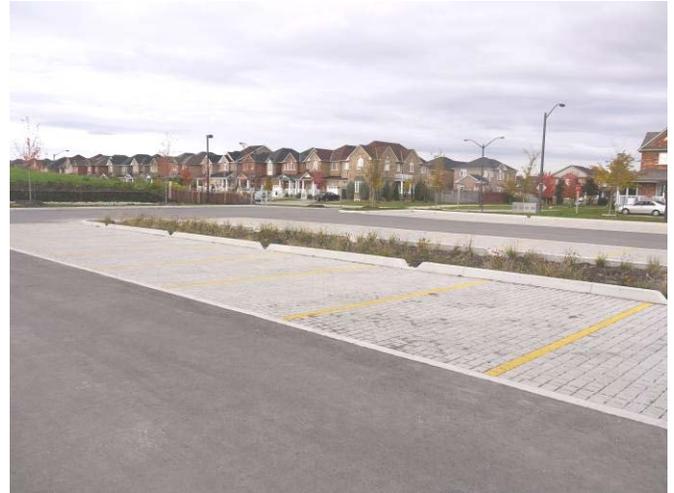
**Permeable pavement surrounding the bioretention cell**

Surrounding the perimeter of the bioretention cell is a strip of permeable paving, which provides spaces for parking on both sides of the cell. The remaining parking area is comprised of asphalt, which is sloped towards the LID features located in the centre of the lot.

Typical rainfall events are managed through the permeable pavers, with larger rainfall events creating sheet flow directed to the bioretention cell through the curb cut-outs.

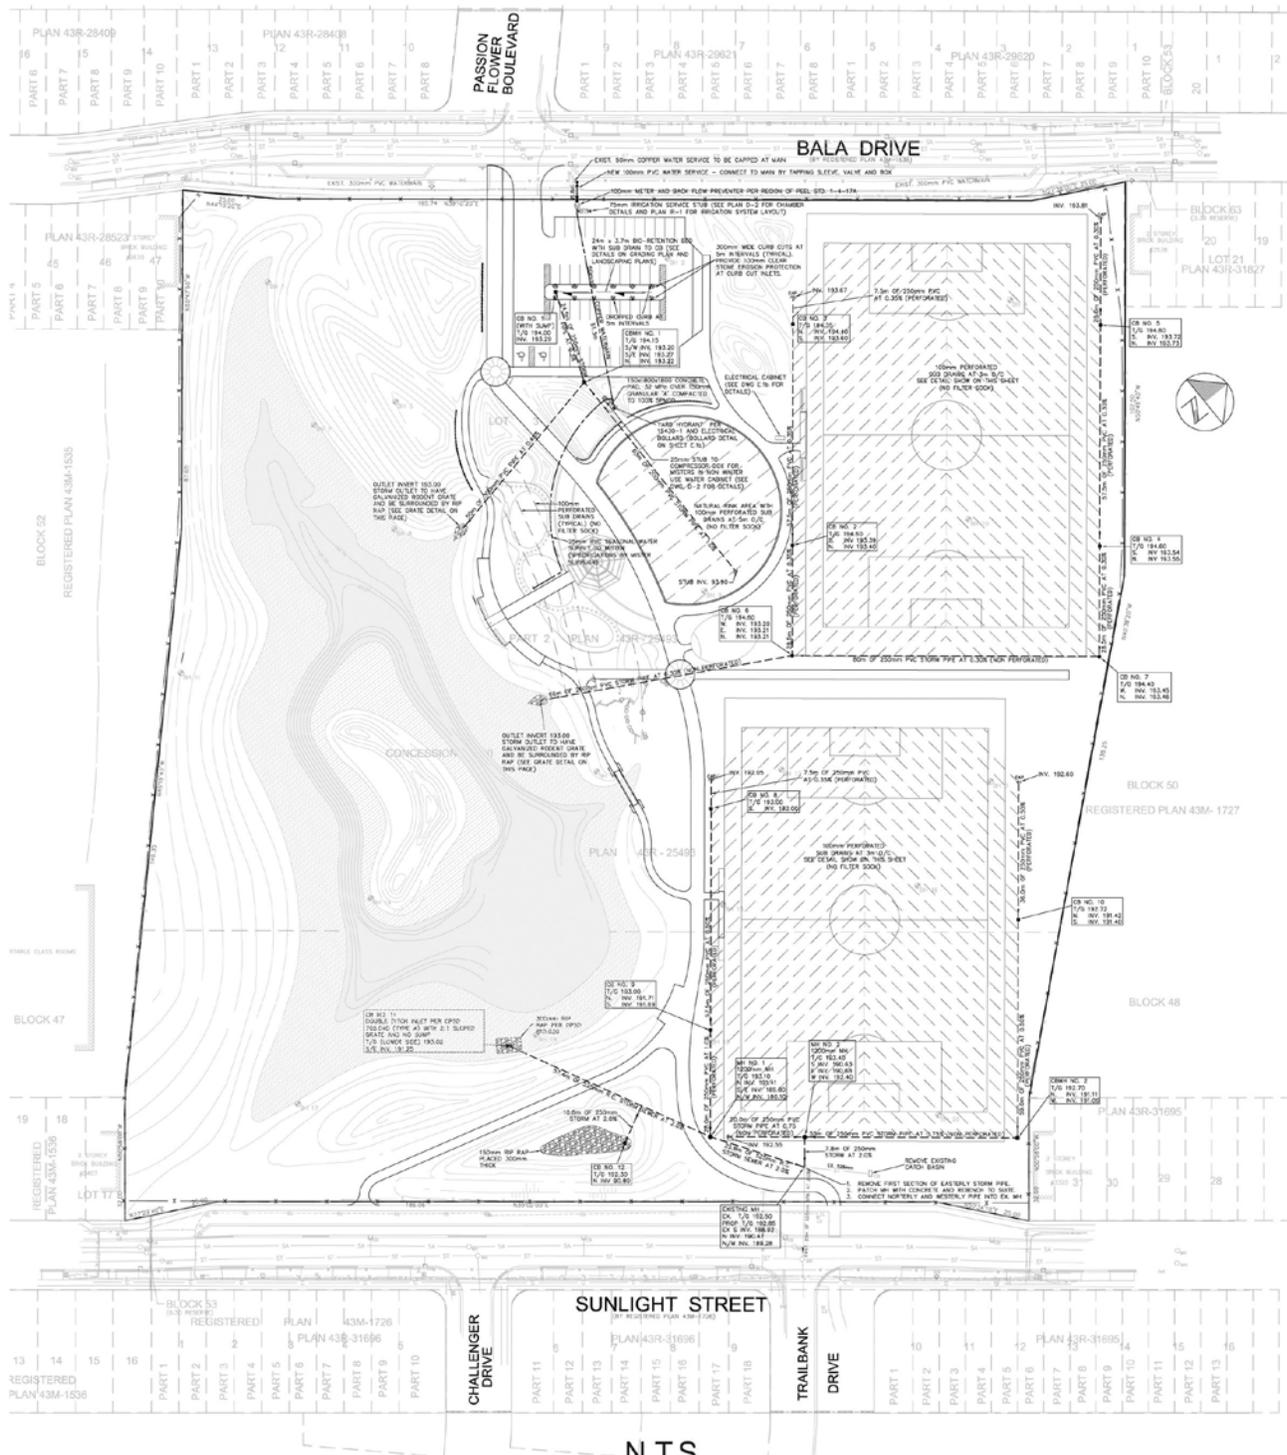
Plan drawing of O'Connor Park (Drawing prepared by AMEC Engineering and PMA Landscaping Architects for the City of Mississauga)

The park also includes a series of infiltration trenches with underdrains that surround the perimeter and cross the soccer fields. These units promote infiltration of water while minimizing ponding and wet conditions on the fields. As with the parking lot LID features, the infiltration trenches also discharge into the wetland. A plan drawing showing the infiltration features of the soccer fields follows.

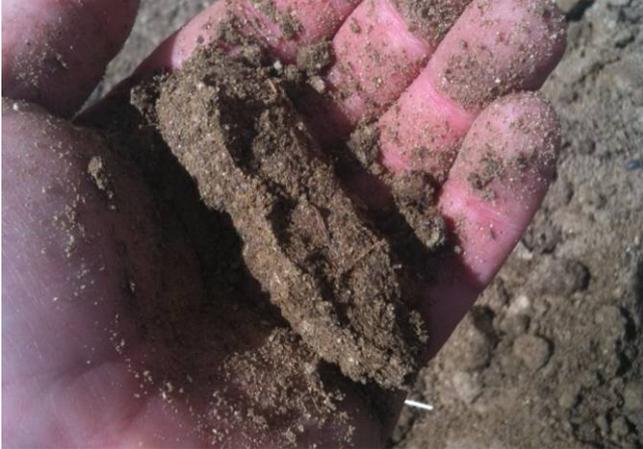
Moist soil formed a solid cast, meaning a higher than desirable amount of fine particles like clays

In order to function properly bioretention soil media must contain a certain ratio of sand, fine and organic matter. Post-construction soils analysis performed by CVC found that the majority of the bioretention cell contains soil that meets the design specification, some of the media contained higher levels of fines, which can impair the performance of the LID practice.

The cause for the excess fines in the bioretention media could be from construction sediment or an improper mix brought to the site. Due to the sensitivity of bioretention performance associated with media mix, it is recommended that rigorous protocols be in place to ensure that the media being installed meets design specifications during construction. Recommendations for installation of bioretention soil media from the [CVC LID Construction Guide](#) include:

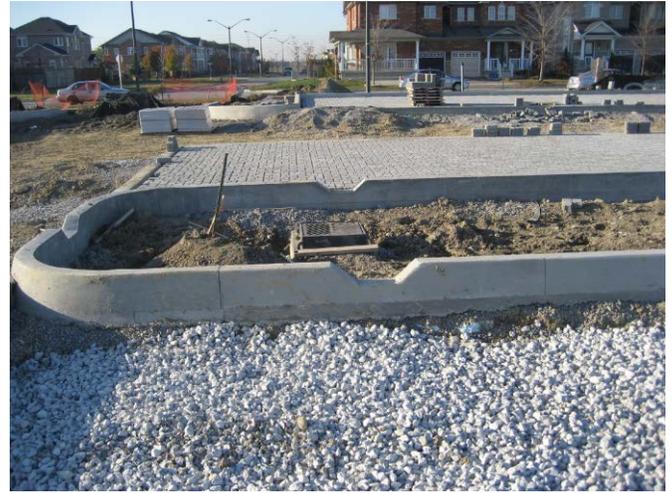
Photograph of the bioretention cell during construction

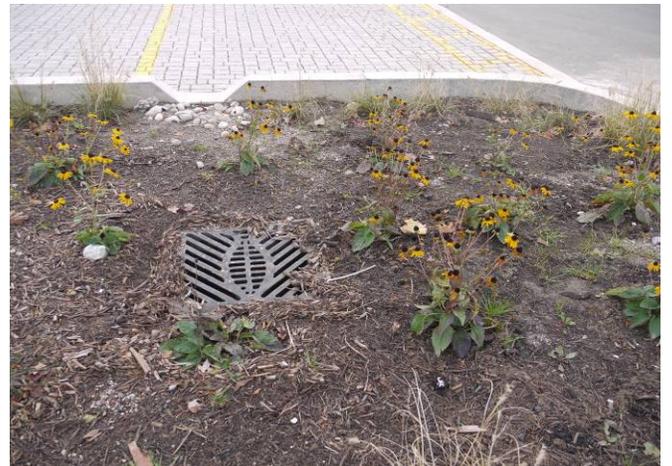
Incorrect catch basin elevation within the constructed bioretention cell

Another issue identified post-construction is the elevation of the catch basin within the bioretention cell. As shown in the cross-section on the next page, the design indicates that the catch basin was to be located 50 mm [2 in] above the bioretention bed elevation.

However, visual inspections of the cell following construction found that the catch basin is level (or even slightly below) the mulch layer in the bioretention cell. A photograph of the catch basin is provided below.

The present elevation of the catch basin impairs the performance of the bioretention cell as it permits surface flows to directly enter the catch basin. Ideally, a raised catch basin forces stormwater to pond for short periods of time (typically 24 hours maximum), encouraging additional infiltration and reducing the

amount of runoff that enters the storm sewer. The City of Mississauga is currently making adjustments to the existing catch basin to provide for short term ponding.

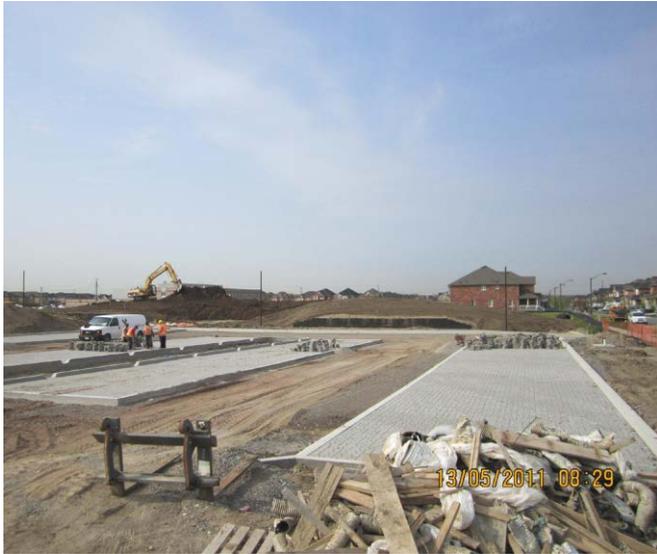
Parking lot during construction

Like with the soil media mix, small variations from the specified design elevation can have a significant impact on the performance of bioretention practice. Contractors may overfill soil assuming that it will settle. However, experience with other bioretention installations in Ontario has found very little settlement of bioretention media. It is important for the project consulting team to follow through and verify detailed

execution of the drawings during construction, especially aspects relating to grading as it has such a large impact on LID performance. It is recommended that inspectors be present to ensure that LID practices are installed correctly, including finished grading and elevations of inlets and outlets to the cells. For further details refer to the [LID Construction Guide](#) (available at [bealeader.ca](http://bealeader.ca)).

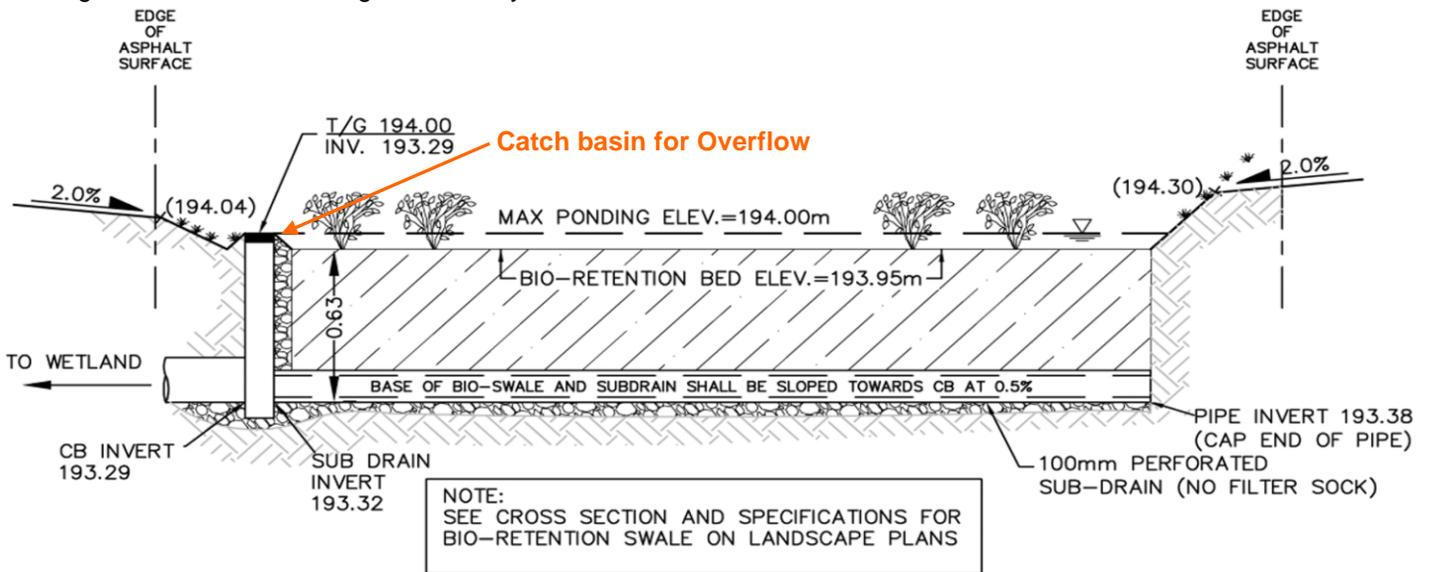
**SECTION A-A**  
N.T.S.

Profile design drawing of bioretention cell, indicating elevation of catch basin and bioretention cell bed (Drawing prepared by PMA Landscape Architects for the City of Mississauga)

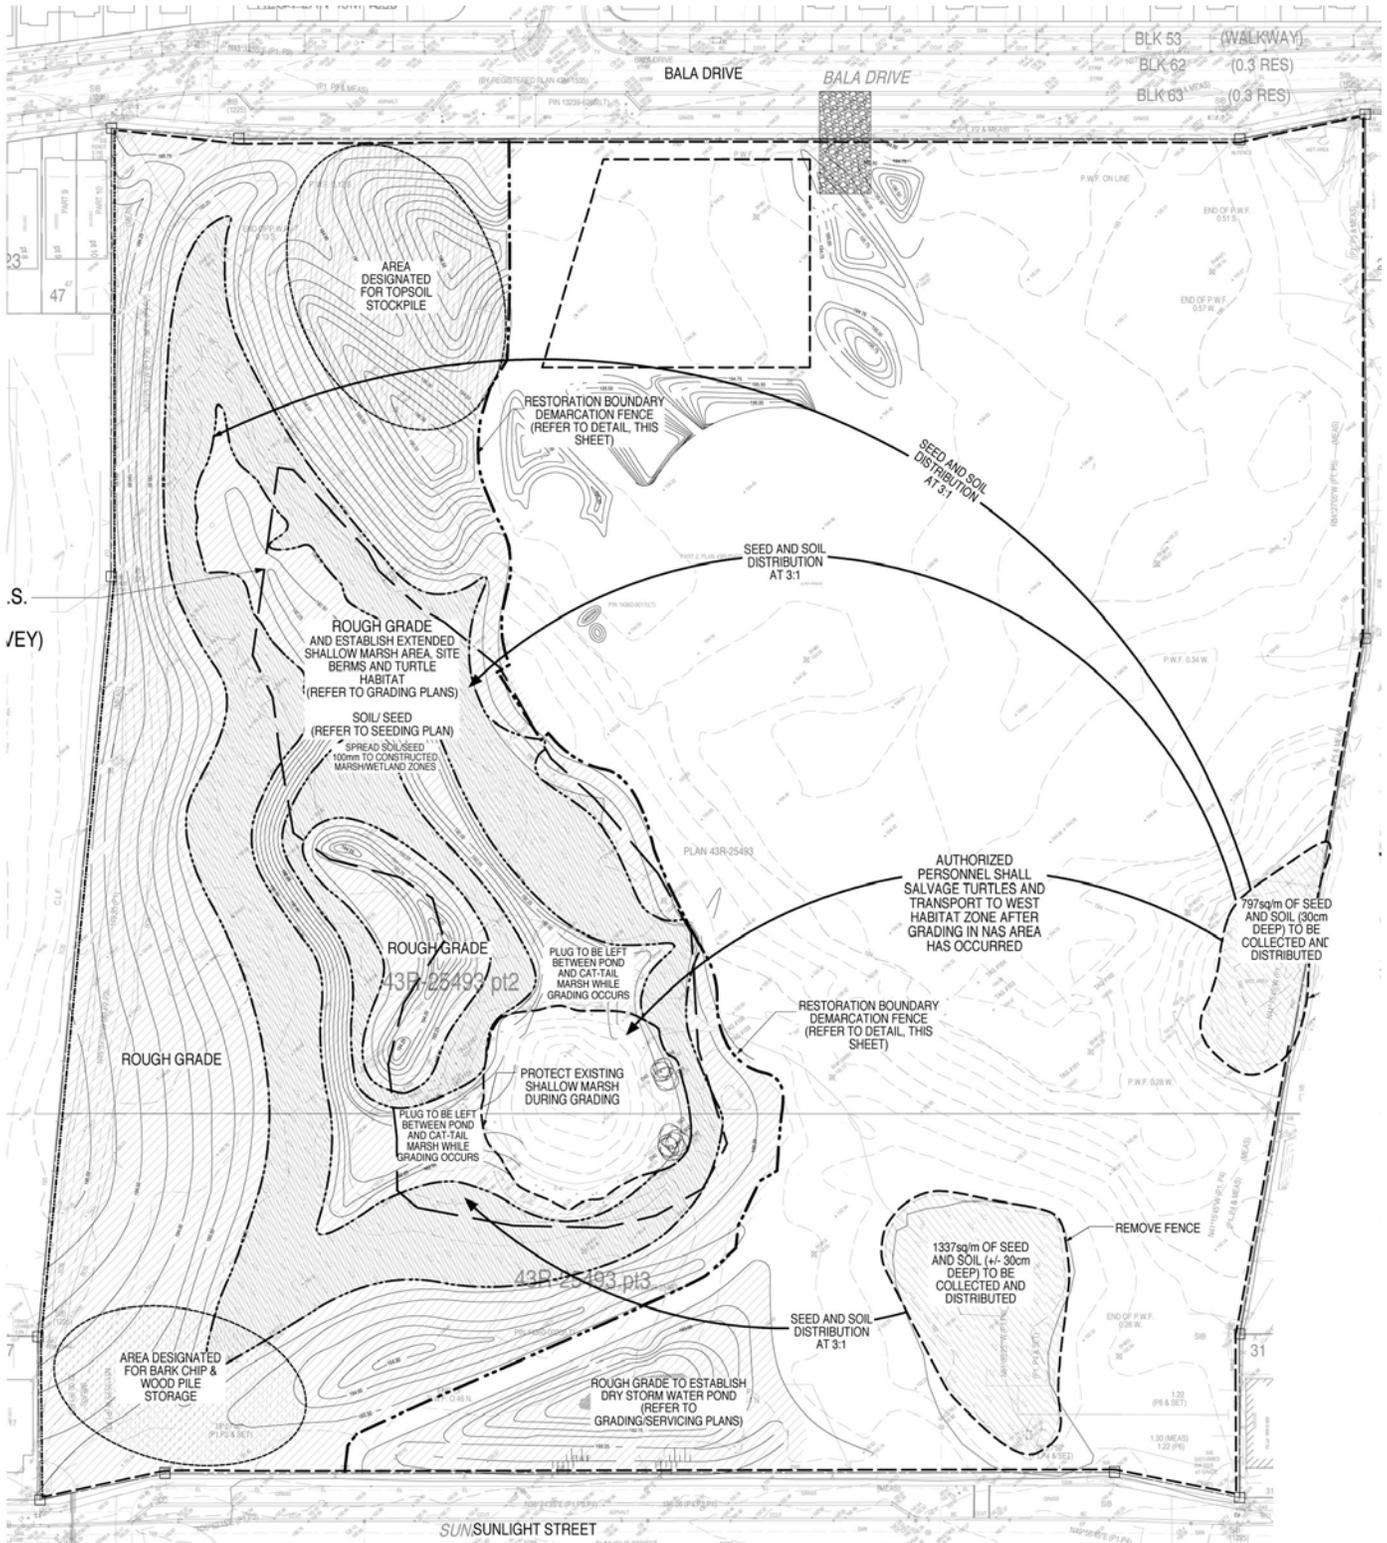
This erosion and sediment control plan indicates where species and wetland soils with native seed banks were to be relocated (Drawing prepared by PMA Landscape Architects for City of Mississauga)

A complex five stage erosion control process was required to protect the wetland and infiltration areas from sediment, compaction, and contamination. Some details of this plan are provided on the erosion and sediment control plan drawing provided on the following page.

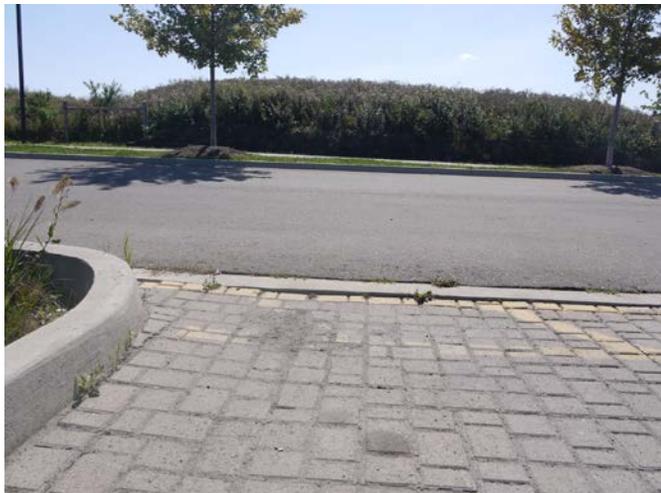
**Settling pavers with sediment collecting between joints causing clogging**

Many of the maintenance concerns that are now recorded are due to construction issues. Over time the permeable pavers surrounding the bioretention swale have been settling, causing depressions where water has been collecting. These areas receive more concentrated runoff from the parking lot and sediment has been collecting between the paver joints, causing them to become plugged over time. The settling has also resulted in the inlets becoming a higher elevation than originally designed, preventing runoff from entering the system and allowing debris to gather in front of them, restricting flow from entering. Although water can still infiltrate most of the permeable paver area, the system is not functioning as well as it could be. The City is looking into these issues and is creating a plan for the permeable pavers to be repaired.

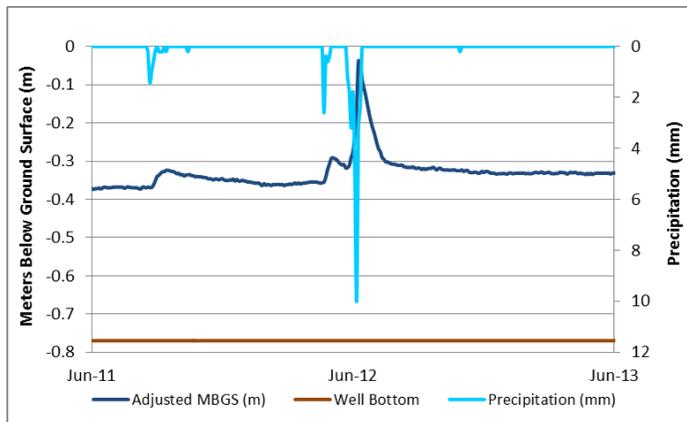
**Precipitation event and measured water level in June 2014**

The graph above illustrates a large summer storm with the second peak of precipitation being intense as a large volume of rain fell quickly. This 37 mm

precipitation event above was fully infiltrated into the bioretention cell without surface ponding. The bioretention cell was able to capture this storm and the sub-surface water level drawdown was able to recede back to the pre-storm level.
