# Elm Drive

Low Impact Development Infrastructure  
Performance and Risk Assessment  
May 2016

## LOW IMPACT DEVELOPMENT INFRASTRUCTURE PERFORMANCE AND RISK ASSESSMENT

### MONITORING RESULTS (2011 – 2015)

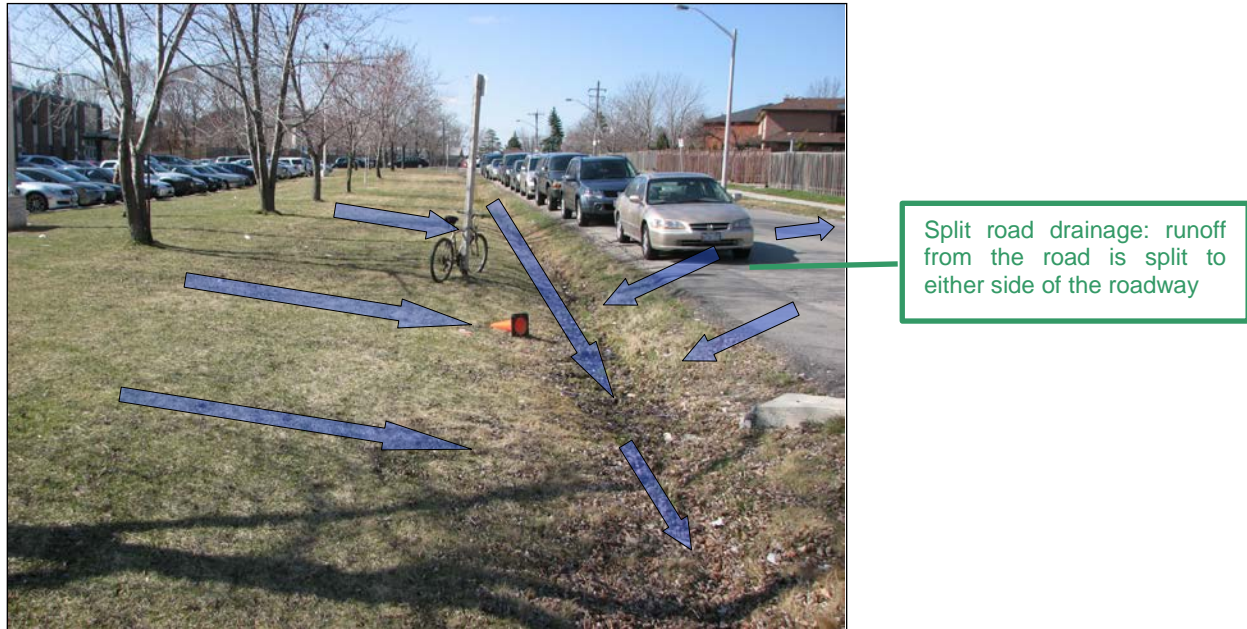
Figure 3-1: Before retrofit; drainage on Elm Drive

Prior to construction, drainage of Elm Drive was divided at the road centreline and routed to each side of the road. The grass swales provided limited treatment for runoff before it entered the municipal sewer system. Post-construction, runoff from all lanes of the road flows towards the permeable pavement lay-bys with overflow going to the bioretention features. Runoff which is not retained by the LID systems through infiltration or evapotranspiration discharges to the municipal sewer. The estimated total drainage area for the site is 0.646 hectares (ha).

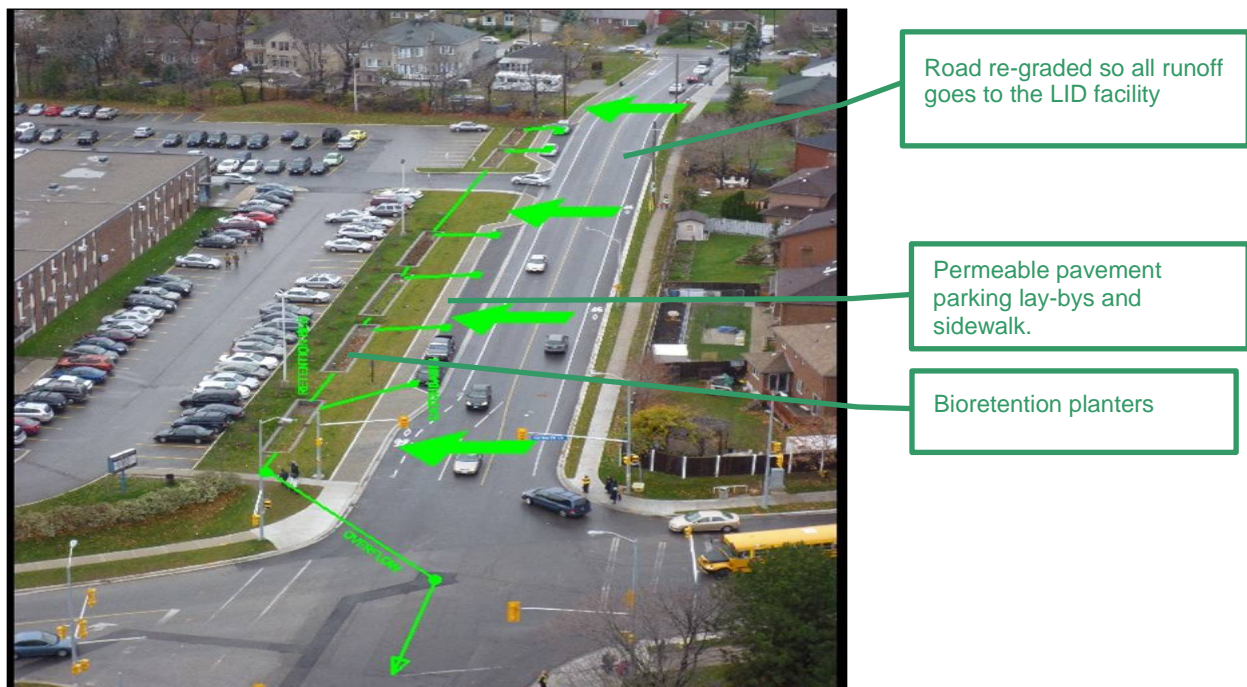
Figure 3-2: After retrofit; drainage on Elm Drive

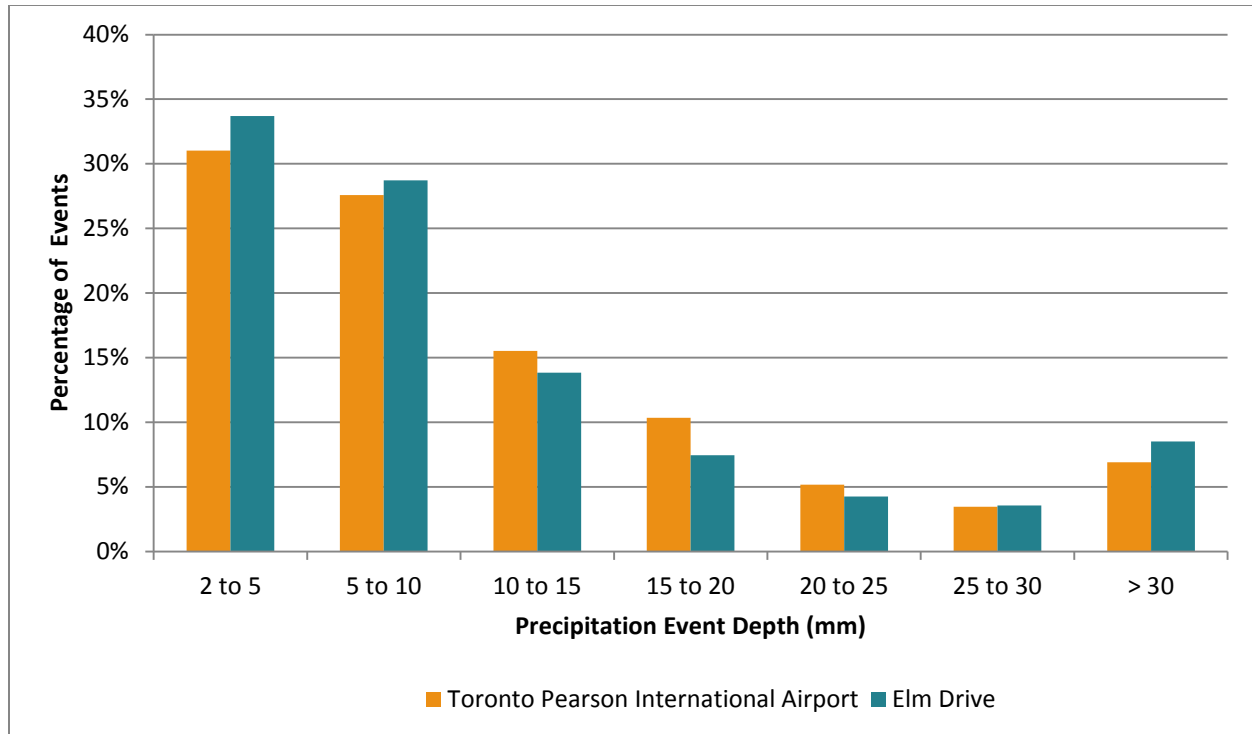
Note: Includes July 8, 2013 event.

Figure 4-2 Rainfall frequency distribution graph between Environment Canada Toronto Pearson International Airport station (1960-2012) and Elm Drive (August 2011-September 2015)

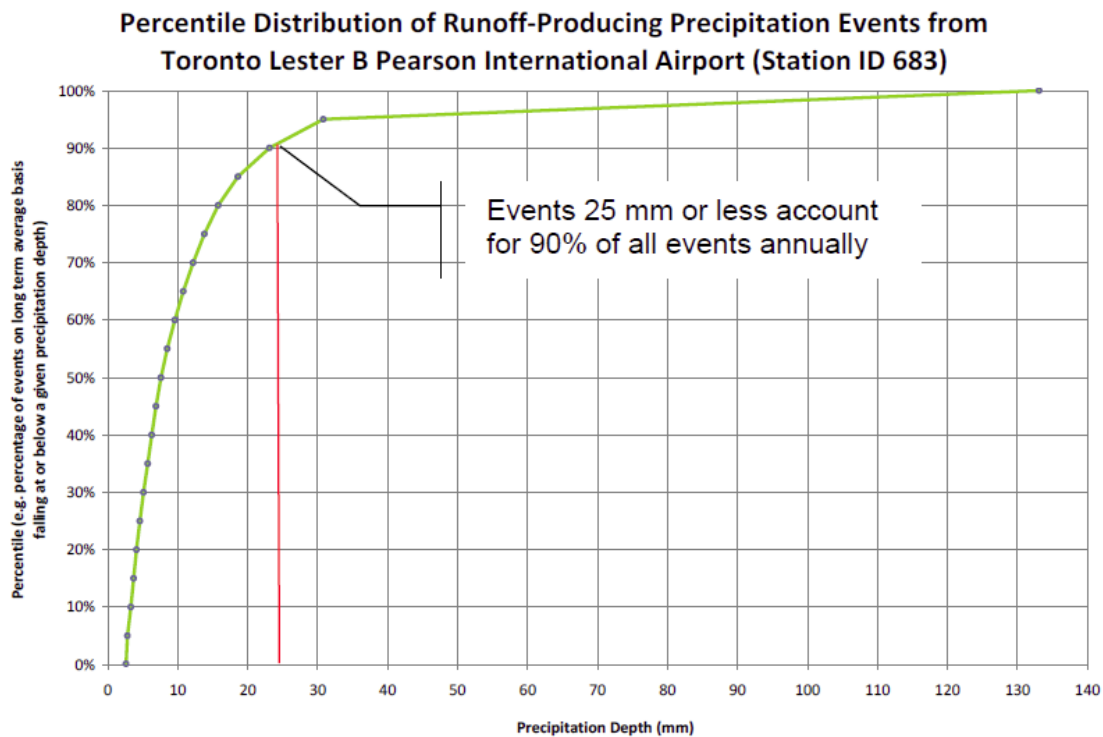
Figure 4-3 Event size related to the frequency of occurrence at Environment Canada Toronto Pearson International Airport station using hourly weather records from 1950-2005

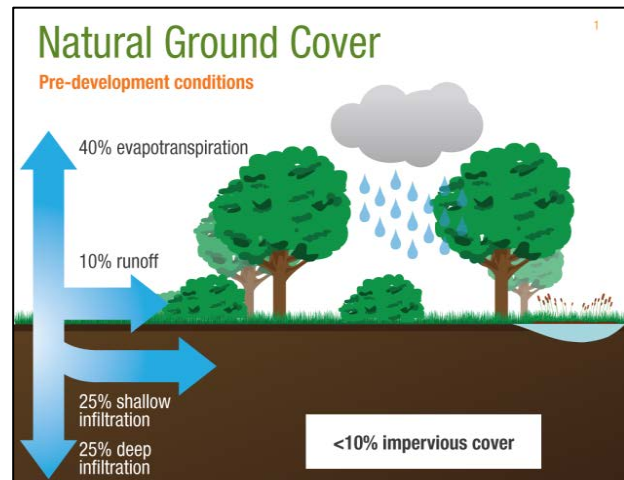
Figure 4-4 Urban water cycle with stormwater management ponds and LID (adapted from FISRWG, 1998)

Land development converts permeable land into impermeable surfaces, including buildings, roads and parking areas. This reduces infiltration and evapotranspiration and increases surface runoff as shown in **Figure 4-4**. Natural drainage is often replaced by curbs and gutters along roadways and storm sewer pipes which rapidly deliver runoff to receiving waters. This contributes to increased peak flow rates.

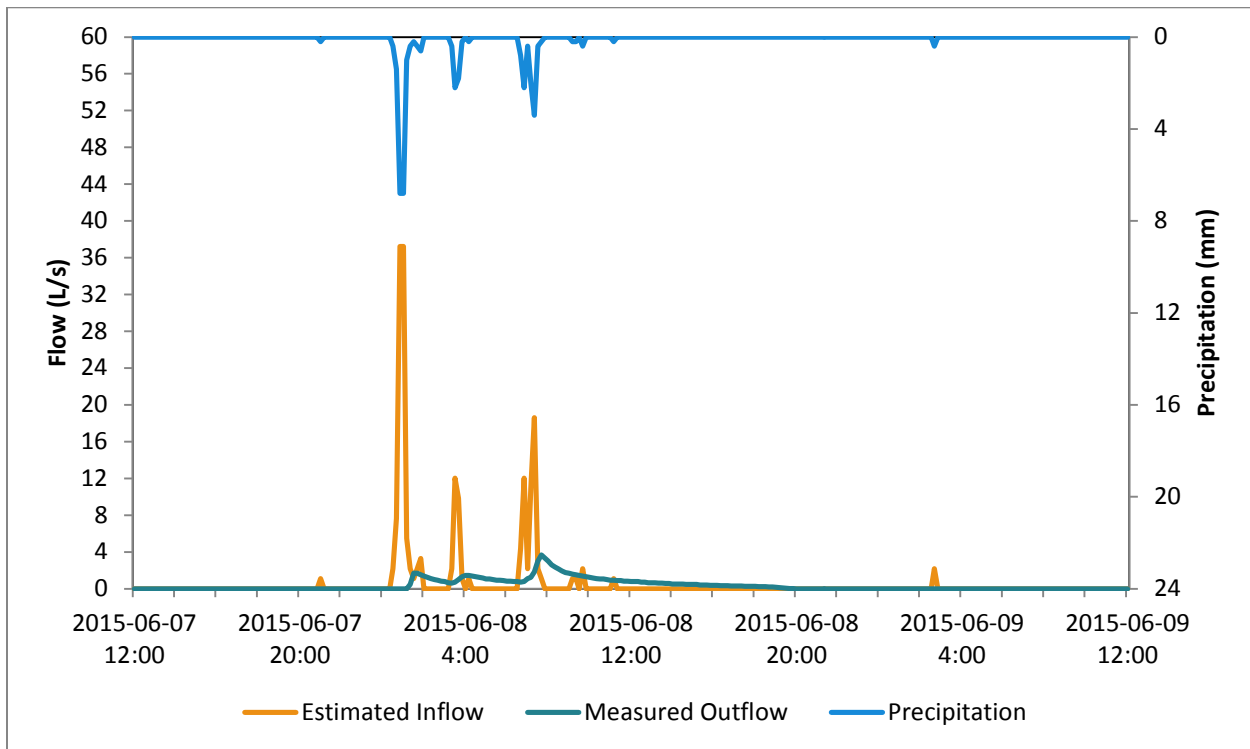
Figure 4-6 Hydrograph for June 7, 2015 (33.4 mm)

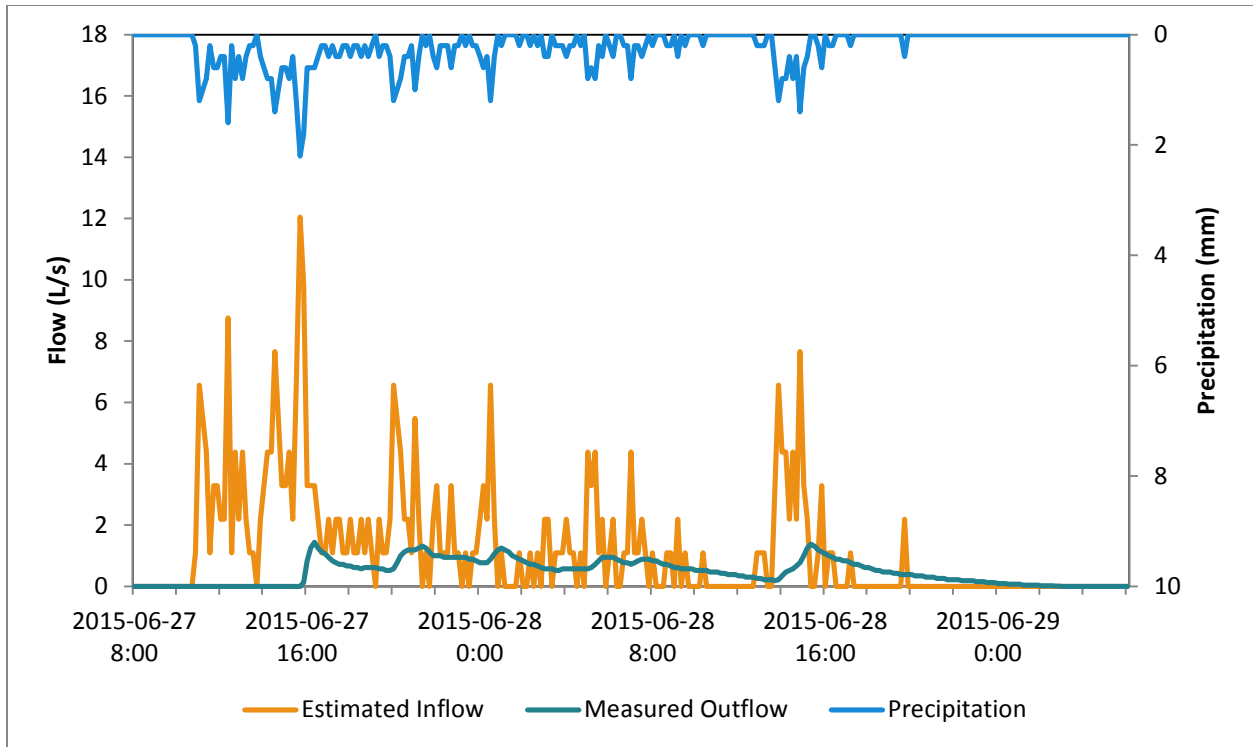
Figure 4-7 Hydrograph for June 27 2015 (62 mm)

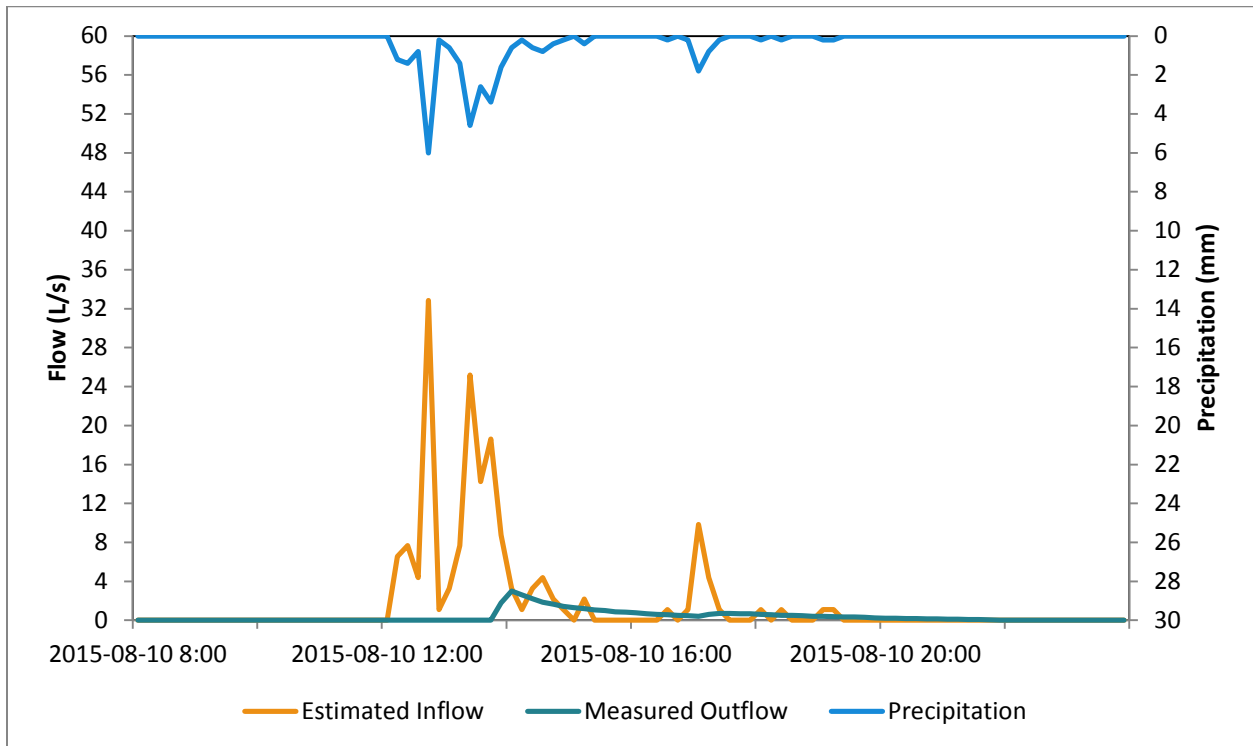
Figure 4-8 Hydrograph for Aug 10, 2015 (31 mm)

The August 10, 2015 event was also large (31 mm) with most of the rain (27 mm) falling in the first three hours. Similar to the June 27 event, no flow was generated until well into the event, after more than 20 mm of rainfall.

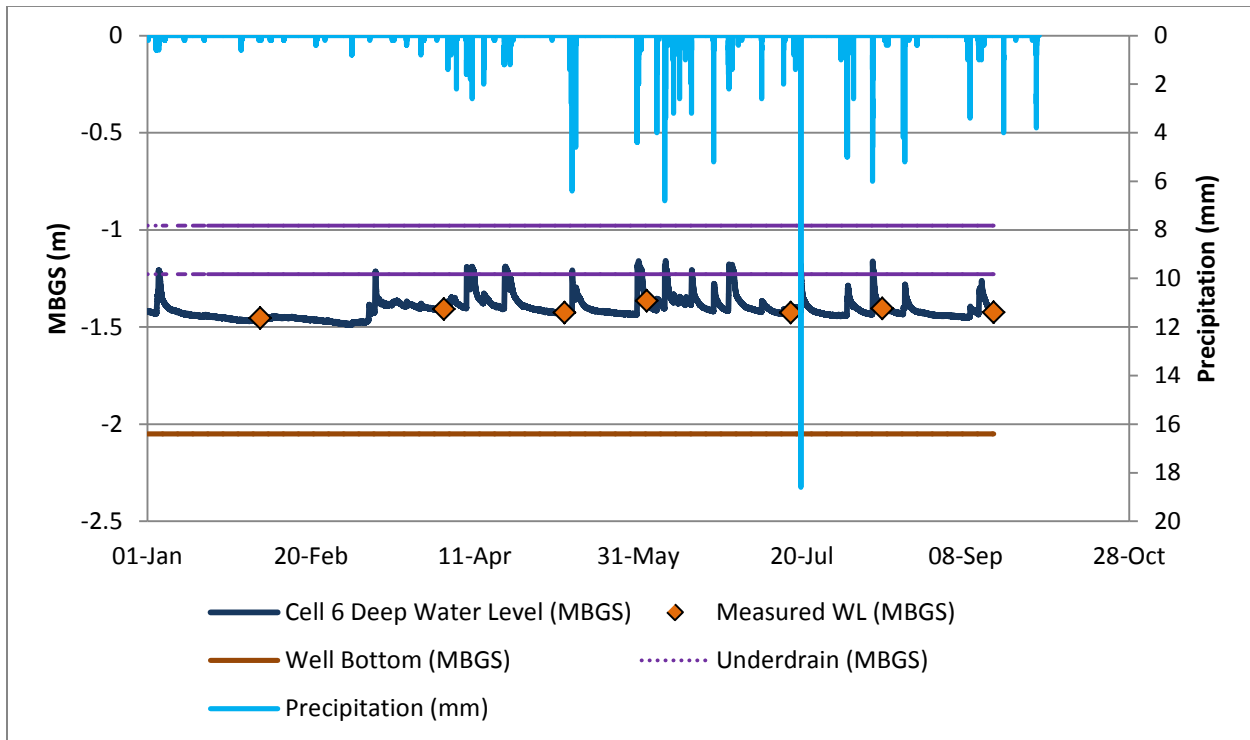
Figure 4-9 Water levels in bioretention cell 6 in 2015

For 2015, data are available for water levels within two of the bioretention cells (4 and 6) and surface ponding depths in two of the cells (1 and 4). The water levels in Cell 4 do not rise above the invert of the underdrain. **Figure 4-9** shows the water levels in Cell 6 which do rise above the underdrain invert on dates that coincide with outflow at the downstream monitoring manhole.

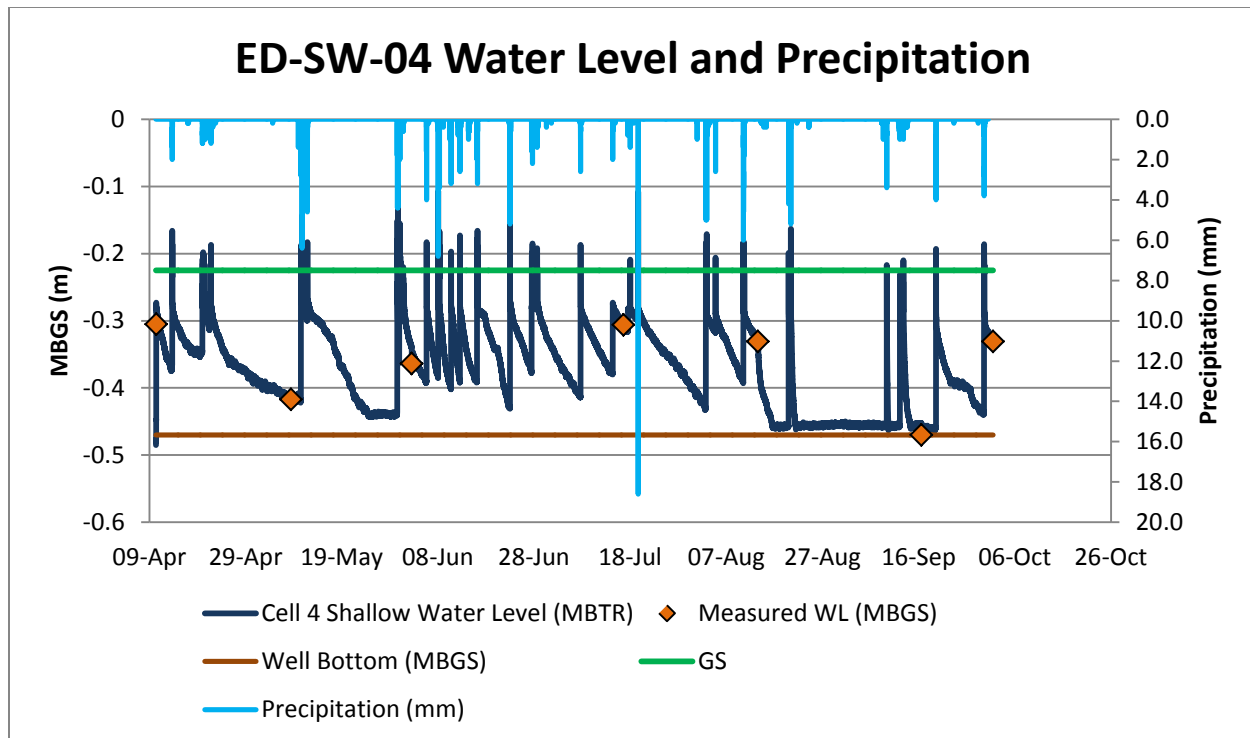
Figure 4-10 Surface ponding in bioretention cell 4 in 2015

**Figure 4-10** shows the occurrences of surface ponding in Cell 4. The timing of ponding in Cells 1 and 4 was similar. Surface ponding often coincided with precipitation of more than 2.5 mm during the 10 minute recording interval (**Figure 4-10**). Not all of these events with high rainfall intensity and surface ponding produced outflow. Ponding depths did not rise to the elevation of the overflow outlet in either of the cells. Ponded water infiltrated into the media quickly (less than an hour after the high intensity rainfall period).

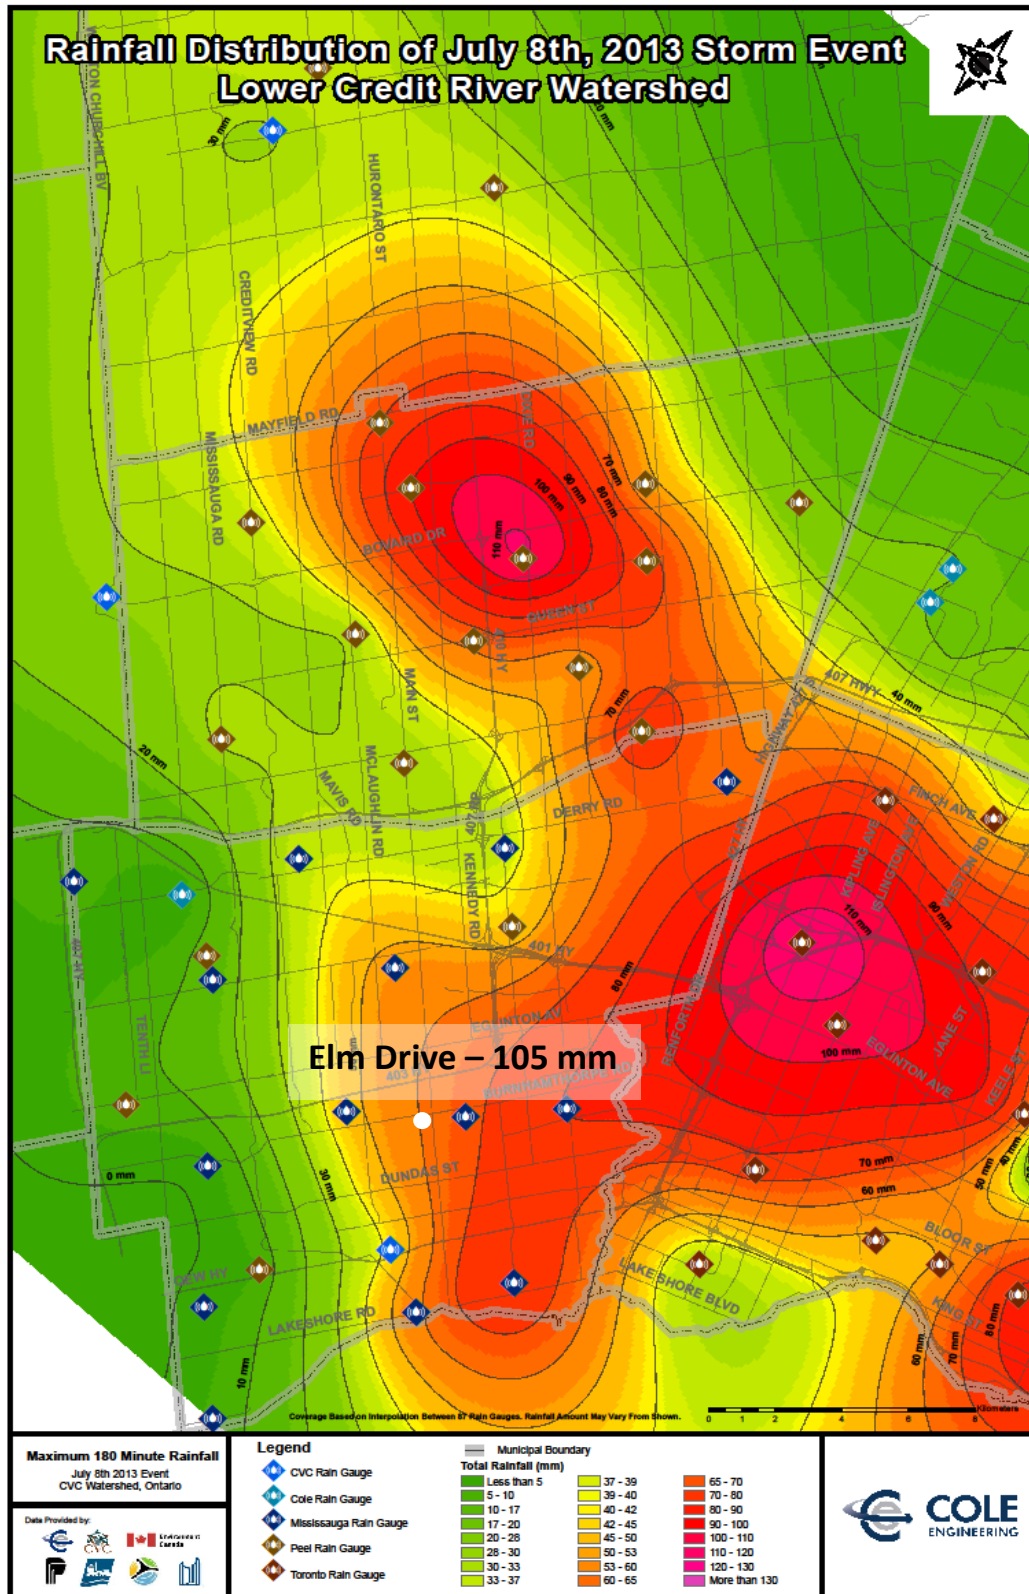
Figure 4-11 Rainfall distribution on July 8, 2013

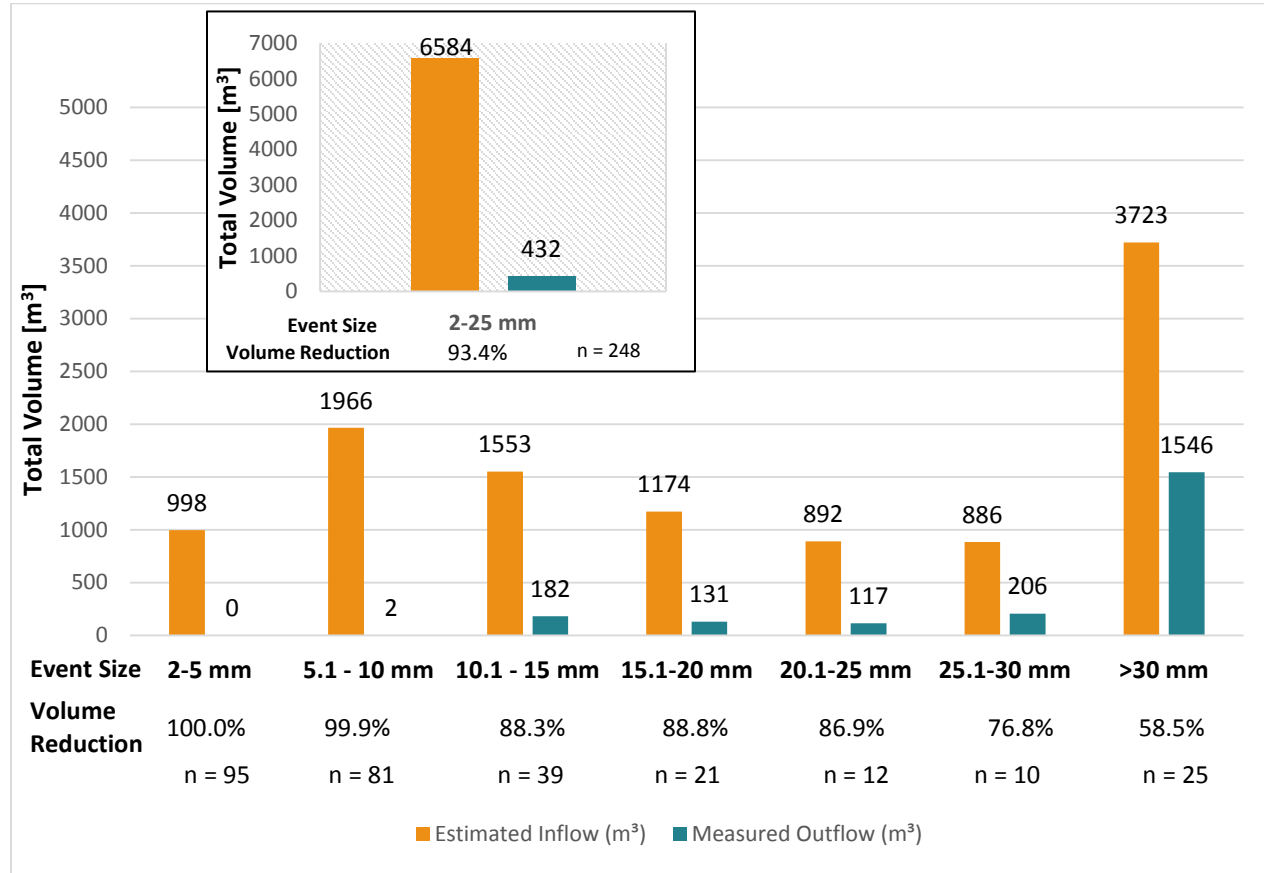
Figure 4-12 Runoff volume reduction achieved at Elm Drive, for different event size ranges, 2011 to 2015

Volume reduction is achieved by retaining water (through infiltration or evapotranspiration) such that it does not contribute to outflow from the site. It is important for groundwater recharge and water balance objectives as well as water quality objectives. In addition, retention of stormwater is an effective means of meeting erosion control objectives. Of the 283 events for which outflow was monitored, only 59 produced outflow. The overall runoff volume reduction was 80 per cent. The runoff volume reductions achieved for events of different sizes are provided below in **Figure 4-12**. For small events (up to 25 mm), the volume reduction was 93 per cent.

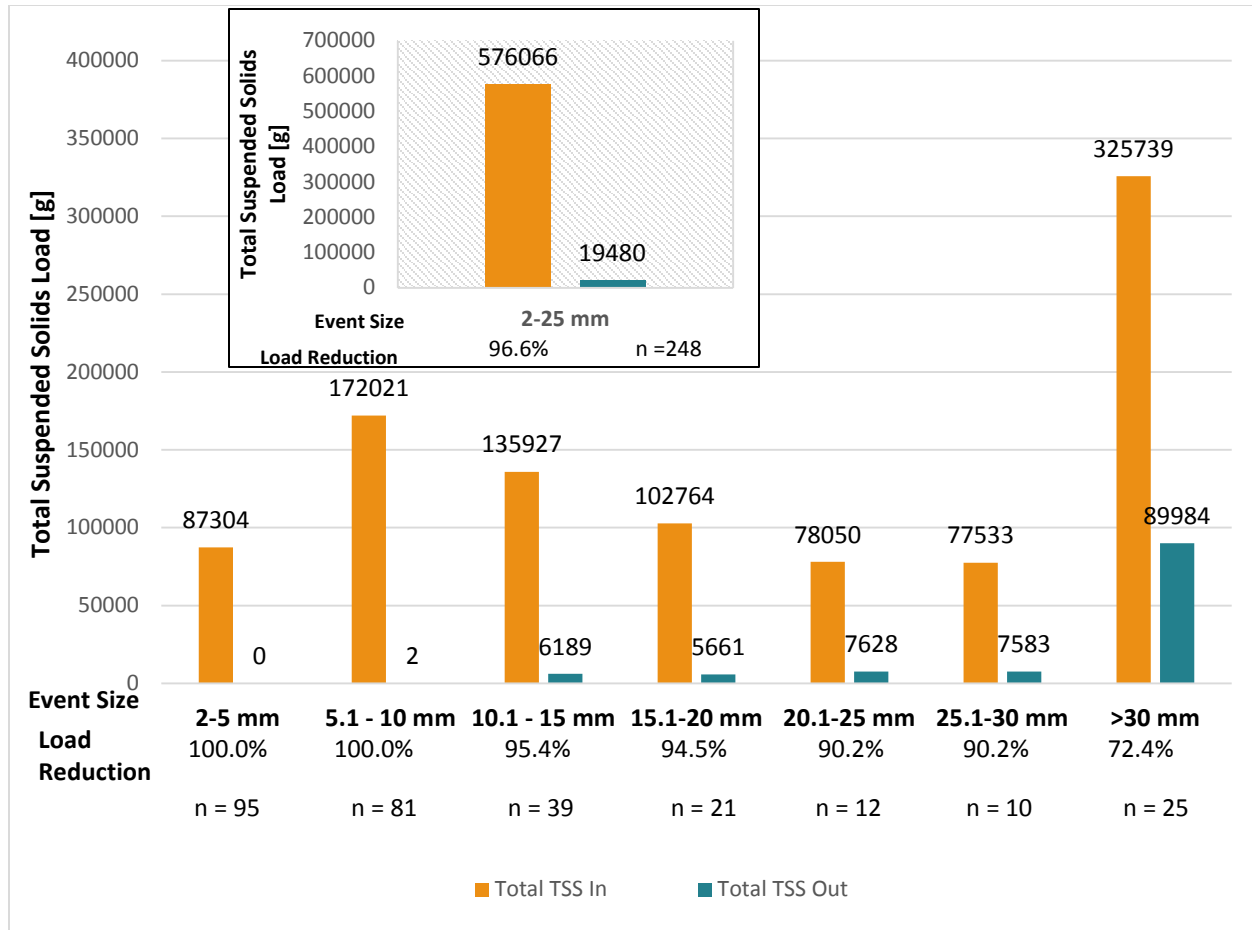
Figure 4-13 Load reductions of total suspended solids for different event size ranges, 2012-2015

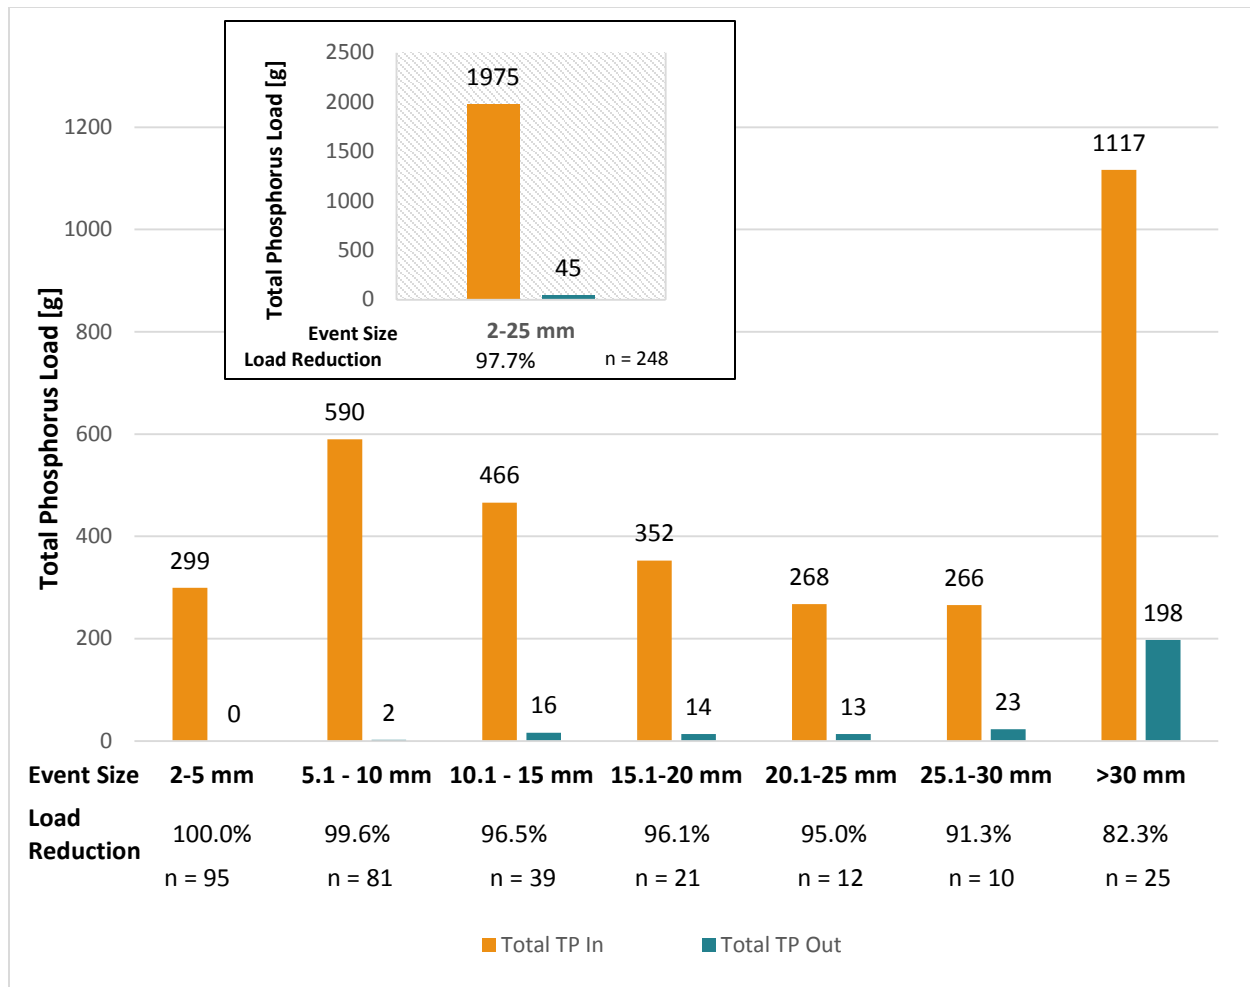
Figure 4-14 Load reductions of total phosphorous for different event size ranges, 2012-2015

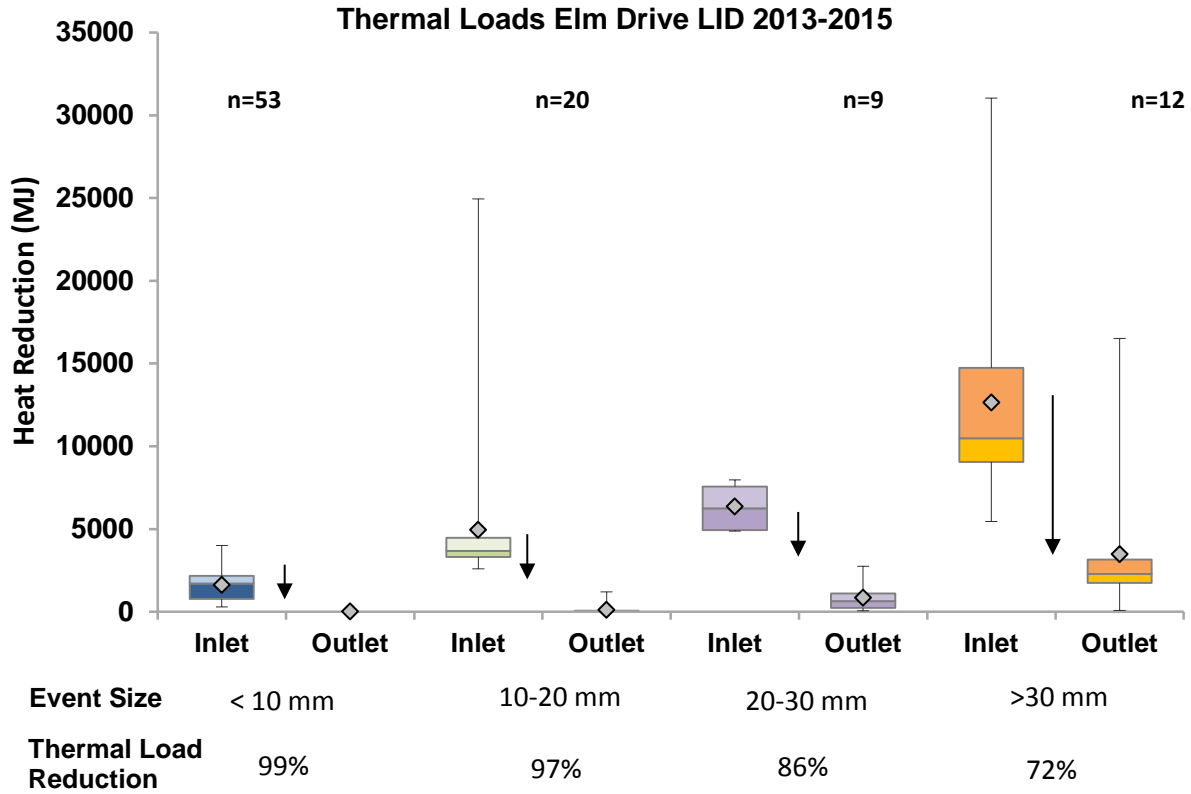
Figure 4-16 Thermal loading results from 2013-2015

**Figure 4-16** illustrates the average thermal load reduction for all storm events divided into 10 mm increments. The decrease in effluent volume through runoff storage within the LID facility is the leading factor in producing high thermal and temperature reductions at Elm Drive. Additionally, any effluent produced must pass through cooler permeable soil where thermal energy is transferred. The treatment train provides high thermal reduction in all events ranges and nearly 100 per cent reduction during smaller more frequent events.

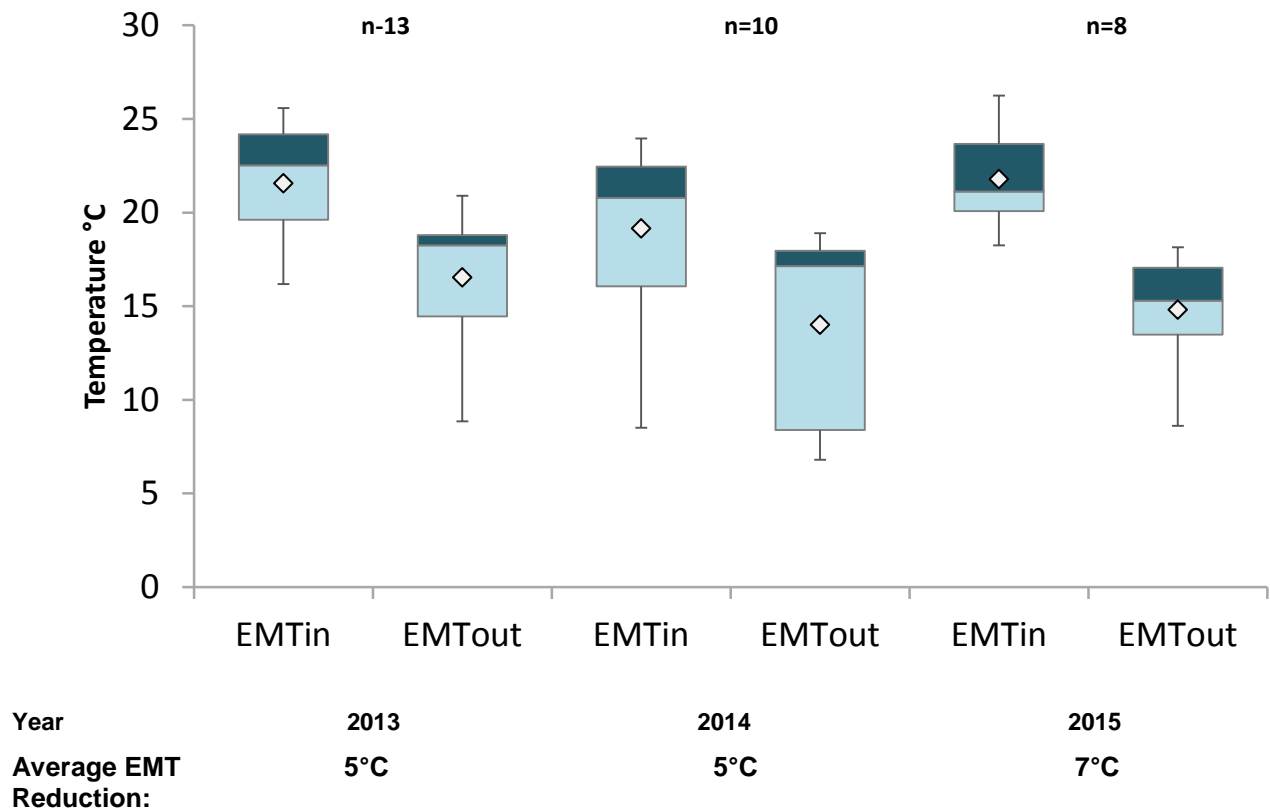
Figure 4-17 Event mean temperature 2013-2015 results

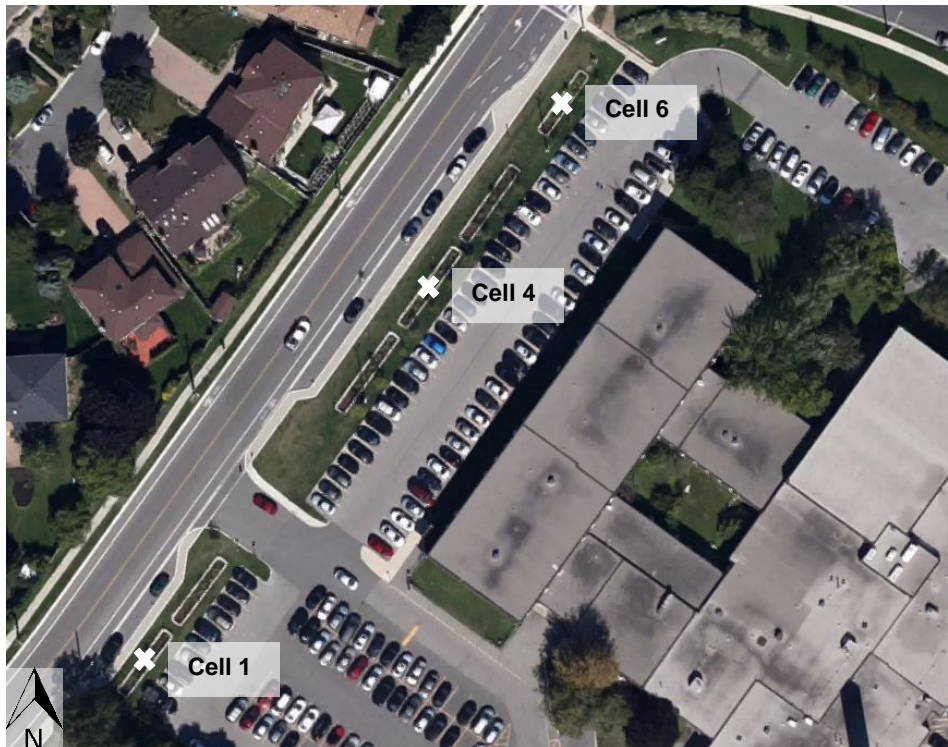
Figure 4-18 Bioretention cell sampling locations

Soil sampling occurred in the bioretention units that receive runoff from the surrounding catchment area. **Figure 4-18** indicates the bioswales and locations where samples were collected. Sampling occurred October 2, 2013 and October 9, 2014 after summer precipitation events but prior to the ground freezing. Soil (filter media) sampling was conducted at two depths. Samples were analyzed by Maxxam Analytics for metals, inorganics, and polyaromatic hydrocarbons (PAHs).

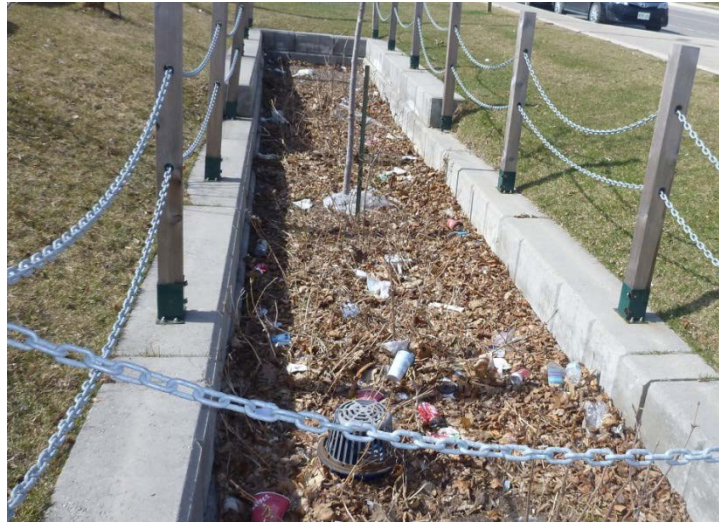
*Figure 4-19 Debris and leaf litter in a bioretention cell*

Litter accumulation is an ongoing problem due in part to the bioretention cells sitting below grade. This is also a high traffic area, due to the facility's proximity to the school and local shopping mall. Inlets to the facility are also experiencing litter and debris accumulation, especially in the spring and fall. During the spring this is likely reflecting garbage that has accumulated during the winter, while the fall likely reflects leaf debris. For this reason the City's maintenance schedule involves a major cleanup in the spring, followed by regular maintenance throughout the year.

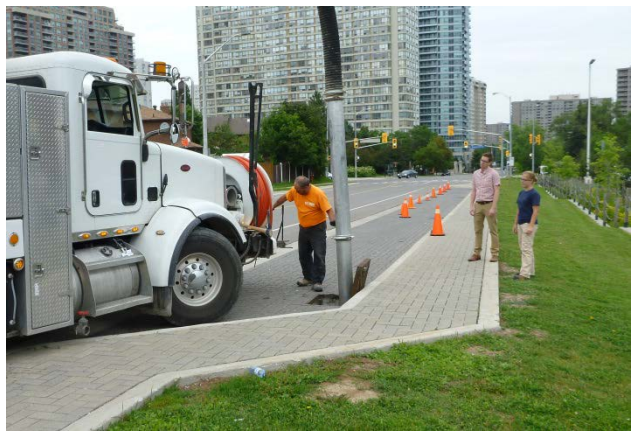
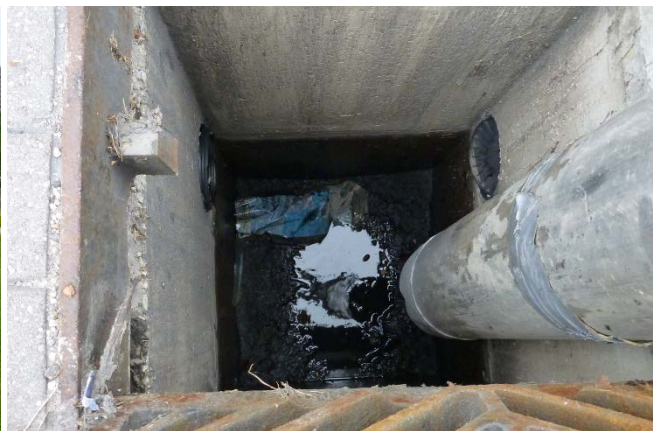
*Figure 4-20 Catch basin maintenance in July 2015*

In July, 2015 the City of Mississauga cleaned the catch basins that receive runoff from the road and convey stormwater to the bioretention planters. This involved removing debris from the catch basin sumps and rinsing the catch basins with water. The pipes that convey stormwater from the catch basins to the bioretention planters were also flushed with water to remove sediment and debris.

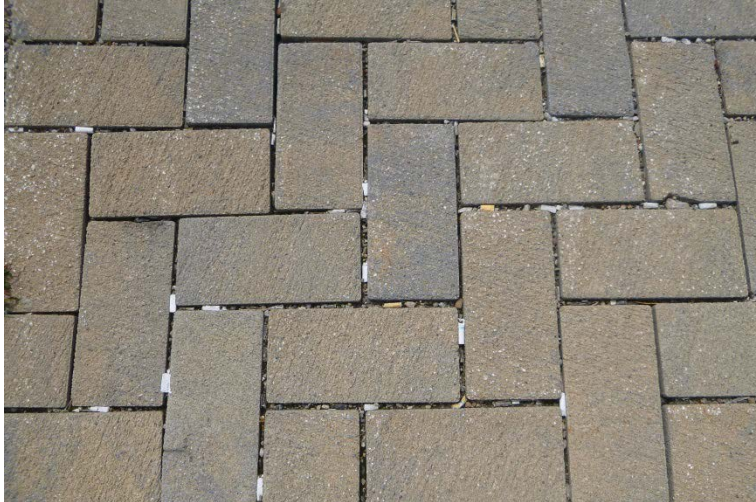
*Figure 4-21 Cigarette butts caught in permeable paver joints*

Staff also inspect the permeable pavement sidewalk and laybys. The sidewalk condition appears to be relatively consistent over time with little sediment accumulation. Since the permeable sidewalk is located in an area where smokers congregate, cigarette butts tend to become lodged between the paver joints. This reinforces the need to implement the right LID in the right location, or to account for the land use (e.g. by installing a facility to place cigarette butts). To avoid this design issue, a site visit by designers is warranted. This will help them to understand how the site is being utilized on a daily basis.

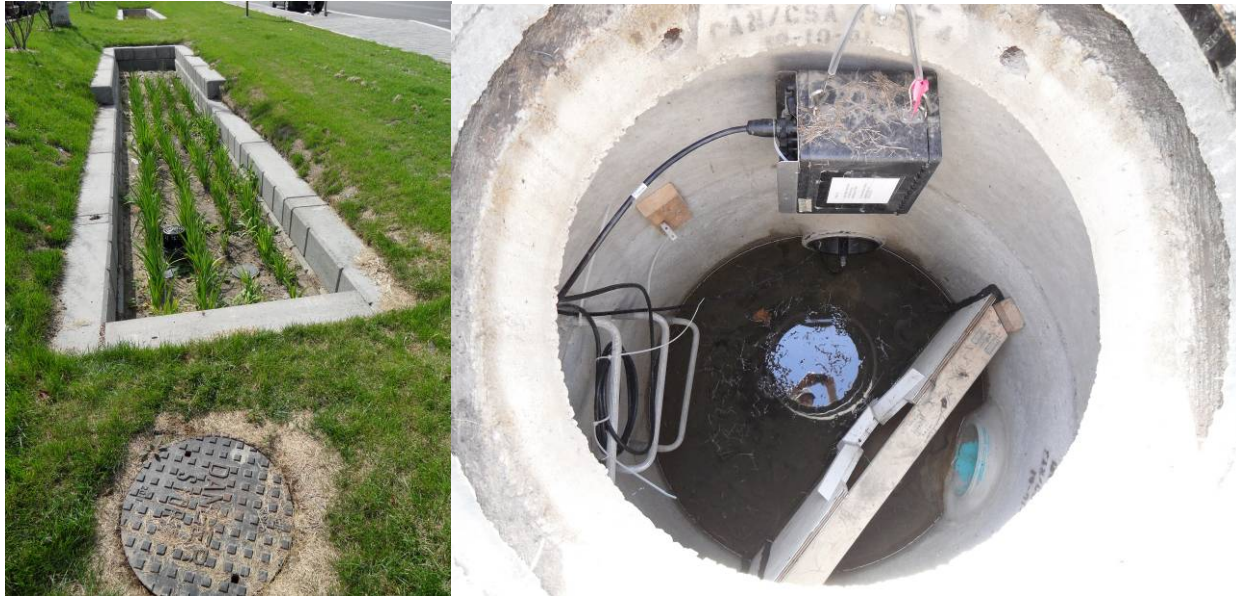
**Figure 3. Monitoring station.**

Existing site plans were reviewed followed by a site walk to gain an understanding of the existing drainage system for the study area. One monitoring station is proposed for this project. During construction, a manhole was installed at the end of the treatment train for monitoring purposes. An automatic water sampler and water level logger will be installed in the manhole. Figure 3 shows an external and internal view of the manhole.

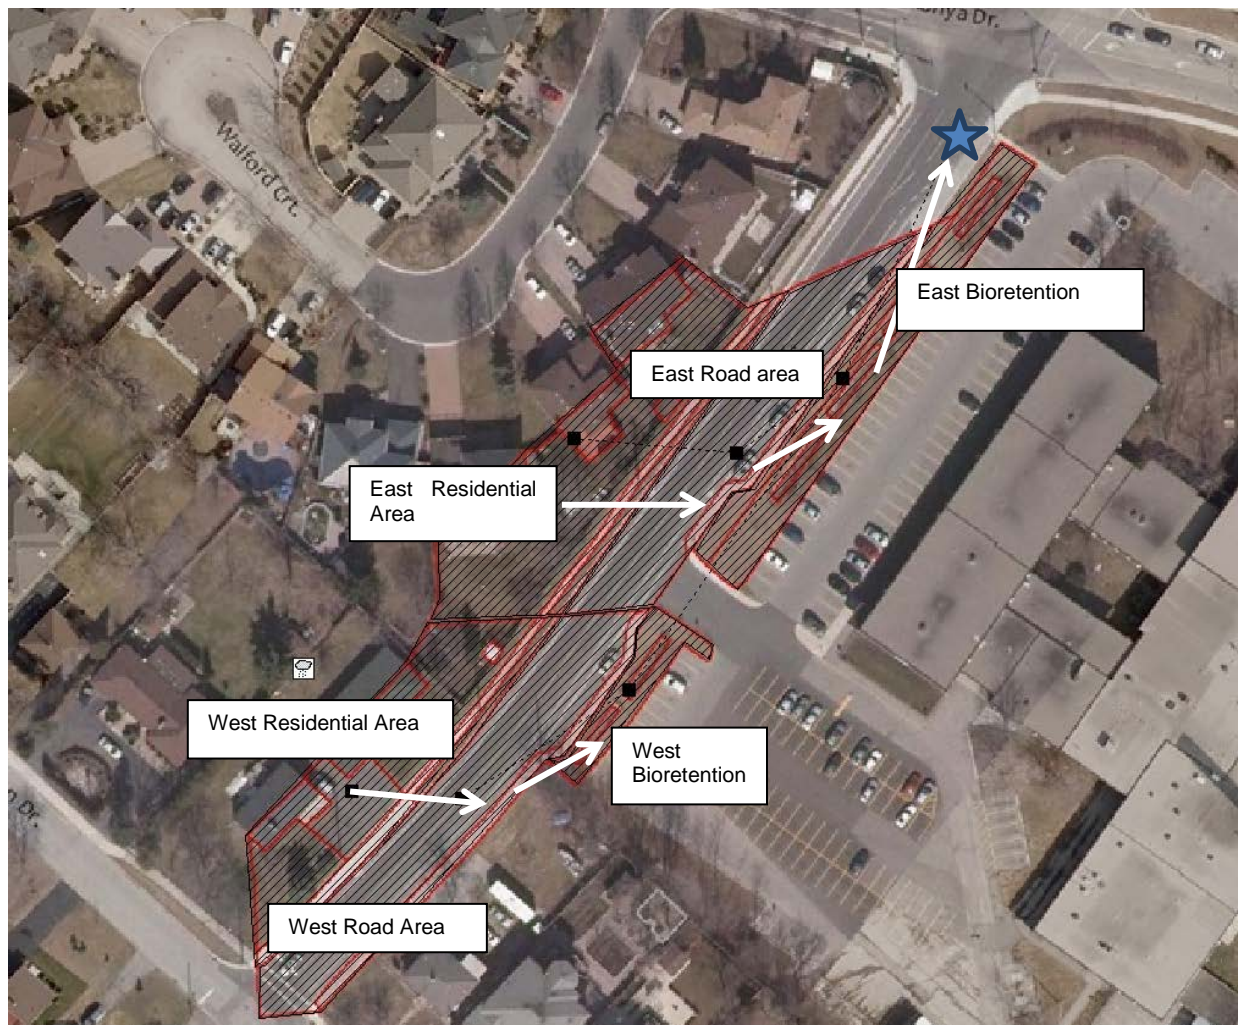
*Figure 1-1: View of the SWMM model setup including the delineation outline for each of the six subcatchments. The white arrows indicate the flow direction. Monitoring data was compared to modeled outflow data in the location identified by the blue star.*

The model was run utilizing available precipitation data from January 1, 2013 to July 12, 2013 at a 10-minute time step. The calibration process involved comparing the modeled outflow volume (both from surface runoff and underdrain outflow) from the east Bioretention area to the monitored outflow volume at this location for four storms. The four storms were calibrated to within 31% of volume. The model calibration can be further improved through the calibration with a greater number of storms, of which there is a high certainty of data quality.

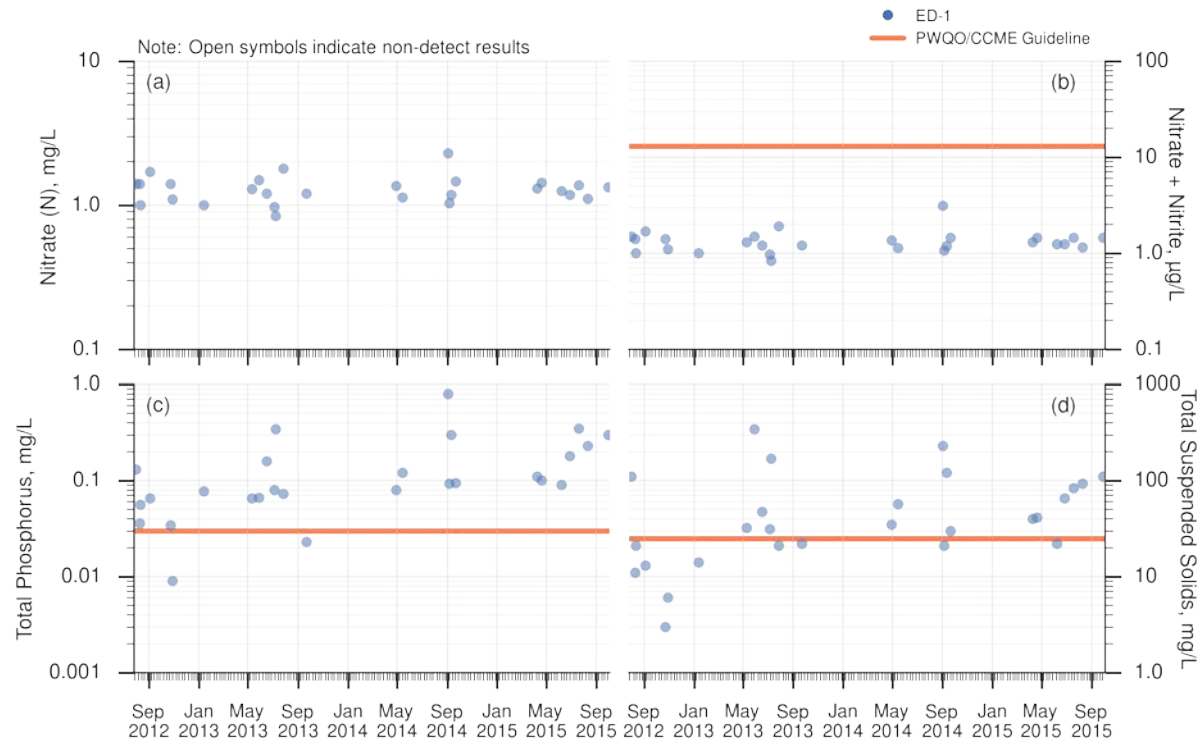
Figure D-1: Time series of effluent concentrations for selected parameters
