# Elm Drive

Low Impact Development Infrastructure  
Performance and Risk Assessment  
May 2016

## LOW IMPACT DEVELOPMENT INFRASTRUCTURE PERFORMANCE AND RISK ASSESSMENT

### MONITORING RESULTS (2011 – 2015)

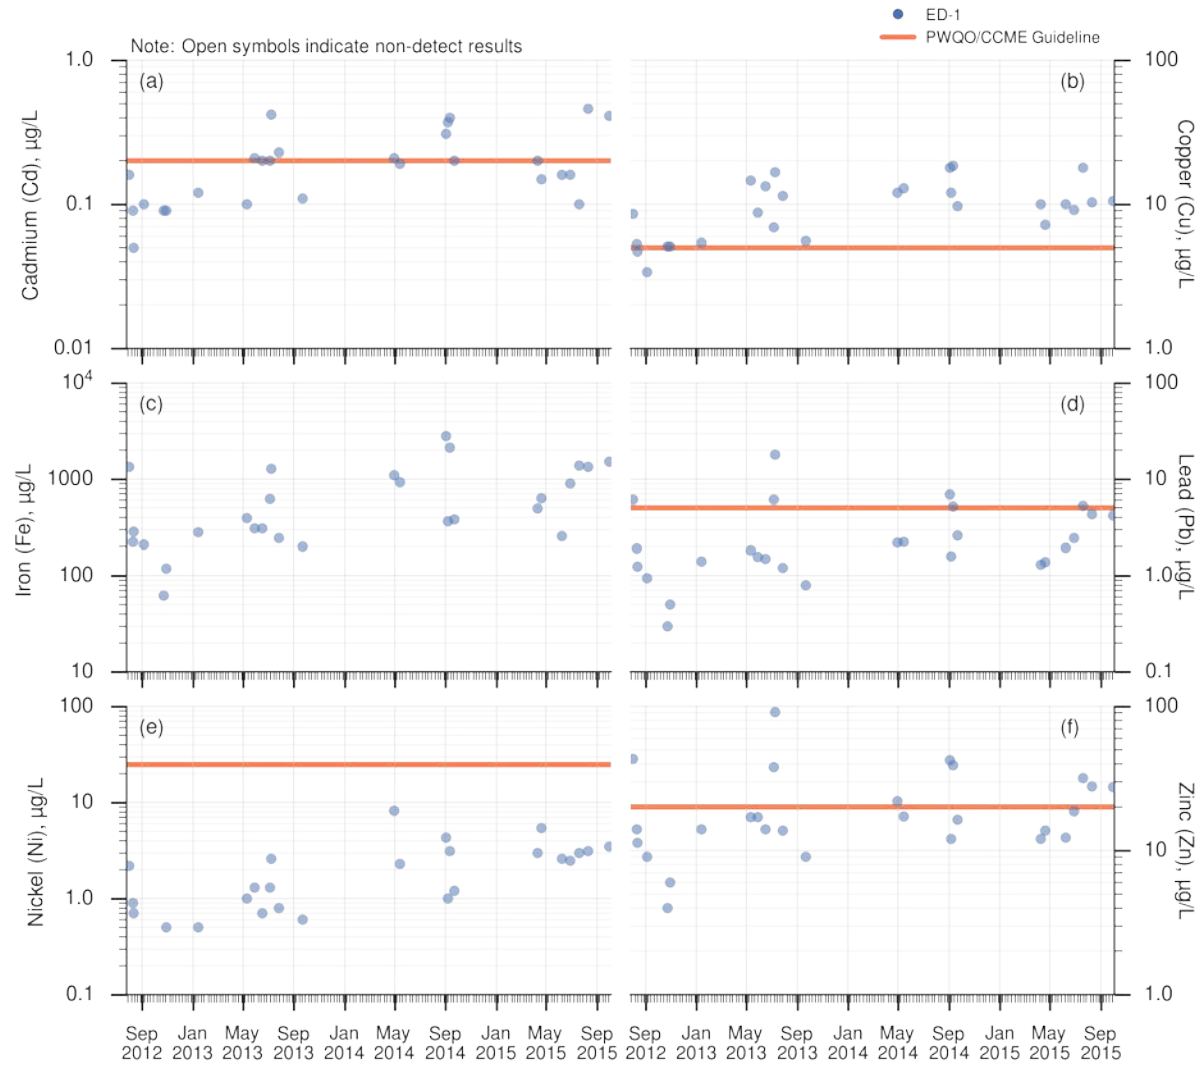
Figure D-2: Time series of effluent concentrations for selected metals

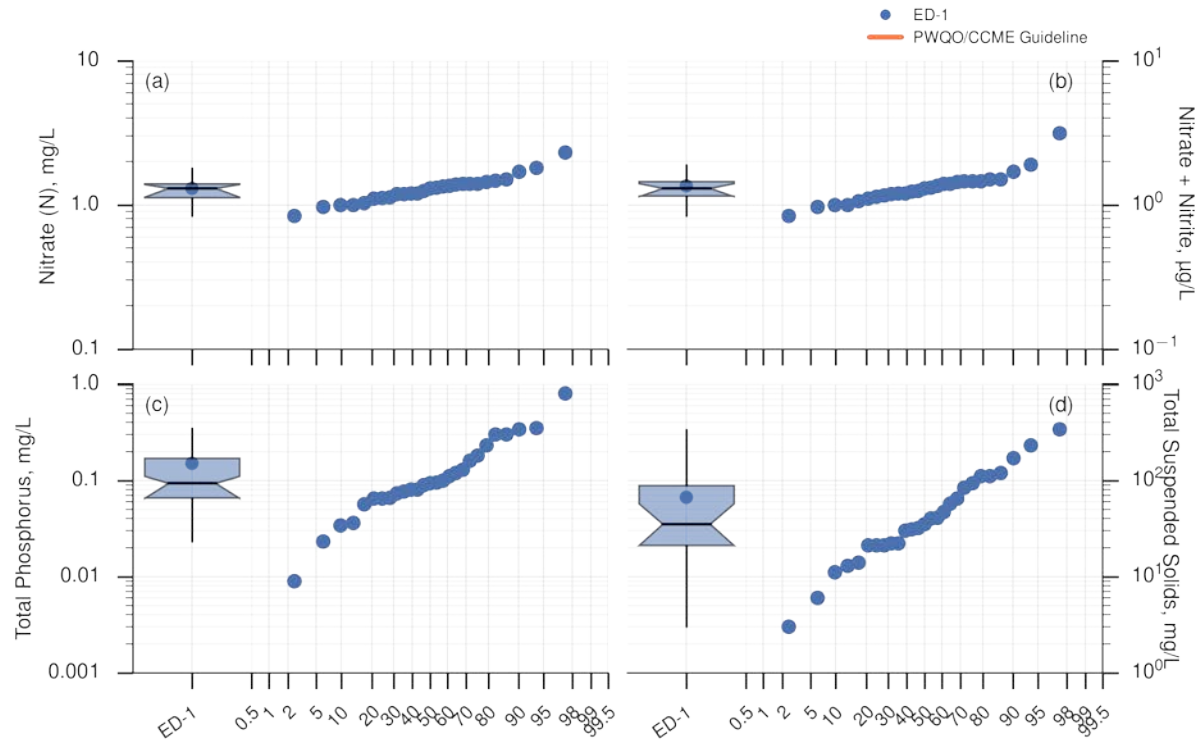
Figure D-3: Probability plots of effluent concentrations for selected parameters

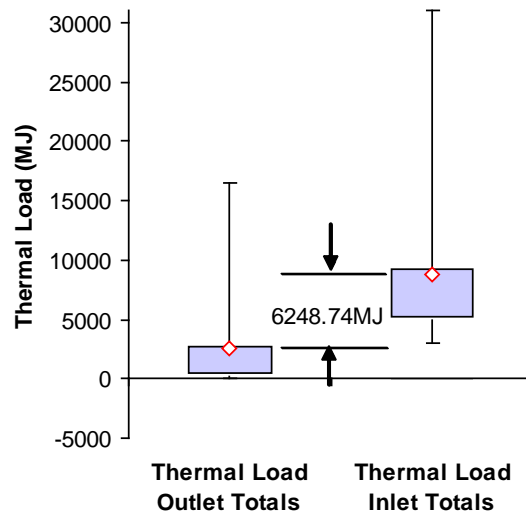
Figure 4: Thermal Load Totals for 2013 Outflow Events

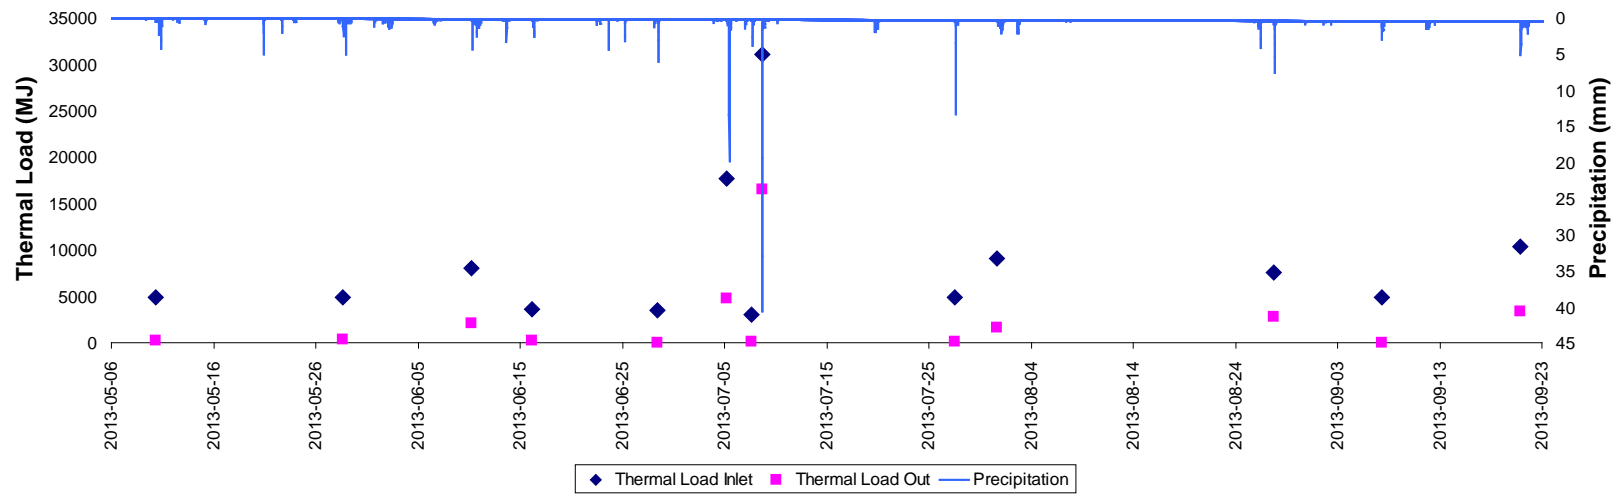
Figure 5: Thermal Load Reductions from Inlet to Outlet

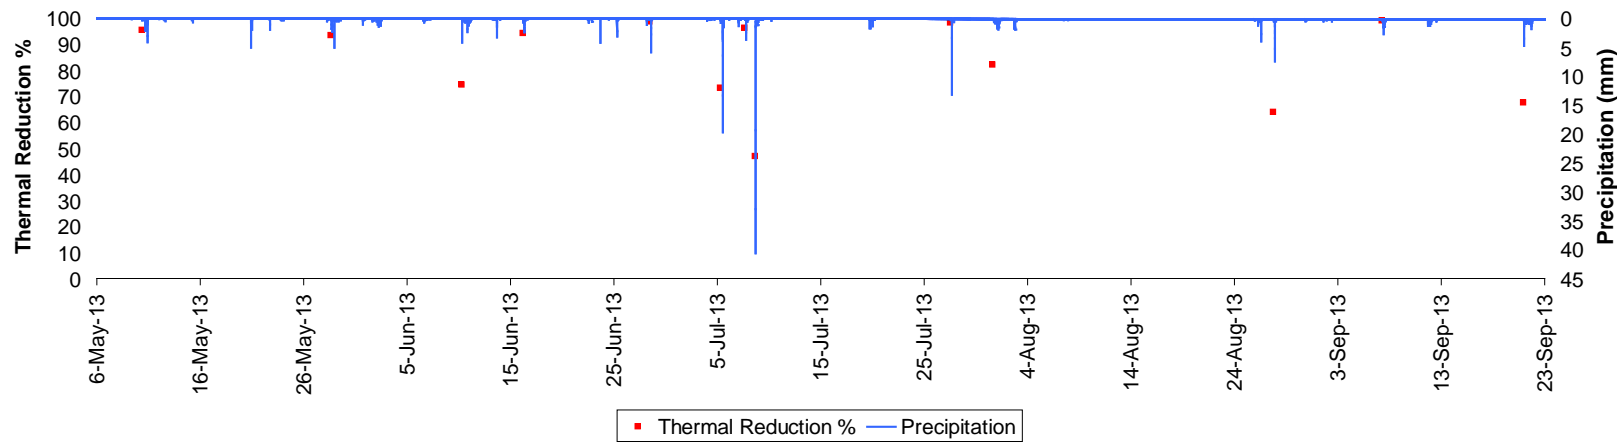
Figure 6: Thermal Load Reductions for all 2013 Events with Outflows

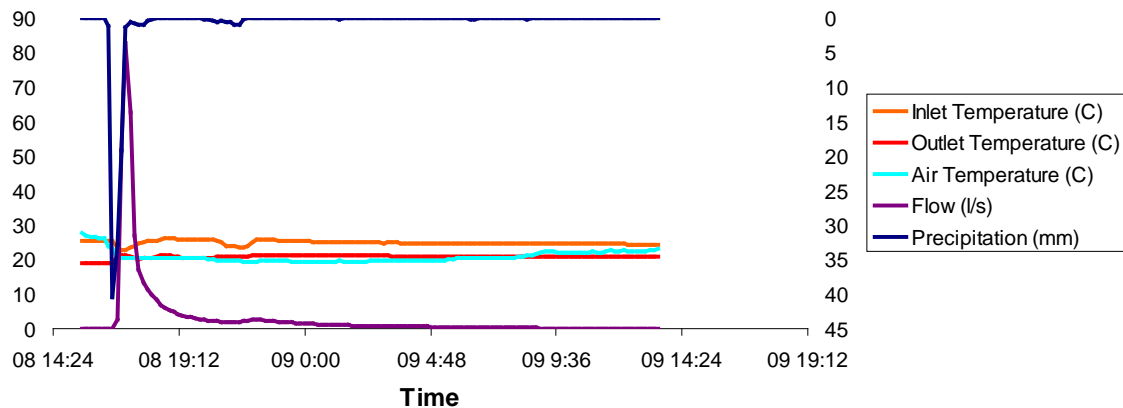
Figure 7: Inflows and Outflows with Temperature during July 8<sup>th</sup> Event

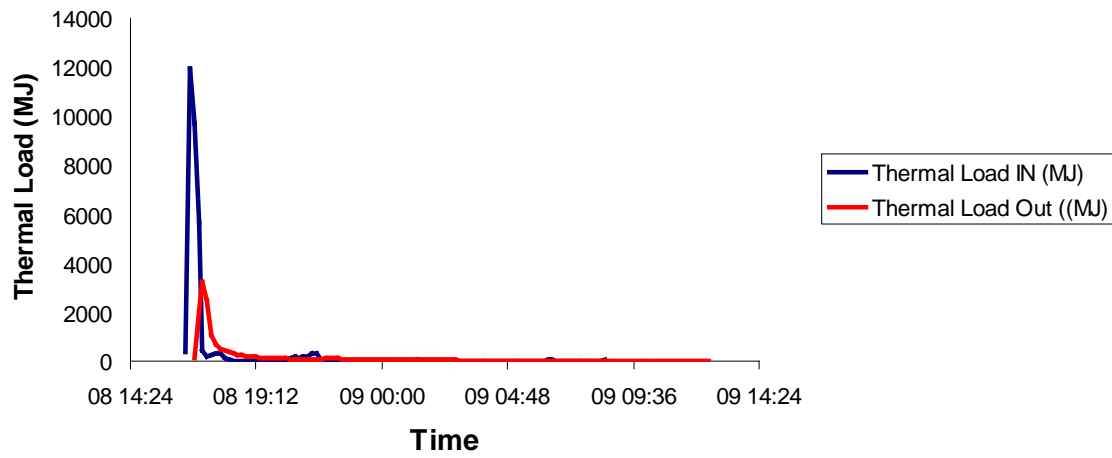
Figure 8: Thermal loads during July 8<sup>th</sup> 2013 Event

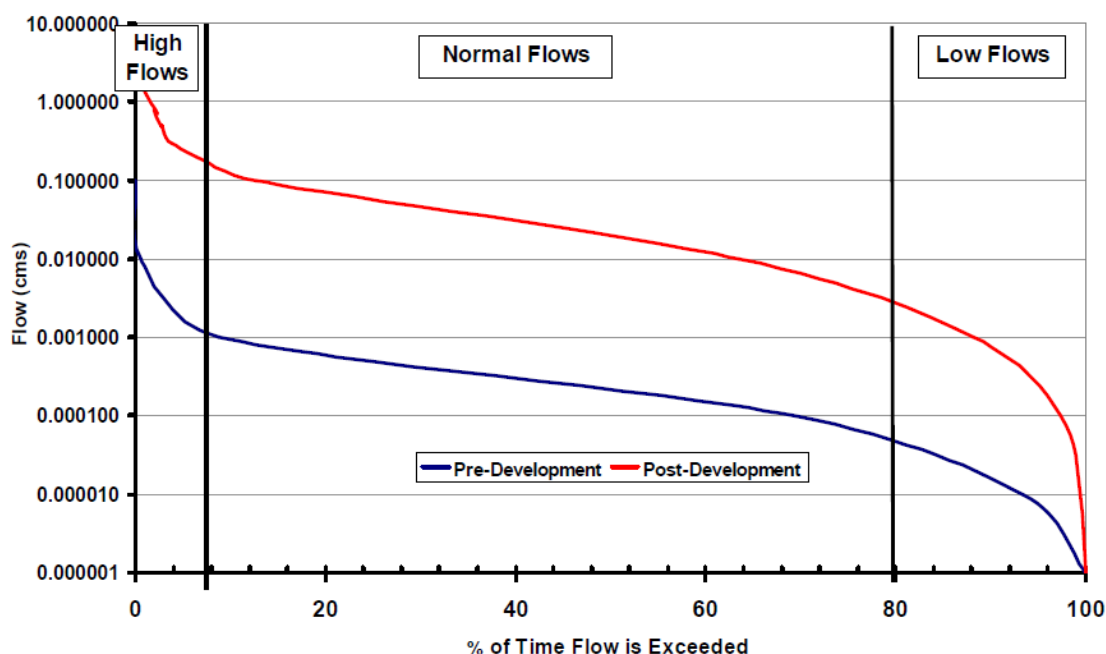
Figure 6: Increasing trends in stream flow pre- and post-construction in Fletcher's Creek

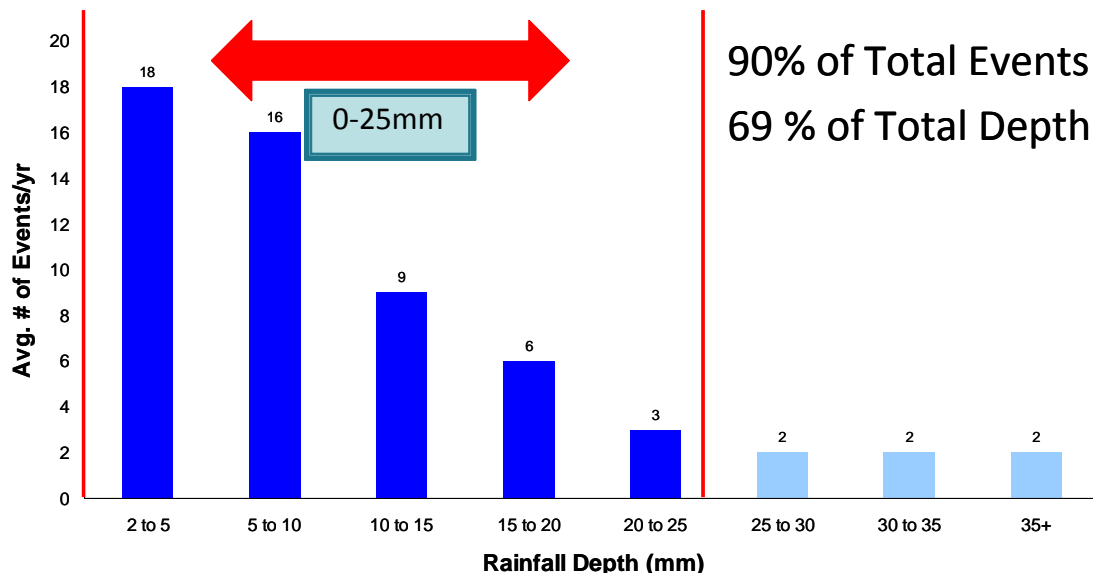
Figure 8: Typical Annual Rainfall Frequency Distribution for Toronto Lester B. Pearson 1960-2012

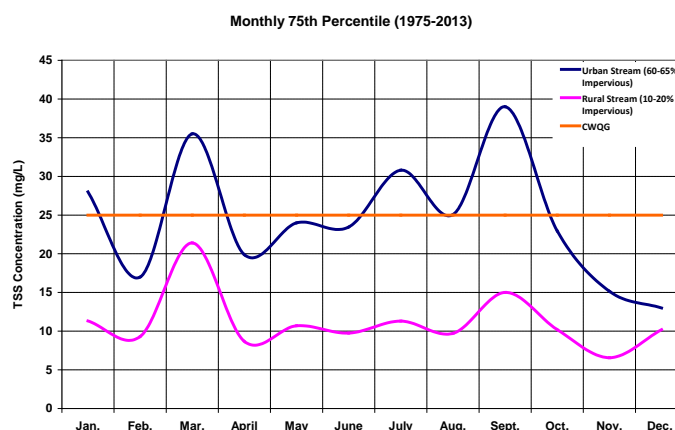
*Figure 10: Monthly 75<sup>th</sup> Percentile Total Suspended Solids concentration compared at an urban vs. rural catchment*

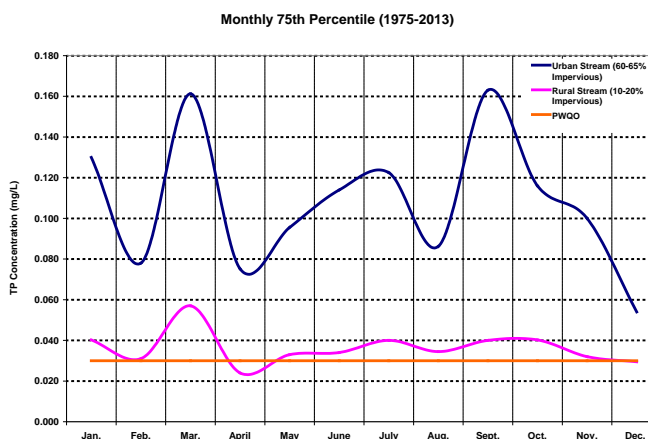
Figure 11: Monthly 75th Percentile Total Phosphorus concentration compared at an urban vs. rural catchment
