Low Impact Development Infrastructure
Performance and Risk Assessment
May 2016

Road Right-of-Way Retrofit

LAKEVIEW DRIVE, CITY OF MISSISSAUGA LOW IMPACT DEVELOPMENT INFRASTRUCTURE PERFORMANCE AND RISK ASSESSMENT

DRAFT TECHNICAL REPORT MONITORING RESULTS (2012 – 2015)

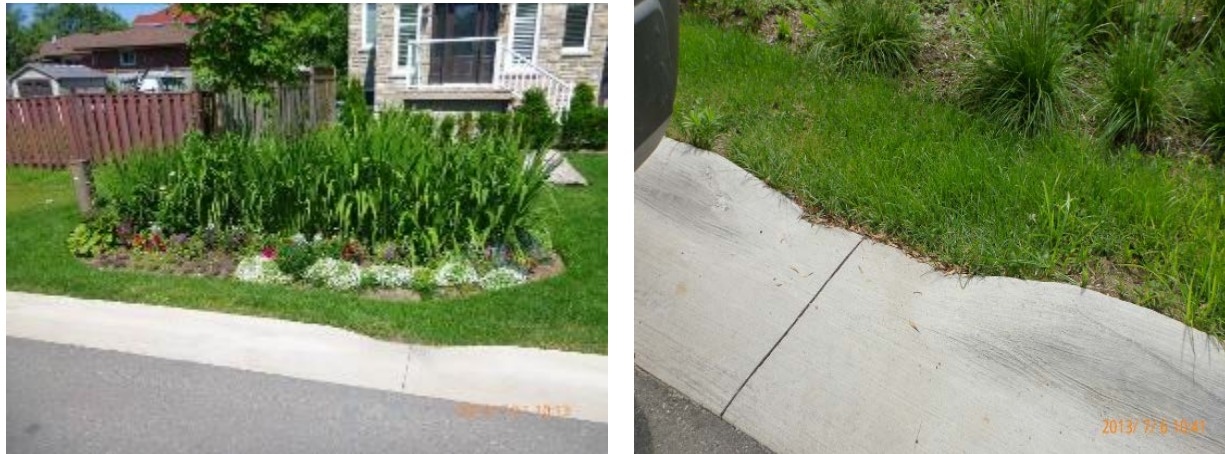
Figure 3-4 Curb cuts allow road runoff to enter the vegetated bioswales

Bioswale units are soil filter systems that temporarily store and filter runoff. These units rely on the engineered soil media placed below the channel invert to provide stormwater runoff reductions and improve water quality. Street runoff flows along the curb and enters the bioswale through curb cuts (**Figure 3-4**) placed in front of each swale.

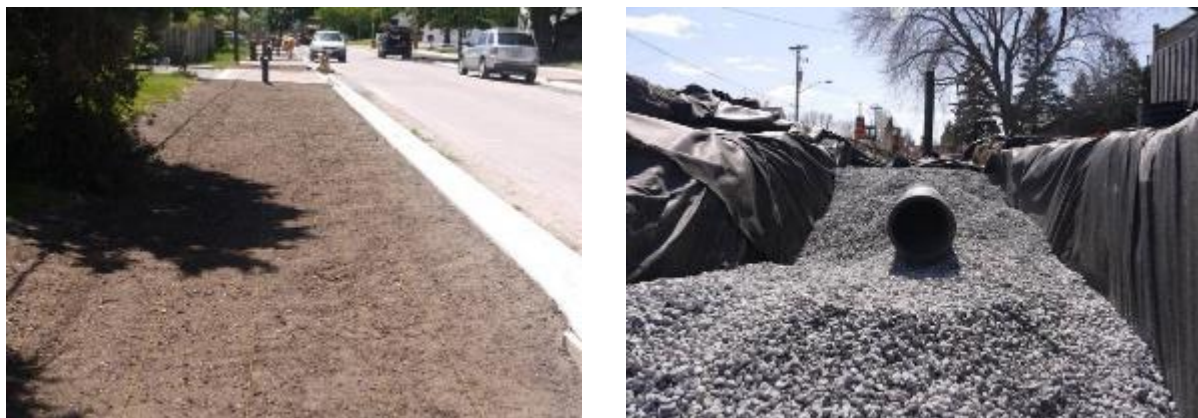
Figure 3-5 Bioswale with underdrain in gravel layer (left), Engineered soil mix within the bioswale (right)

Stormwater runoff treated by the soil media bed flows into the ground or the underdrain (**Figure 3-5**), which moves treated runoff to the subsurface stormwater conveyance system further downstream. The underdrain consists of a perforated pipe within a gravel layer below the engineered media bed. The non-woven geotextile cloth fully wraps the gravel so it covers the top of the gravel, separating the gravel and soil materials.

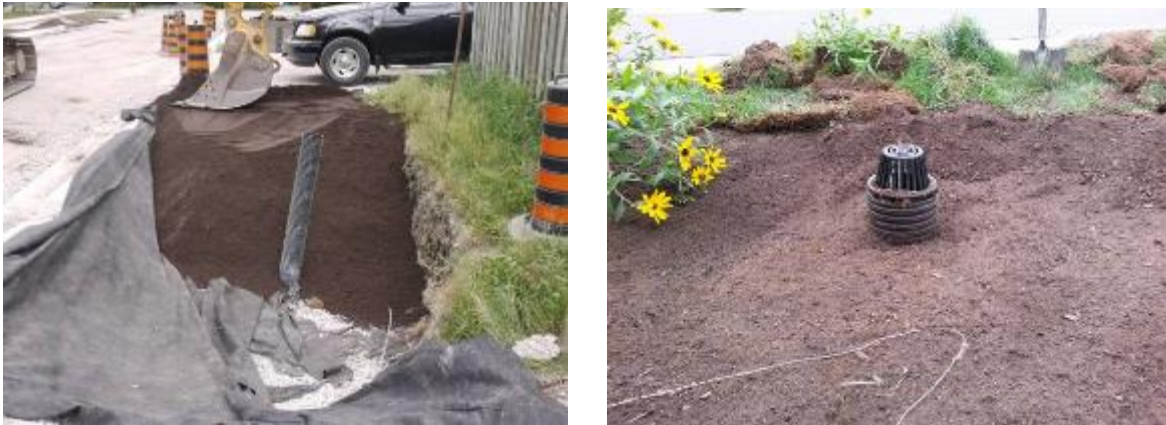
Figure 3-6 Overflow pipe with debris screen (left), Soil media being installed around an overflow pipe (right)

An overflow pipe with a debris screen (**Figure 3-6**) is connected to the underdrain. The pipe allows stormwater to flow directly into the underdrain if ponded water becomes too deep.

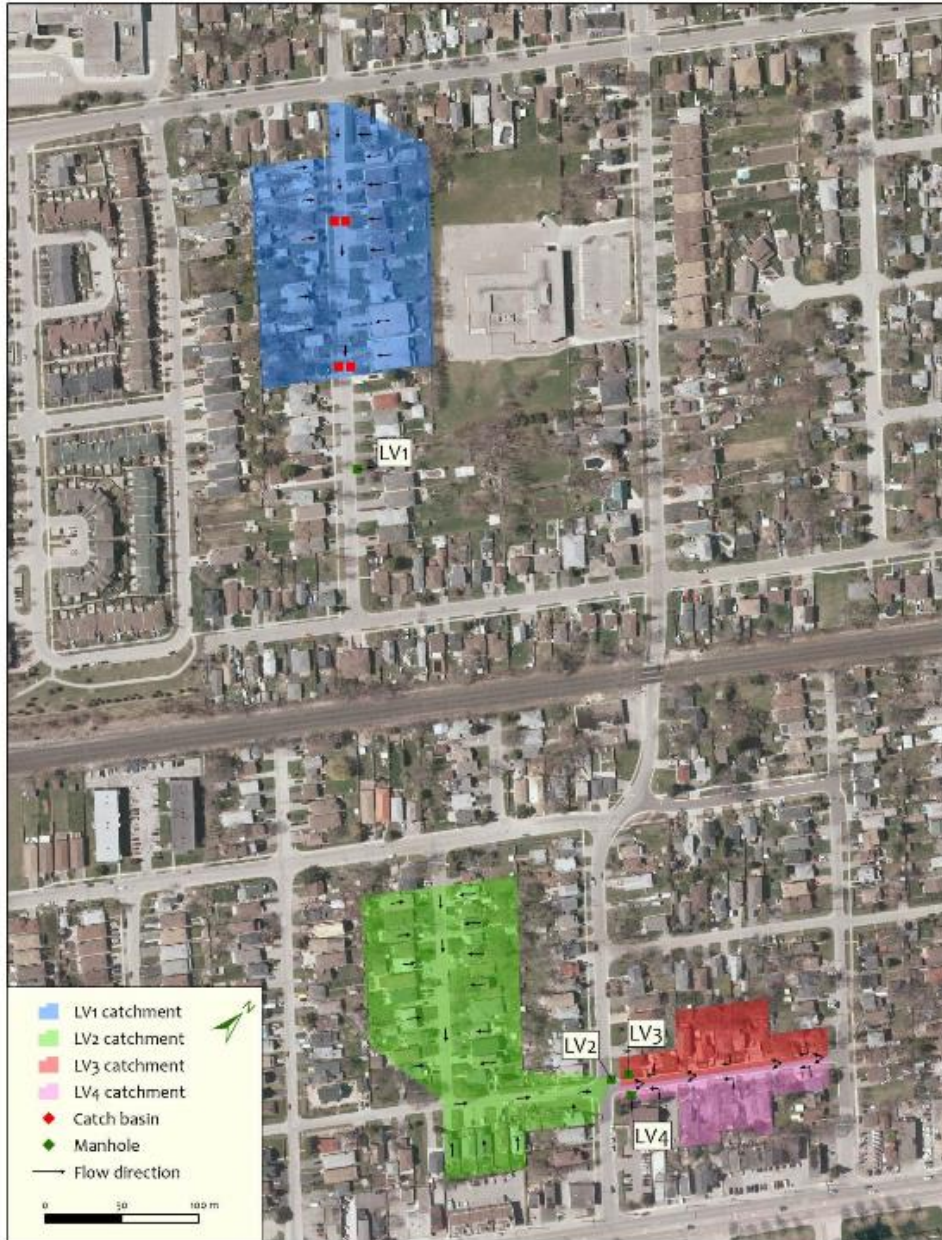
Figure 3-8 Overview of catchments monitored within the Lakeview neighborhood

Figure 3-8 provides an overview of the study area with all of the monitored catchments. This figure shows the close proximity of the water quality reference site (LV-1) to the swale (LV-2) and bioswale (LV-4) monitoring sites.

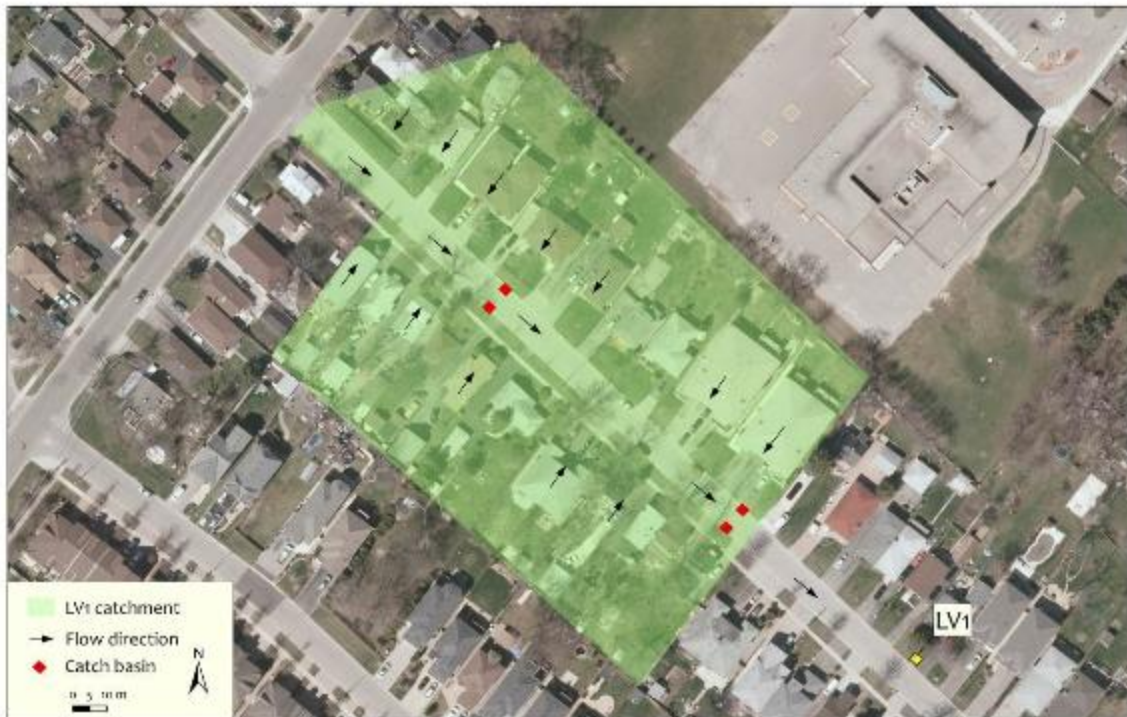
Figure 3-9 LV-1 Water quality reference site drainage area with direction of runoff

The LV-1 catchment, which has typical curb and gutter to inlet and storm sewer pipe systems, was intended to serve as a reference and water quality control site (**Figure 3-9**). Four catch basins (shown in red) located upstream capture and convey runoff towards the sampling location referred to as LV-1. The LV-2 catchment, which has conventional vegetated swales for drainage, allows the benefits of the enhancements to be evaluated (**Figure 3-10**). The monitoring manhole, LV-2, was used for pre-construction monitoring and continues to be monitored post construction, providing baseline data for traditional ditches. **Figure 3-11** shows the locations of LV-3 and LV-4 on one of the retrofitted streets. LV-3 receives drainage from the north side of the street. Data from LV-3 are not analyzed in this report; modifications to improve the LID features are planned, such as potentially modifying the inlet curb-cuts to allow more inflow of stormwater runoff. Runoff from the south side of the retrofitted street flows to LV-4.

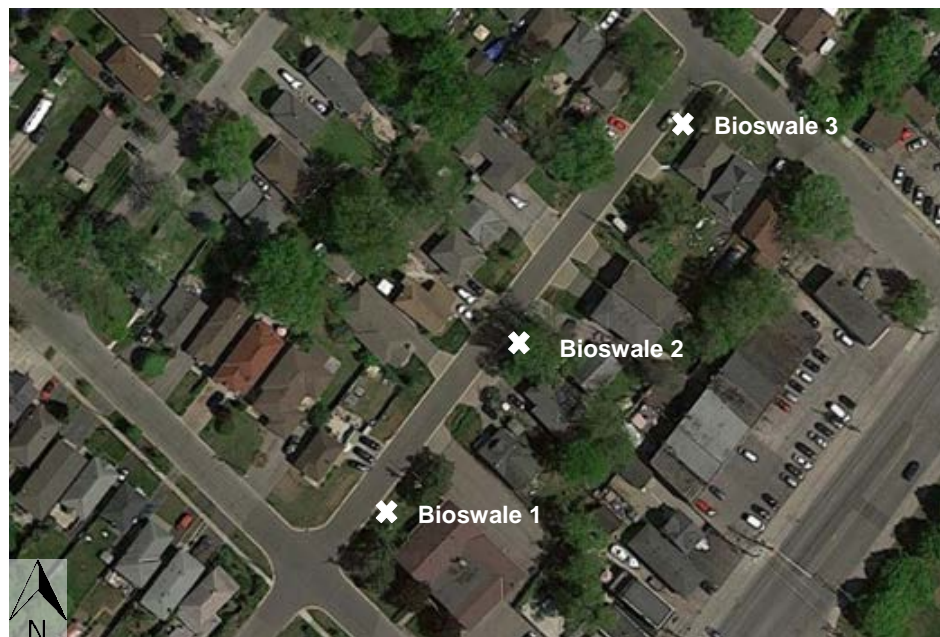
Figure 4-15 Soil sampling locations in the Lakeview bioswales

Soil sampling occurred in the bioretention units that receive runoff from the LV-4 catchment area. **Figure 4-15** shows the bioswales that samples were collected from. Sampling occurred October 9, 2014 after summer precipitation events but prior to the ground freezing. Soil (filter media) sampling was conducted at two depths. Samples were analyzed by Maxxam Analytics for metals, inorganics, and polycyclic aromatic hydrocarbons (PAHs).

Two composite soil samples were collected from three bioretention cells (six samples total). The shallow and deep samples were collected at approximately 5 cm and 30 cm below the filter media surface, respectively. In the sampled cells, three subsamples from each depth were combined to produce one composite sample. Comparison between two sampling depths provides information regarding the depth at which pollutant removal occurs for different parameters. In addition, sampling at two depths helps determine whether or not pollutants are migrating through the soil column over time. Collecting samples

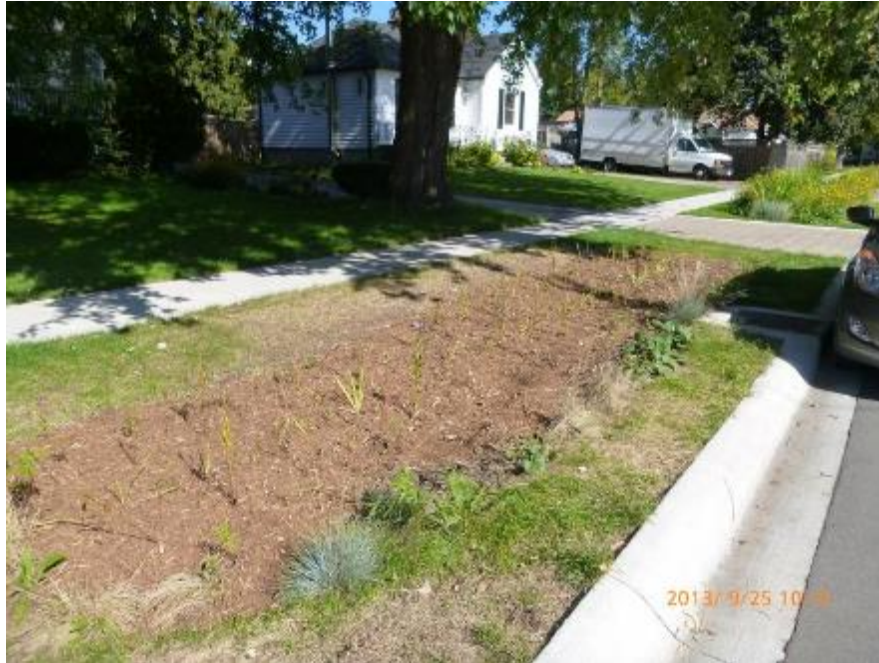
Figure 5-2: New plantings were just done in one of the bioswales at Lakeview. They will now require extra care and maintenance until they are established.

Plants should ideally be planted in the spring and fall when temperatures are cooler and rain is more frequent. In their first season of establishment they should be watered daily. This will help the roots grow and spread out throughout the filter media layer. Larger, more mature plants are usually less likely to die, but plugs will grow nicely if proper care is taken. It is also important to choose the right plants for the area and different factors should be considered while making this decision, such as the amount of sunlight, soil conditions, and aesthetics. It is good to have a variety of plants that will bloom throughout the season and offer different colours and textures for an interesting garden. The height of the plants is also important depending on location as they could result in a visual hazard if planted close to roads or driveways as visibility is reduced. For further information on plant selection and establishment refer to CVC's Landscape Design Guide for Low Impact Development (CVC, 2010), LID Certification Protocols: Bioretention Practices (CVC, 2015), and various factsheets and case studies that can be found on the website.

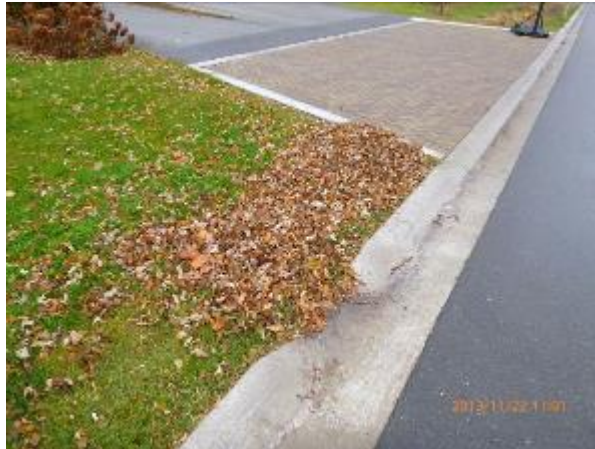
Figure 5-3 Leaves blocking the inlet and partially covering the bioswale, which could impede flow and reduce performance

- Large amounts of organic debris (such as leaves and pine cones) are present in the fall and can block inlets (**Figure 5-3**).

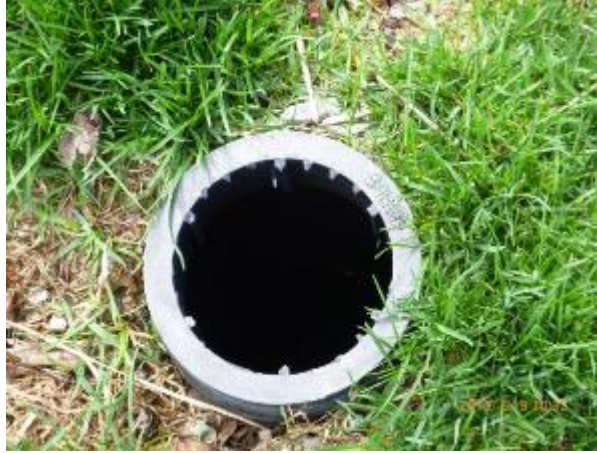
Figure 5-4 Missing overflow cap at the outlet pipe in the Spring after the snow has melted

- Snow from the street is plowed and dumped into some of the bioretention cells which has caused damage to the overflow caps (**Figure 5-4**) as the weight of the snow and/or snow plows have cracked or removed them

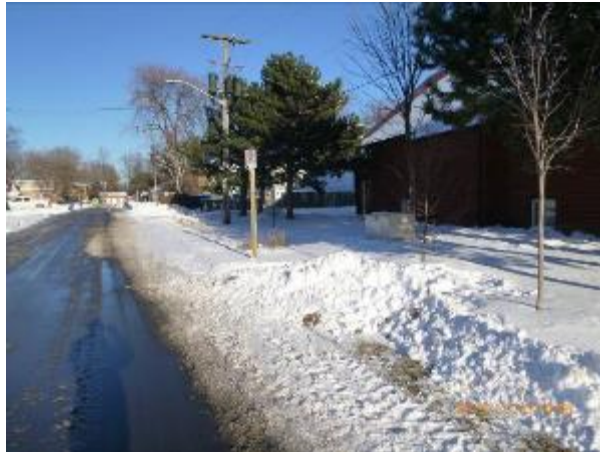
Figure 5-5 Street in Lakeview after being plowed by the City of Mississauga

- Winter monitoring is important to ensure damage to the facility does not occur during City snow plow operations (**Figure 5-5**).

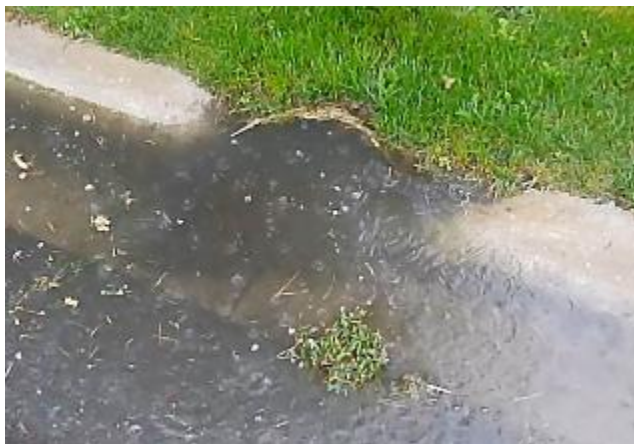
Figure 5-6: Inlet with incorrect grading, water is unable to enter the bioswale

The inlets did not match design elevations at the grass surface, which prevented runoff from entering the facility (**Figure 5-6**). To correct the issue, grading was lowered on the grass sections to match the design drawings (**Figure 5-7**). Further improvements, such as adding paved channels at the inlets to better direct the stormwater runoff into the bioswales, are being planned for the fall of 2016.

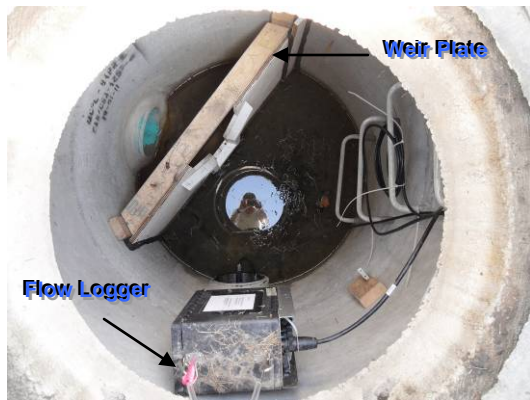
Figure 2-1: Flow Logger and Compound Weir

Weirs have been installed in the manholes downstream of each site. The weirs are custom compound weirs by Thompson Flow Investigations. The lowest measurable flow is 0.021 L/s^1 at LV-1 and LV-2 and 0.008 L/s^1 at LV-3 and LV-4. According to the manufacturer, the weirs do not need still water upstream (as it is not a sharp lip weir), and the level logger can be mounted close to weir, because it has been tested/calibrated to do so. An ISCO 4150 flow meter (or HACH FL901) has been installed in the monitoring manholes with the probe secured to the bottom of the manhole, upstream of the weir to ensure accurate water level measurements. The flow meter records water levels at 10-minute intervals (5-minute intervals at LV-1). The monitoring stations (excluding LV-3) are equipped with an ISCO 6712 automatic sampler for collection of water quality samples. The automatic sampler is set to trigger based on water level measured at the monitoring station (water elevation relative to the weir notch is used to determine flow). A heated tipping bucket rain gauge near the Lakeview sites (Mississauga Rain Gauge Network - S01 Third St.) provides the site precipitation data. The rain gauge is located on the roof of the Third St. fire station so the likelihood that the gauge will be subjected to higher winds during more severe storm events is higher. This could potentially cause the rain gauge to “undercatch” rainfall. Precipitation data collected during more severe storm events will be more closely examined for accuracy. A precipitation event is considered to occur when 2 mm or more precipitation is recorded. If more than 6 hours elapse between precipitation events, they are considered to be separate events.

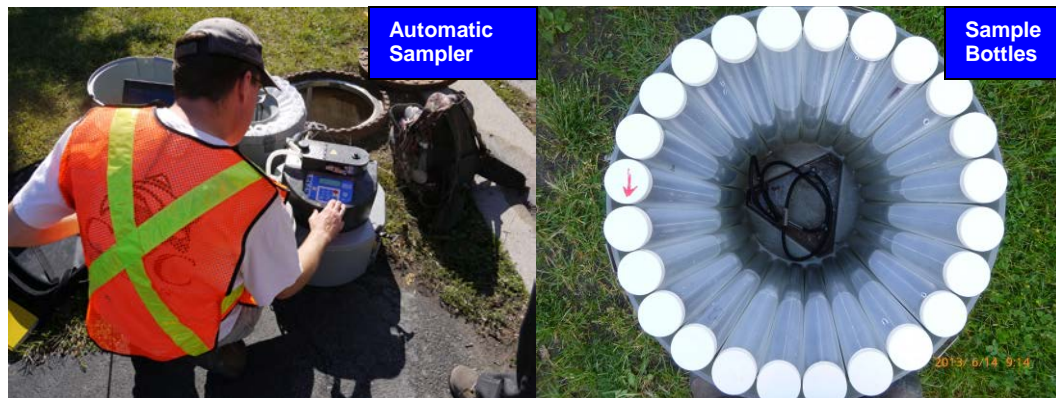
Figure 2-3: Water Quality Sampling

The automatic sampler is programmed to collect samples that will allow for a composite sample to be compiled for water quality analysis for each event at the outflow monitoring station. The sampler holds 24 1-litre bottles. When the sampler is triggered, all bottles are filled provided there is sufficient runoff. Bottles that were sampled while outflow was observed are used to generate a flow-weighted composite sample. Currently the sampler is programmed to collect samples at a fixed time interval. The length of time between bottle fills may be lengthened or reduced depending on the event forecasted. This will either shorten or lengthen the sampling program in order to provide a flow-weighted composite sample that is representative of the event and that provides adequate sample volume to perform laboratory analyses. CVC has developed program lengths of 6, 12, 18, and 24 hours, with associated sample collection intervals of 10, 20, 30, and 40 minutes, respectively. Depending on the expected duration of the storm event forecasted, this program length is adjusted to collect samples over the entire storm hydrograph. Once the sample program is completed, CVC staff download data and create a flow-weighted composite sample for EMC analysis.

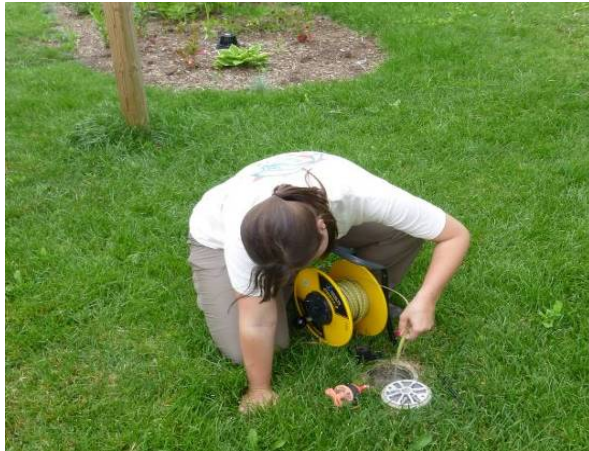
Figure 2-6: Manual level measurements to verify accuracy of readings and to calibrate level logger as needed

A piezometer was installed downstream of LV-3 and LV-4 near the monitoring location. HOBO U20 water level loggers have been installed in the piezometers to measure water levels. An additional logger has been installed at a nearby location to record barometric pressure that will allow for level measurements to be compensated accordingly. All level loggers have been set to record at 10-minute intervals. Water level readings will be compared to precipitation amounts to estimate surface water infiltration in the bioretention cells. In addition, it is possible to estimate the drawdown time for stormwater to fully infiltrate into the bioretention cells.

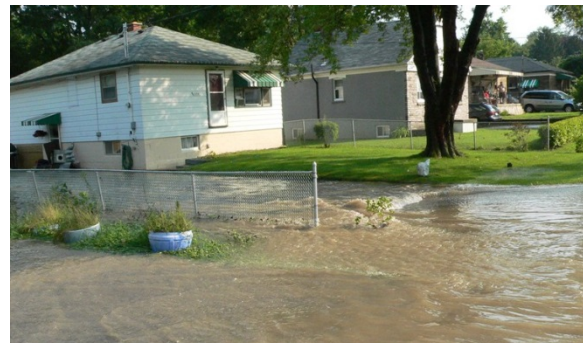
Figure 1-3: Flood prone area in Cooksville Creek watershed

Urban areas are particularly susceptible to flooding due to a high concentration of impervious surfaces that channel precipitation runoff into the city's underground infrastructure. During rainfall events of high intensity, duration and/or frequency, the runoff component of the water balance will be overwhelmed and not mitigated by infiltration, creating flood-prone areas in urbanized zones (**Figure 1-3**).

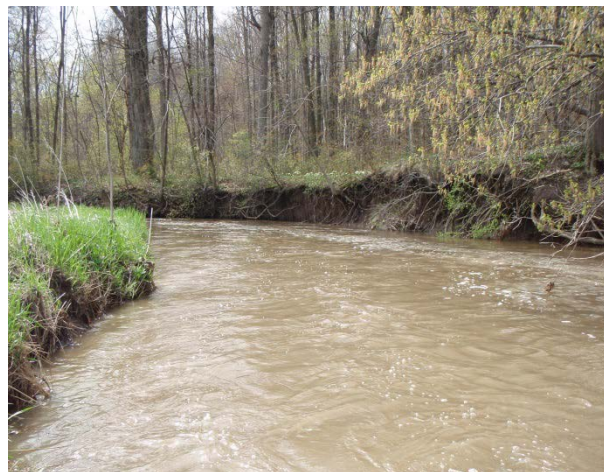
Figure 2-2: High stream flow in Fletcher's Creek

The longer duration of higher flows due to increased volume combines with that from downstream tributaries to increase the downstream peaks. As a result, the portions of Fletcher's Creek is experiencing extensive bank slumping and erosion (**Figure 2-2**).

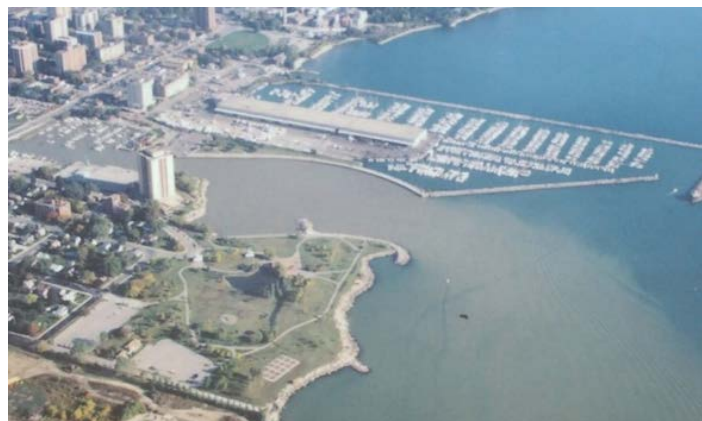
Figure 3-1: Sediment Plume from Credit River to Lake Ontario (Photo Credit: Aquafor Beech, 1990)

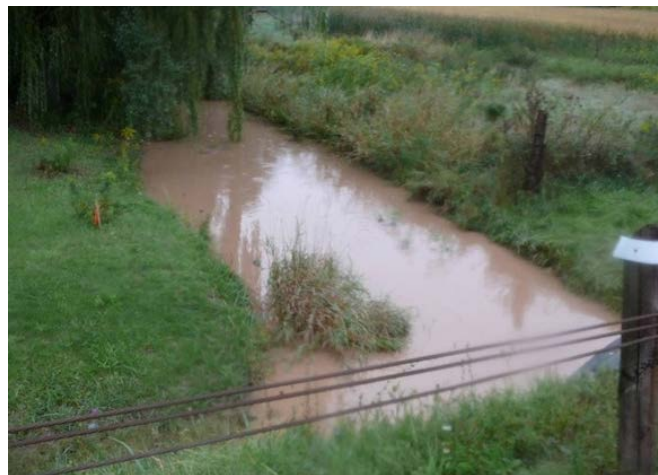
Figure 3-4: High TSS from urban runoff in Springbrook Creek habitat of Redside Dace
