Lake Ontario Integrated Shoreline Strategy

Characterization Report

Prepared by: Credit Valley Conservation

December 2018

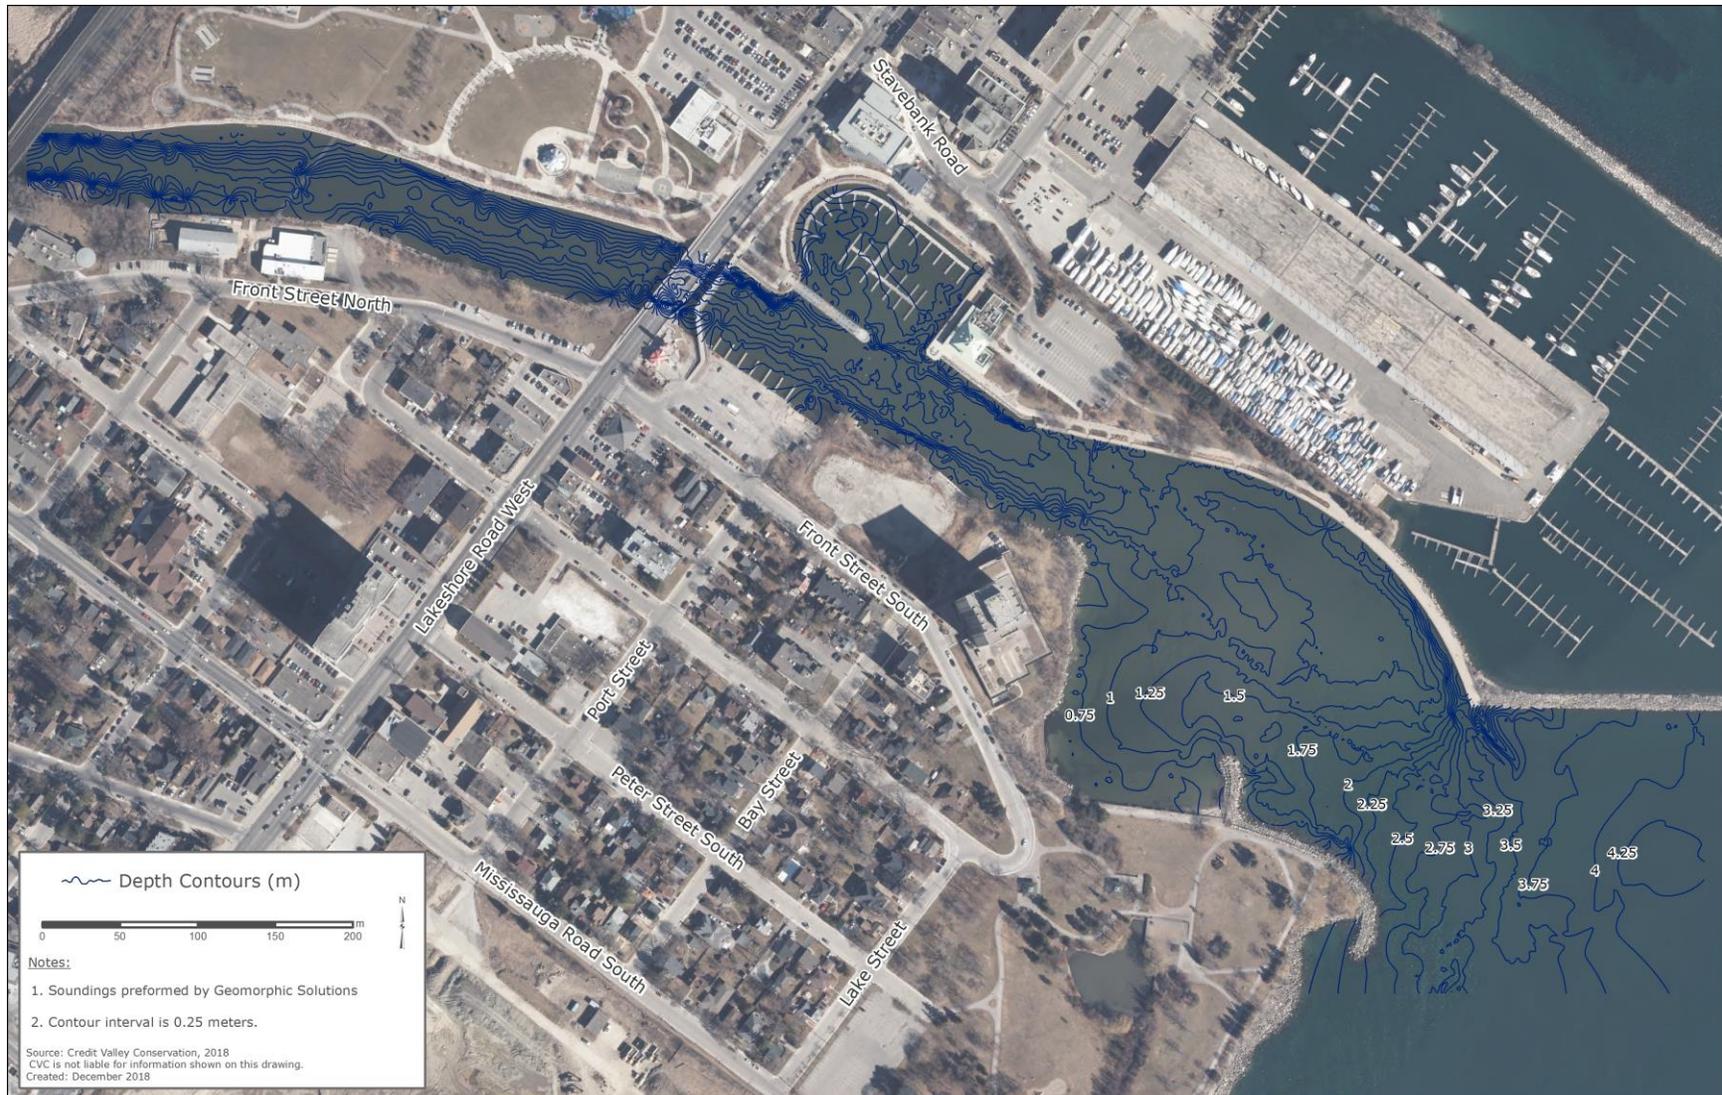
Figure 3-8: Bathymetry at the mouth of the Credit River in 2012. (source: Geomorphic Solutions 2012b)

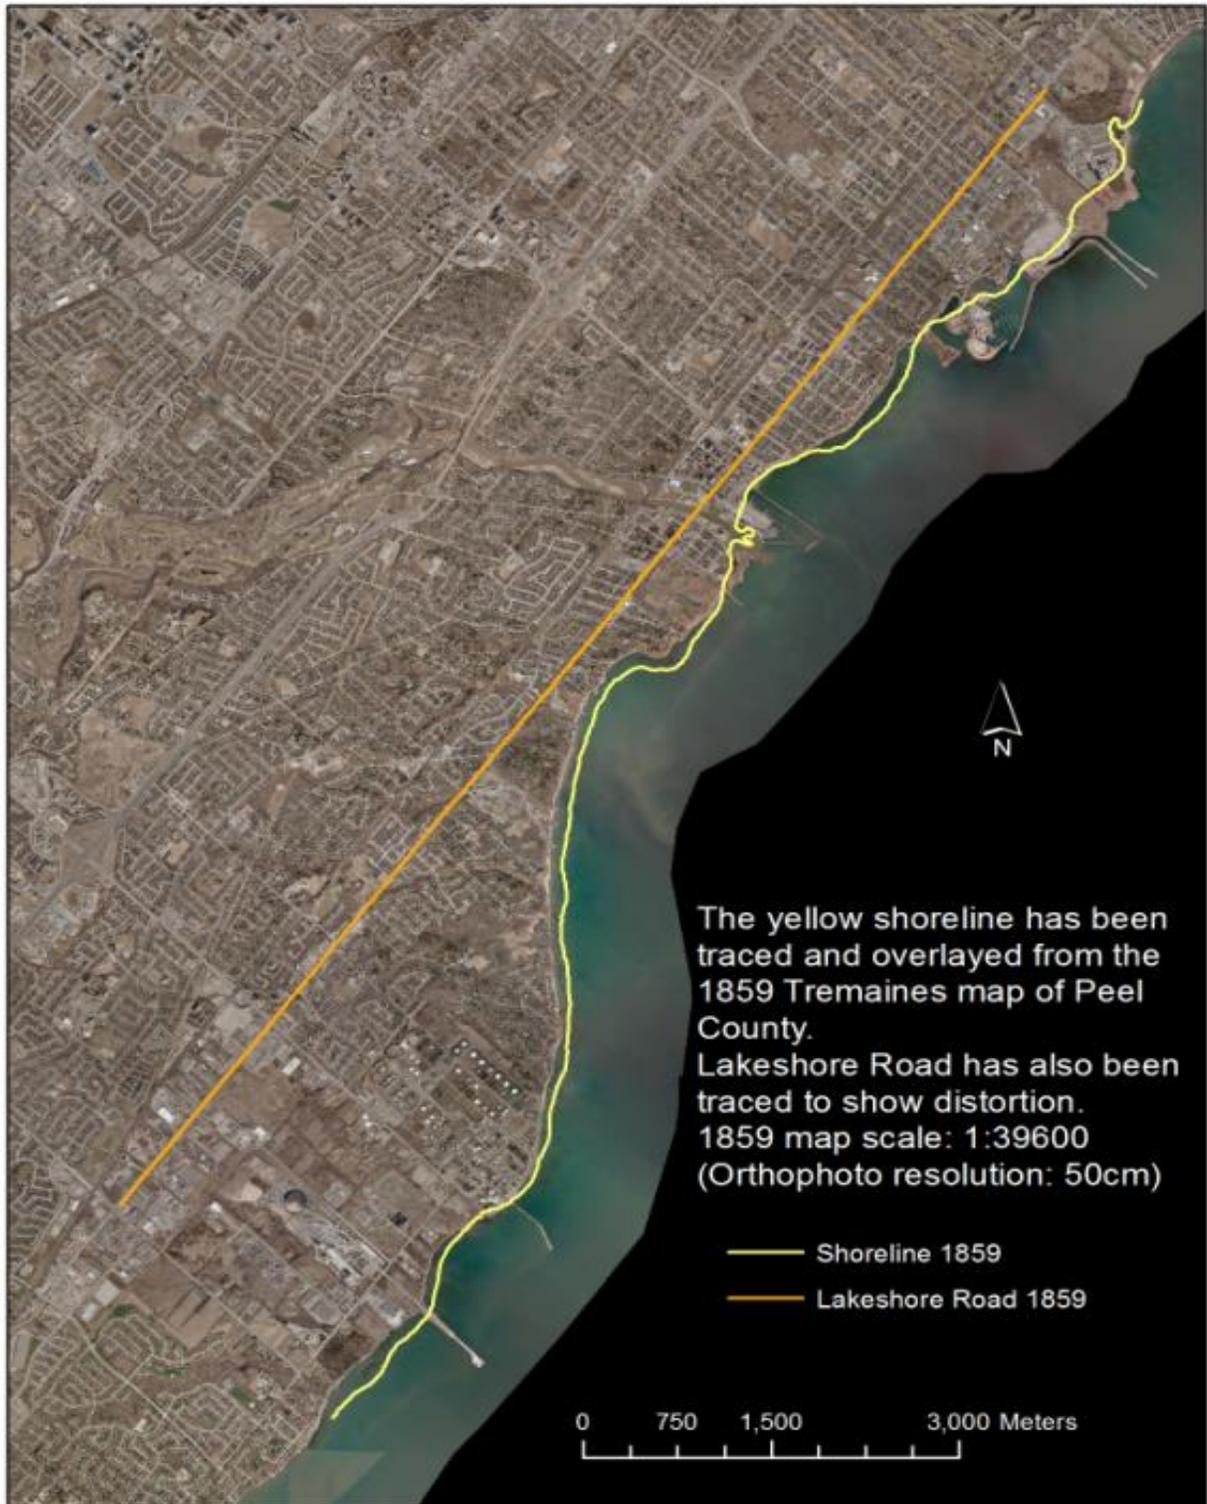
Figure 3-17: Coarse-Level Shoreline Modifications (1859 vs 2012) (Ruthart 2012)

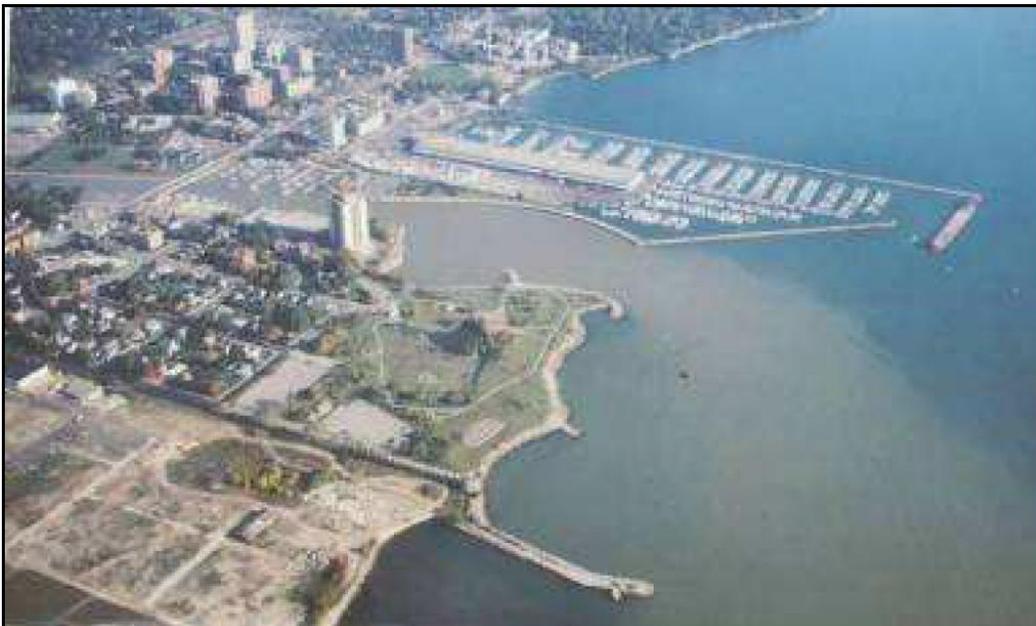
Figure 3-18: The sediment plume from Credit River entering Lake Ontario (Photo Credit: Aquafor Beech Ltd 1990)

The Background Review identified that the largest watercourse within the LOISS Study Area, the Credit River (Figure 3-18) has the greatest effect on most water quality parameters. The Credit River contributes more than two times the combined phosphorus load of the Clarkson and Lakeview Wastewater Treatment Plants to Lake Ontario. As well, it contributes 86% of the suspended solids, 66% of the nitrates, and 80% of the heavy metals entering Lake Ontario from within the study area (ABL 2011). The study concluded that while historical data exist relating to concentrations of water quality parameters from storm sewer outfalls and within watercourses, water quality data along the waterfront are limited. Therefore, it was recommended that an assessment be completed as to how flows, sediment, and pollutants move and circulate along the nearshore. Additionally, the report identified lake and watershed modeling, instream and nearshore water quality sampling of key parameters, and nearshore water temperature monitoring as some of the tasks required to characterize water quality of the LOISS study area. The identified water quality gaps and their current status is presented in Table 3-19.

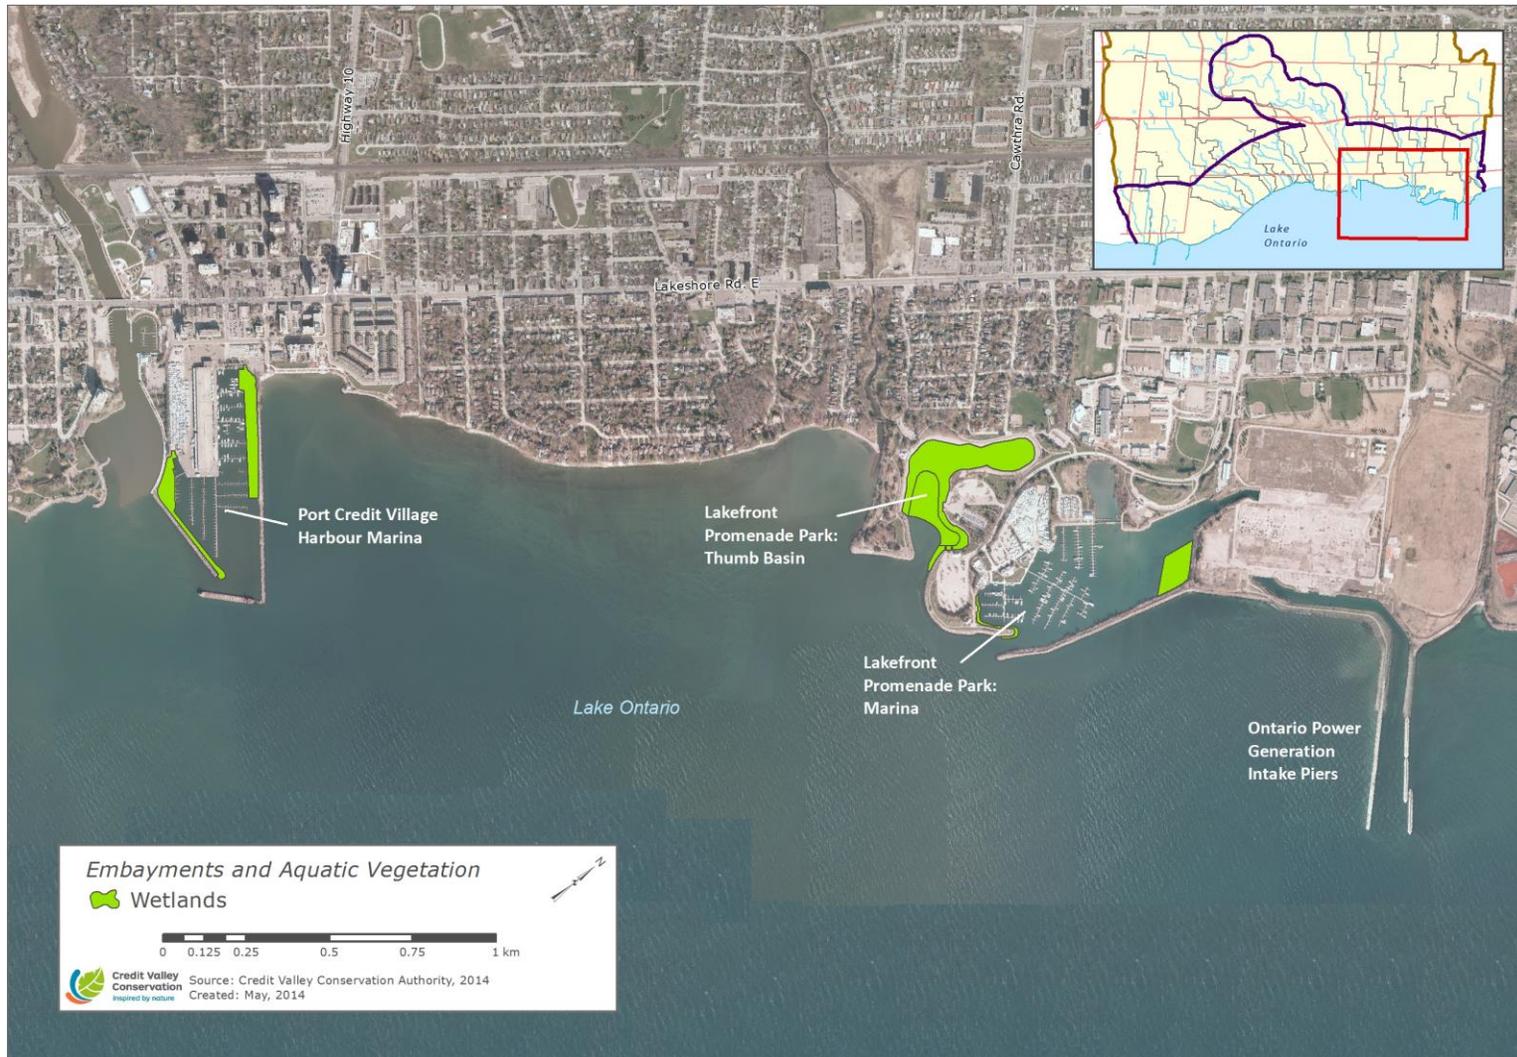
Figure 3-38: Identified wetlands and embayments along the shoreline in the LOISS study area.

The study area contains four embayments (Figure 3-38):

1. 2 – Lakefront Promenade Coastal Reach: Former Ontario Power Generation intake piers.
2. 2 – Lakefront Promenade Coastal Reach: Lakefront Promenade Park marina behind DFO breakwater
3. 2 – Lakefront Promenade Coastal Reach: Lakefront Promenade Park (Thumb Basin)
4. 4 – Port Credit Coastal Reach: Port Credit Marina
