Green Glade Sr. Public School Rain Garden Retrofit

Location: Mississauga
Constructed: 2011

Project Objectives, Design & Performance

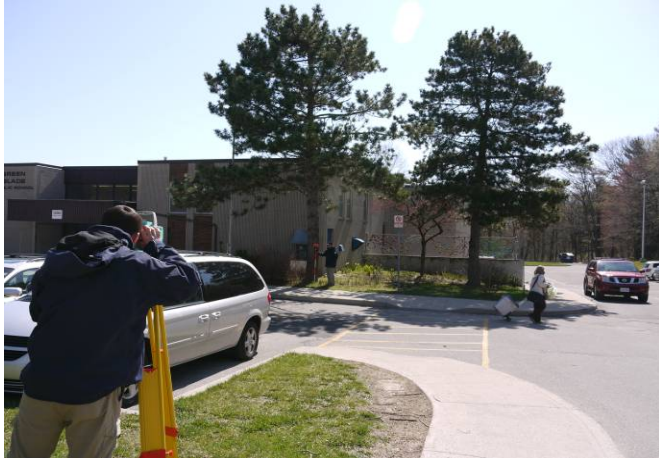
Surveying of the proposed rain garden site

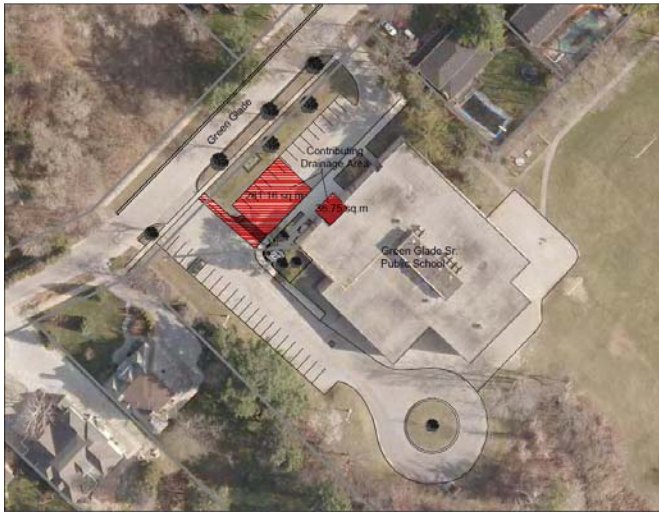
Contributing drainage area of rain garden

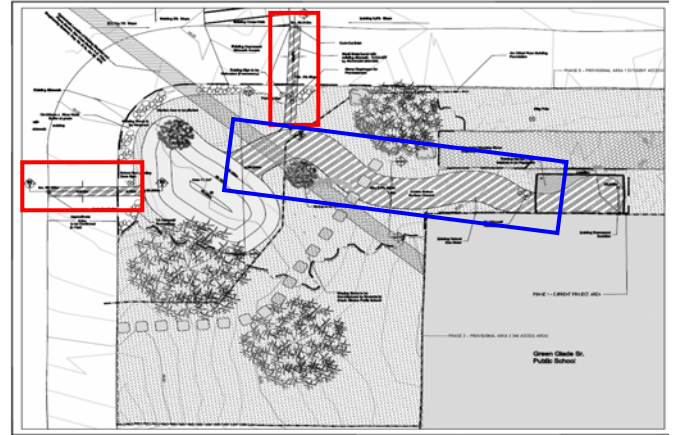
To address the ponding issue along the front walkway the curb and walkway was cut in two locations to provide an inlet and an outlet (outlined in red in the figure below). The design of the inlet cannot address the ponding issue completely. However, when the school's parking lot is resurfaced, the grade of the lot can be modified to direct more of the water into the rain garden inlet to further reduce any ponding. In addition, the rain garden design accounted for the roof top drainage which was directed to a dry river bed which then flowed into the depression (outlined in blue in the figure below).

Rain garden site plan

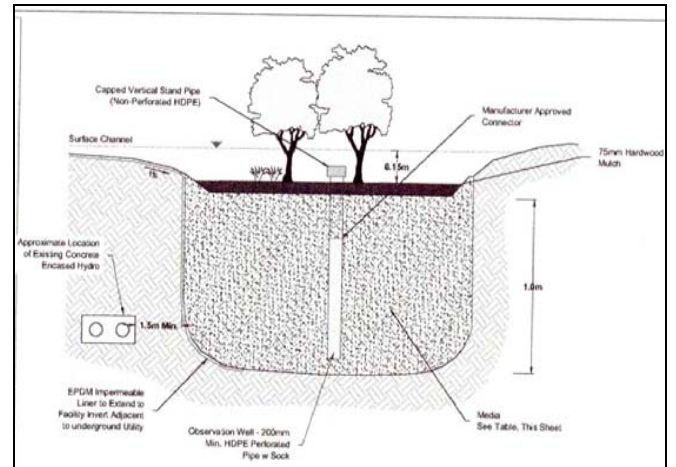
The dimensions of the rain garden are approximately 3.5 m long by 1.5 m wide by 1.4 metres deep. The rain garden has a maximum ponded depth of 150 mm and can provide water quality treatment for 7.95 m³ (7,950 L). An observation well was included in the design plans for the garden. The observation well can be used by school staff to monitor how well water is draining within the garden. Monitoring equipment (depth probes) can also be installed within this well to automatically monitor water levels within the bioretention area. This arrangement is detailed in the following cross section.

Cross section of the rain garden

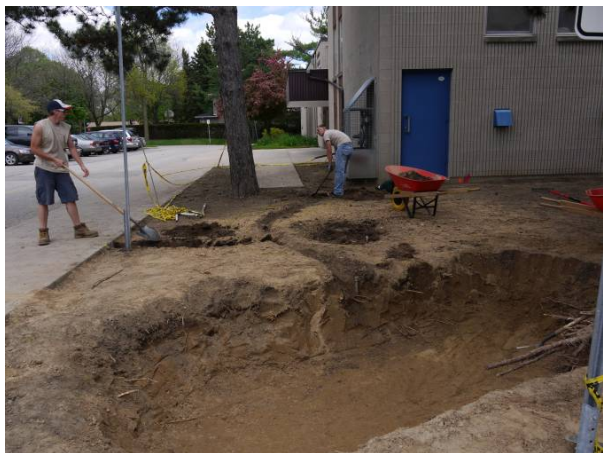
Once the dry river bed had been dug out the bottom of the bed was covered with an impermeable geotextile liner. The bioretention area was further excavated and the observation well was installed. Additional impermeable geotextile was installed on the side of excavated space nearest to the school to minimize water accumulating near the building foundation.

Excavation Work Being Conducted at Rain Garden
