Lake Ontario Integrated Shoreline Strategy Moore Creek: Fluvial Geomorphology Assessment

A report submitted by:
Aquafor Beech Ltd.

October 31, 2014

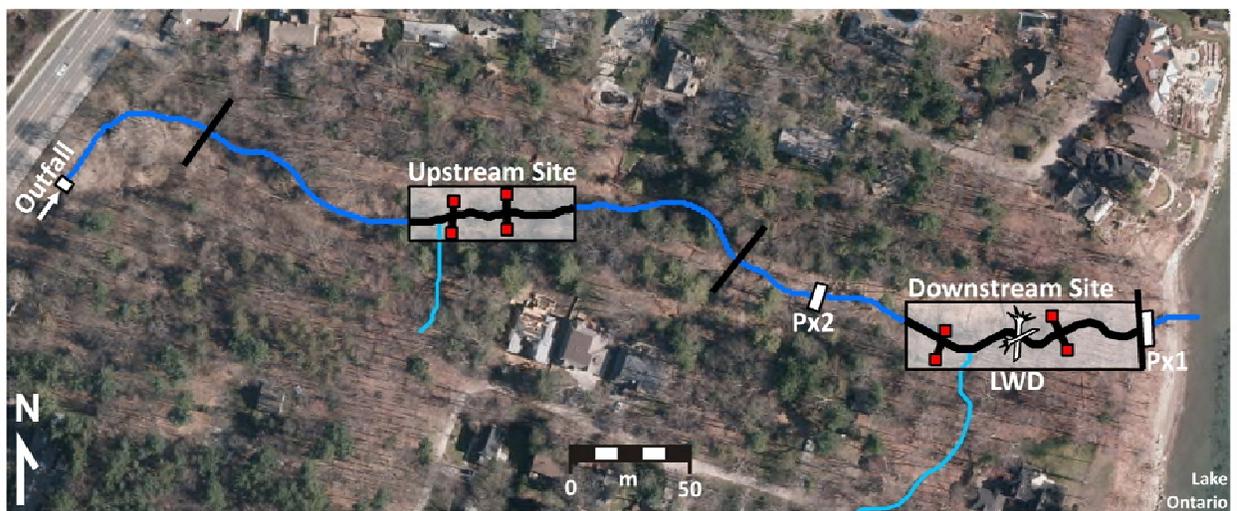
Figure 3.1: Locations and extents of detailed topographic surveys on Moore Creek completed in Summer/Fall 2013: Upstream (Reach 2) and Downstream (Reach 1) sites, respectively. Red square points represent locations of installed iron bars (IBs) for survey control monuments (4 per site) at “master” cross-sections (2 per site).

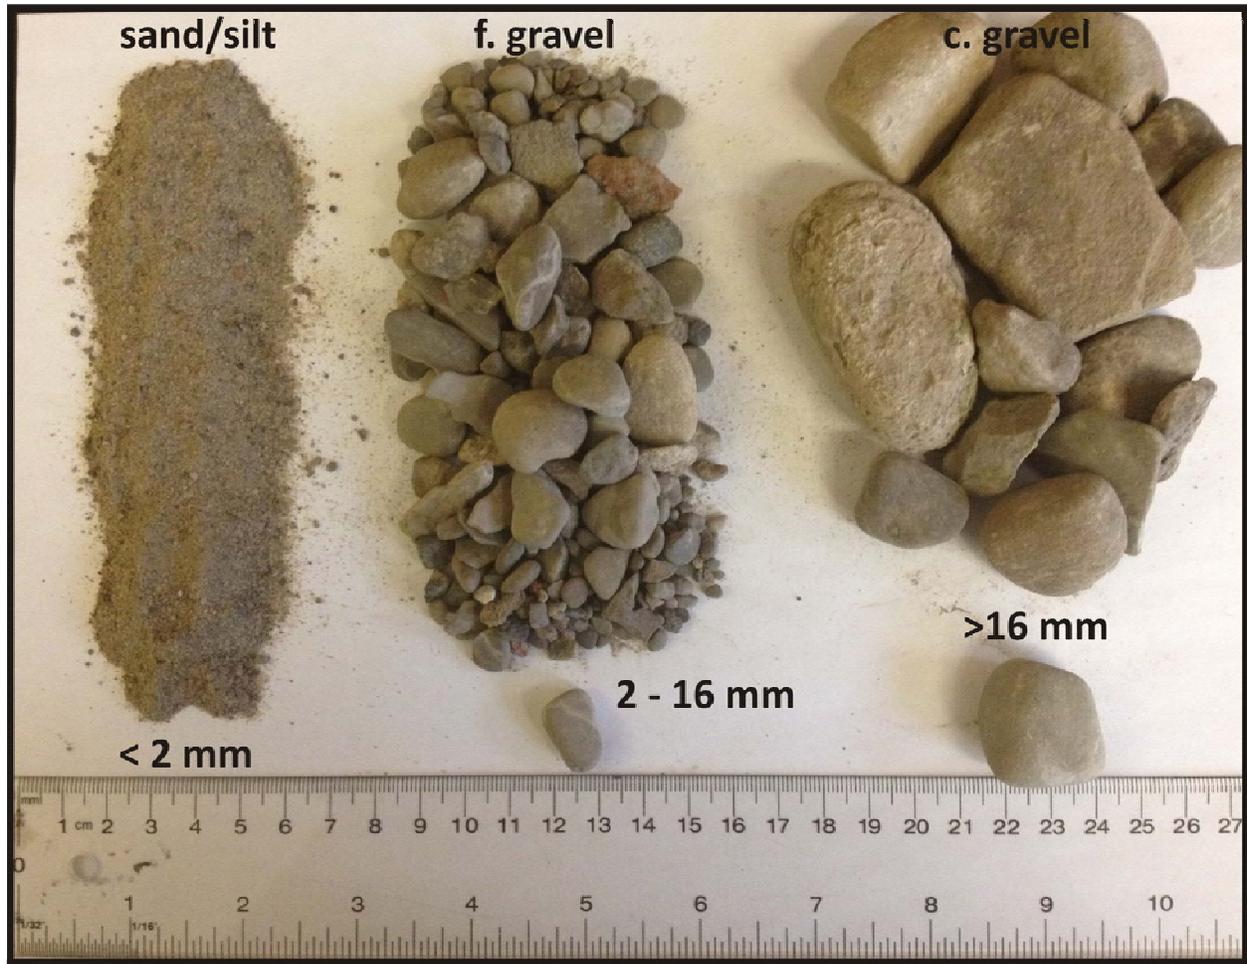
A summary of the grain size data for Reaches 1 and 2 is provided in **Table 4.1**. The average thickness of sediment bar deposits based on field observations was 0.25 m and 0.15 m for Reaches 1 and 2 respectively. Topographic surveys of representative bar areas and channel deposits within each reach were used to estimate the approximate volumes of sediment storage within the bankfull channel. Representative grain size classifications are shown in **Figure 4.1**.

Figure 4.1 – Representative bed material grain sizes for Moore Creek Reaches 1 and 2.

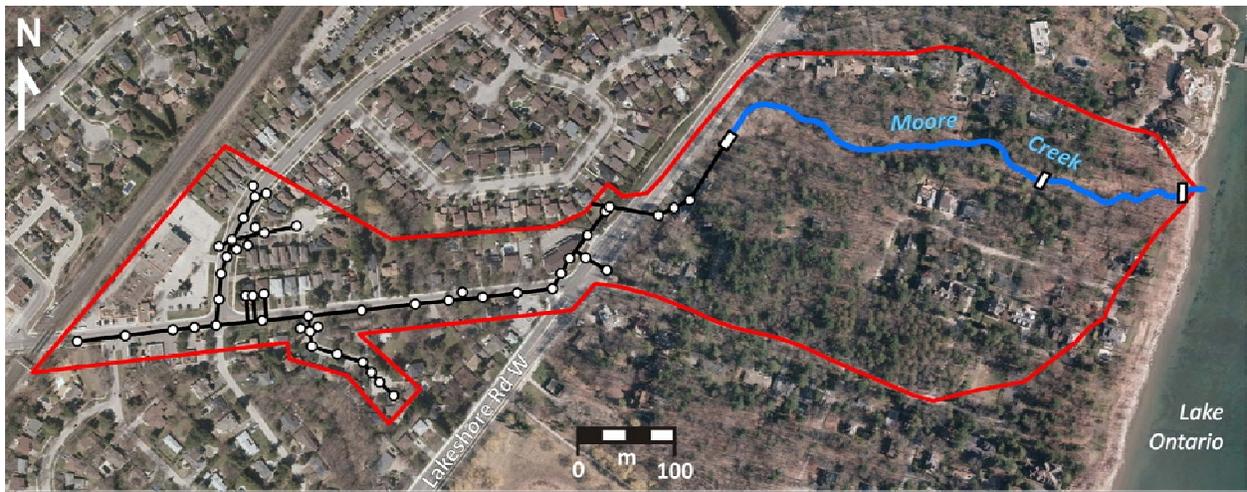
Figure 5.1: Moore Creek catchment area including storm sewers based on DEM and storm sewer datasets from City of Mississauga. Estimated drainage area of Moore Creek is 21 ha (or 0.21 km²).

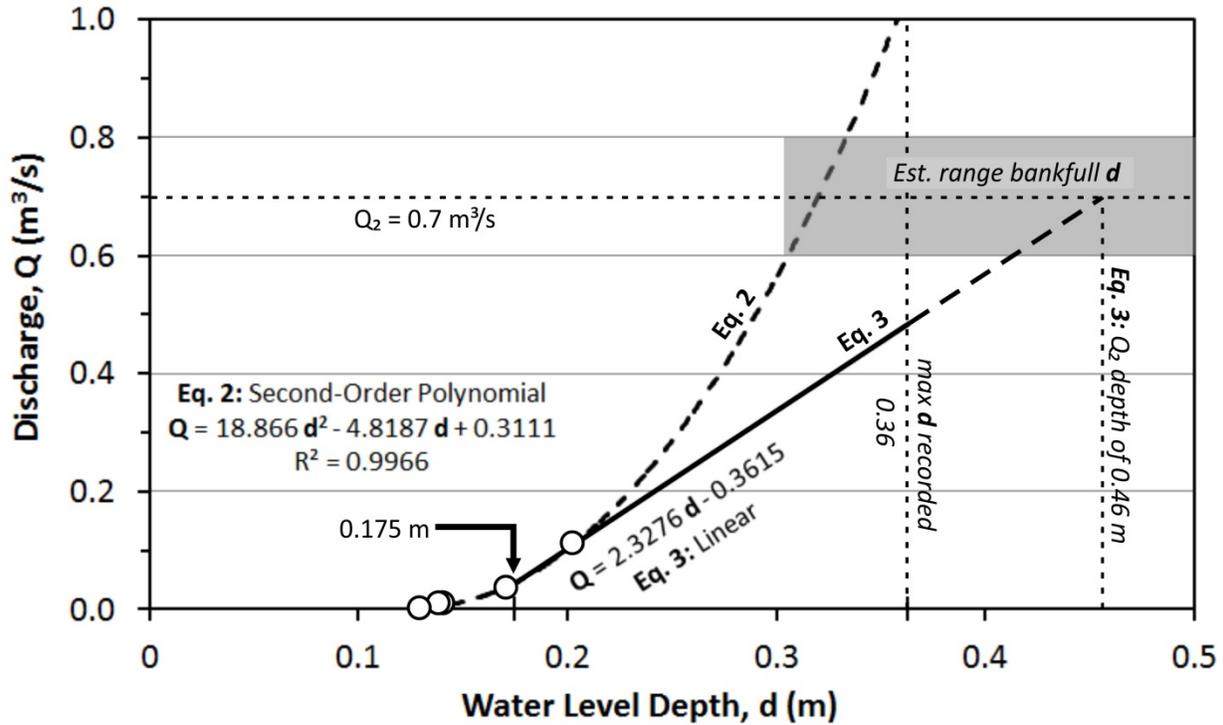
To correlate the water-level reading to discharge in the creek, direct flow measurements are required for a range of known water levels. Aquafor collected 5 flow measurements using the velocity-area method. The results of these measurements are presented in **Table 5.3**. Stage-discharge rating curves are presented **Figure 5.2**, including two alternative models: **Eq. 2** is a second-order polynomial equation which shows a high degree of fit with the data ($r^2 = 0.9966$), but may overestimate discharges for higher discharge flood events; and **Eq. 3** is a linear equation which shows more reasonable extrapolation to the bankfull discharge. All subsequent analysis of the discharge records in this report are based on **Eq. 2** for water levels less than 0.175 m and on **Eq. 3** for water levels greater than 0.175 m (i.e., the black curve in **Figure 5.3**).

Figure 5.2: Stage-discharge rating curve(s) for Moore Creek based on 5 discharge measurements (white circles) using the velocity-area method (Table 5.3). See discussion in text and caption for Figure 5.3 regarding models using Eq. 2 (second-order polynomial) and Eq. 3 (linear) to extrapolate to higher discharges beyond the sampled measurements.

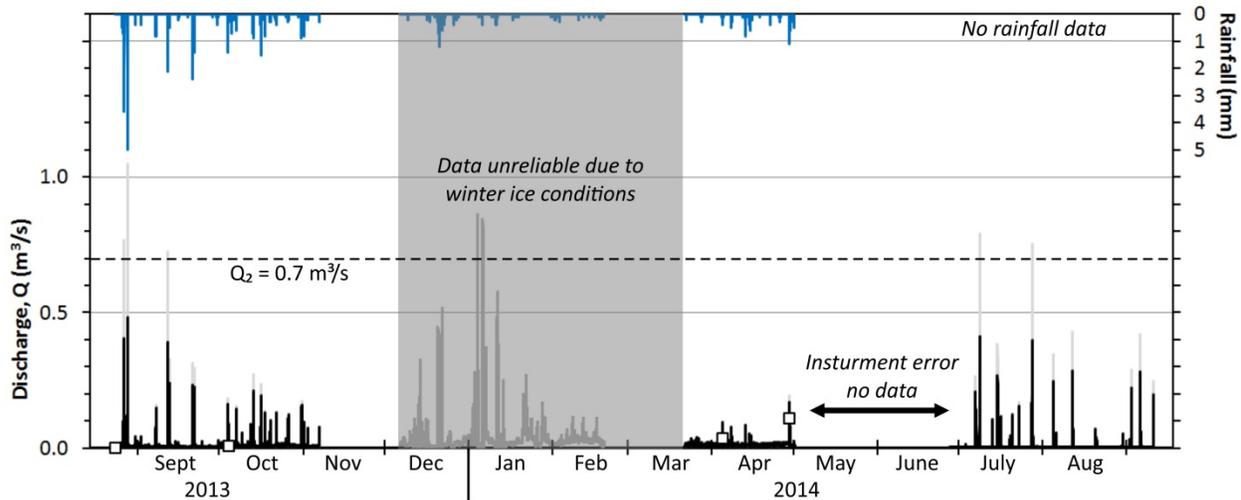
The continuous discharge record and rainfall data are presented in **Figure 5.3** for the period of August 23, 2013 to September 10, 2014. While the lowest summer baseflows are likely less than 1 L/s, more typical low-flows are about 3 L/s and in the range of 5 – 10 L/s in the wet seasons of fall and spring. Based on **Eq. 3**, the highest extrapolated peak flow over the monitoring period was 483 L/s (or 0.483 m³/s) on August 27, 2013. Additional peaks above 0.4 m³/s were also recorded for July 2014. Although the plotted discharges above 0.11 m³/s have been extrapolated with **Eq. 3** and should be interpreted cautiously, the 2013-2014 discharge records for Moore Creek provided a reasonable basis to compare sub-bankfull flows in terms of hydraulic modeling (Section 6) and to estimate sediment transport to the lake (Section 7).

Figure 5.3: Continuous (5 minute interval) discharge record for Moore Creek (August 23, 2013 to September 10, 2014), with nearby rainfall data (blue lines). As per Figure 5.2, discharges for water levels less than 0.175 m were calculated based on Eq. 1. For water level values above 0.175 m and discharge values above 0.045 m³/s the black time series is based on Eq. 2 (linear) and the light grey time series is based on Eq. 1 (second order polynomial). Black squares represent sampled discharge measurements as summarized in Table 5.3.

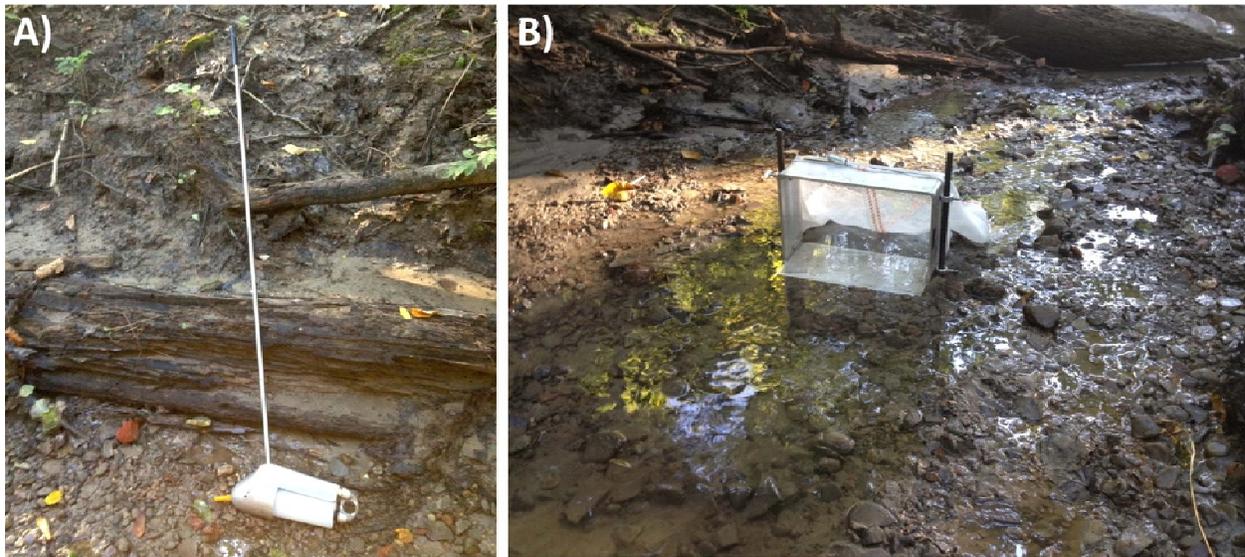
Suspended sediment concentrations (C_{ss} , mg/L) were sampled using a DH-48 depth-integrated sampler (**Figure 7.3A**) during discharge measurement events as summarized in **Table 5.3**. The C_{ss} values for all baseflow and low-flow measurements for the first three measurements were generally between 0.1 and 0.2 g/L. For frequent storm flow events (greater than 0.03 m³/s), suspended sediment measurements suggest C_{ss} values are generally in greater than 10 g/L (**Table 5.3**). Although the completed 2013-2014 field sampling of C_{ss} for Moore Creek is not statistically significant, the data provide a crude model estimate for the suspended sediment rating curve, where $C_{ss} = 34 Q^{0.76}$ ($r^2 = 0.52$). Based on this relationship, the continuous discharge data were used to estimate the total suspended sediment load (G_{ss}) over the 266.8 day monitoring period (where $G_{ss} = \sum C_{ss} \times Q$ for all 5 minute time intervals = 1900 kg). If this preliminary estimate is extrapolated to be representative of an entire year then the annual suspended sediment load to Lake Ontario is in the range of 2600 kg (or ~3 t/yr).

Attempted bedload transport measurements using a standard USFS Bedload Trap (**Figure 7.3B**) were unsuccessful due to narrow time-periods of peak discharge. The bedload trap was installed for one storm flow event on October 4th, 2013; however, the 420 g of sand/silt material captured was not considered representative of sediment transport as the bedload trap had become clogged with fallen tree leaves (i.e., a limitation in fall season), thereby obstructing flow through the trap.

Figure 7.3: Sediment transport sampling devices. **A)** DH-48 depth-integrated suspended sediment sampler. **B)** US Forest Service (USFS) Bedload Trap.
