Lakeview Neighbourhood

Road Right-of-Way Retrofit

Project Objectives, Design and Performance

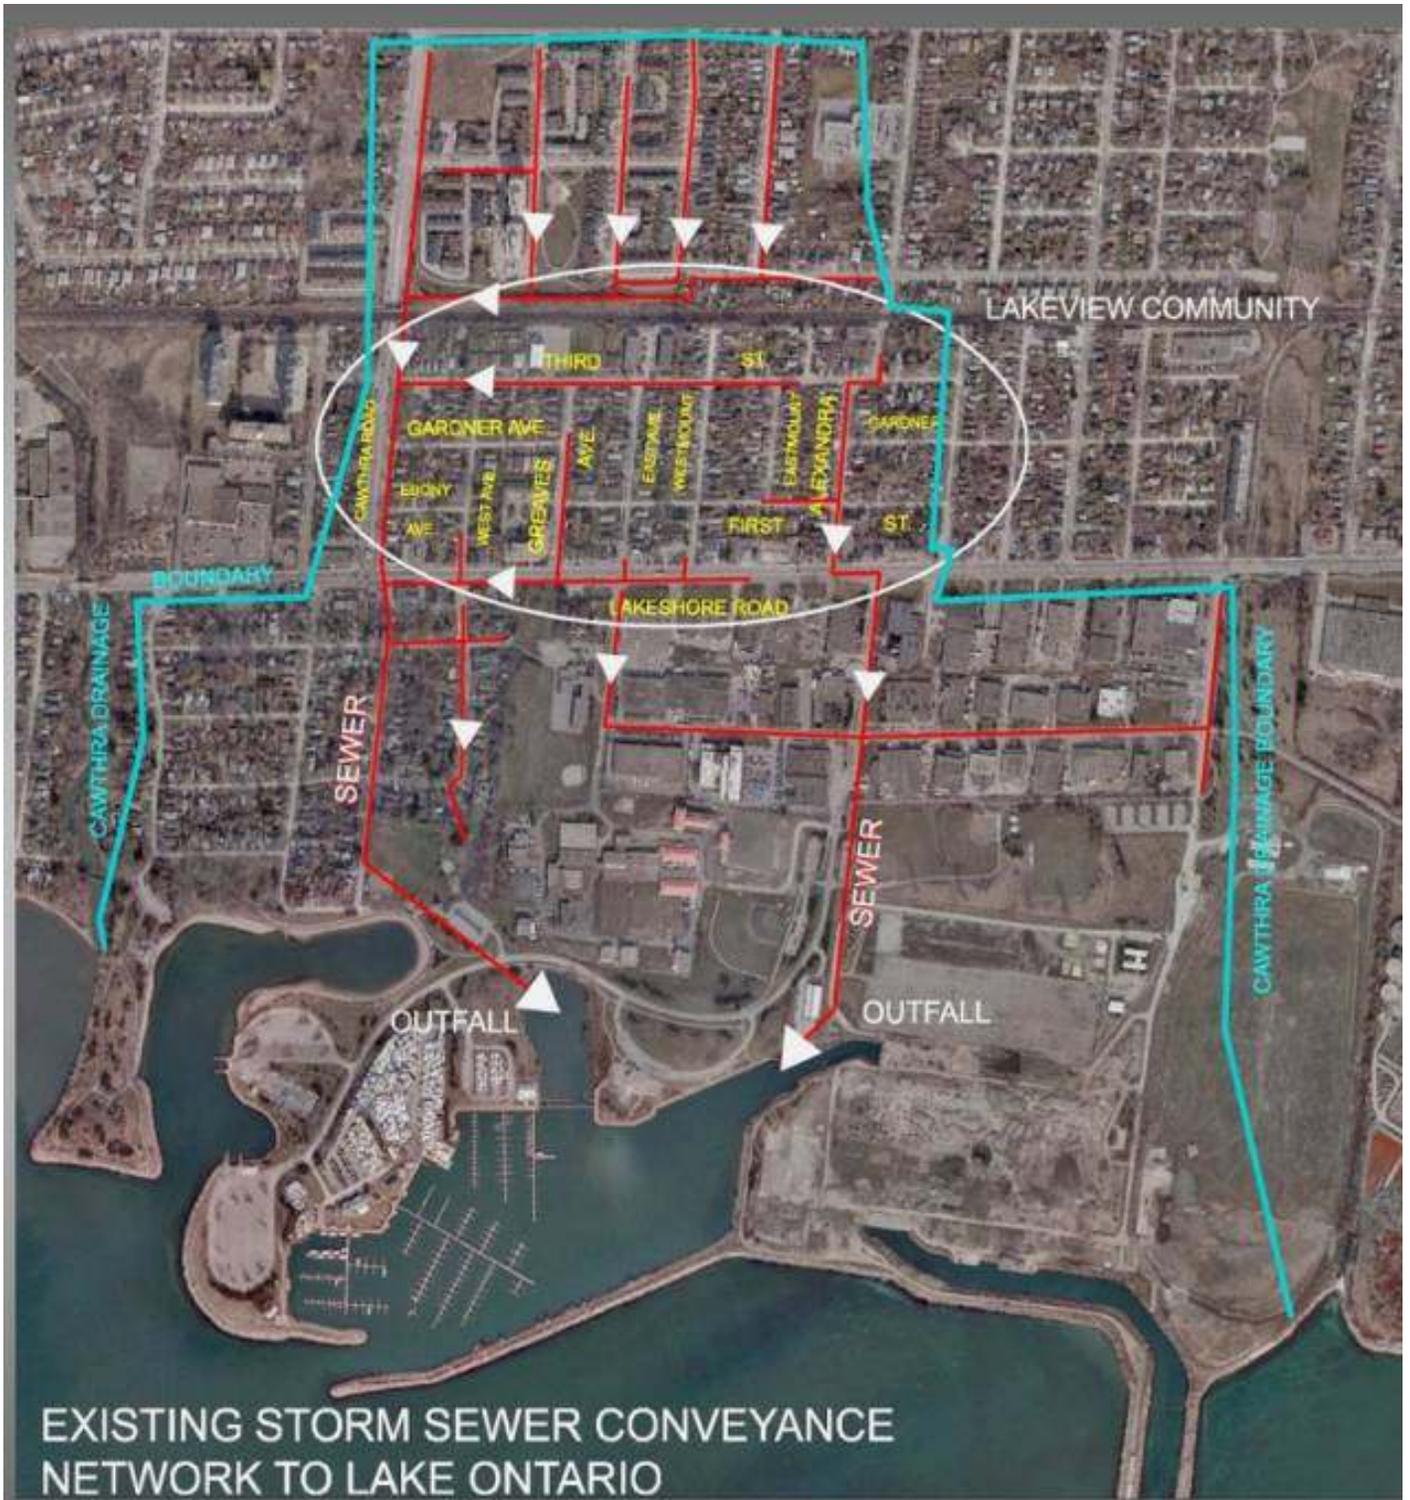
Figure 4 – Existing storm sewer conveyance network to Lake Ontario. Cawthra Drainage area is marked by blue and the sewer system is identified by red.

The Lakeview community drainage network consists of a combination of traditional catch basins and sewer networks and roadside ditch and culvert systems that discharge directly to Lake Ontario. **Figure 4** demonstrates the Cawthra drainage network which includes the Lakeview community.

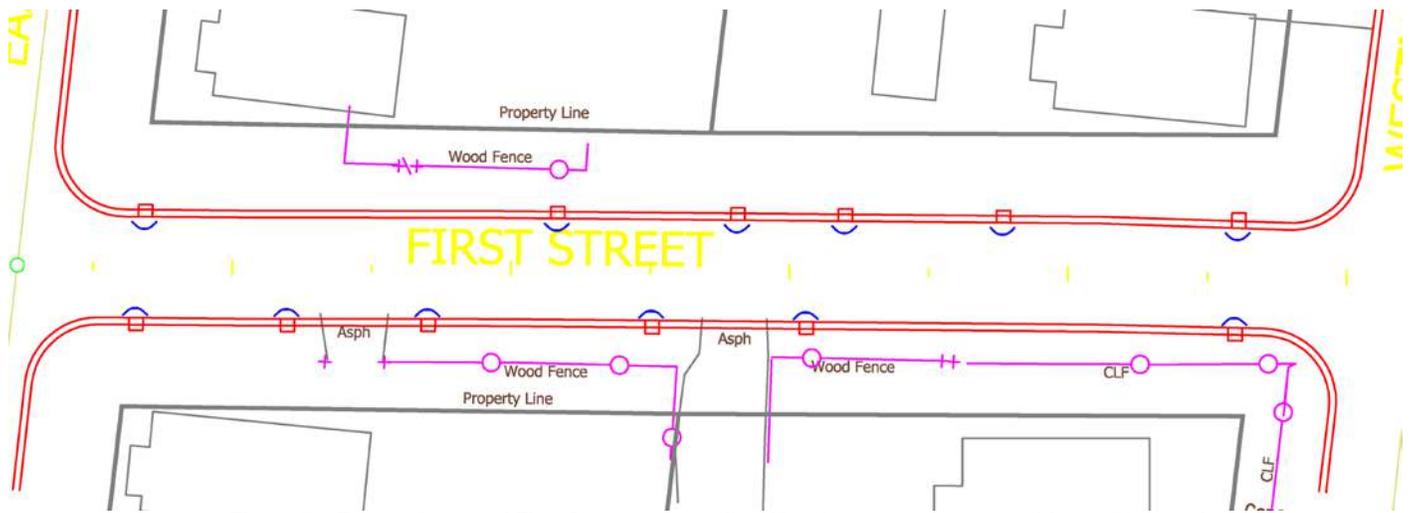
Figure 7 – Encroachment of First Street property line (Grey) versus private wood fence (Magenta)

Since the project was implementing LID practices within the municipal road ROW, areas adjacent to the road had to be available for design purposes. In many cases encroachments from private fences, parking areas, and other structures impacted the availability of space for LID implementation. **Figure 7** demonstrates the type of encroachment observed throughout the site area. A photograph of an encroachment is provided in **Figure 8**.

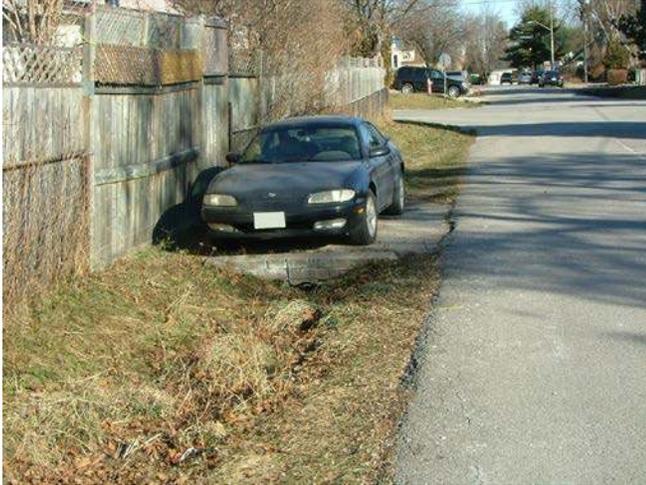
Figure 8: Fence line encroachment on First Street

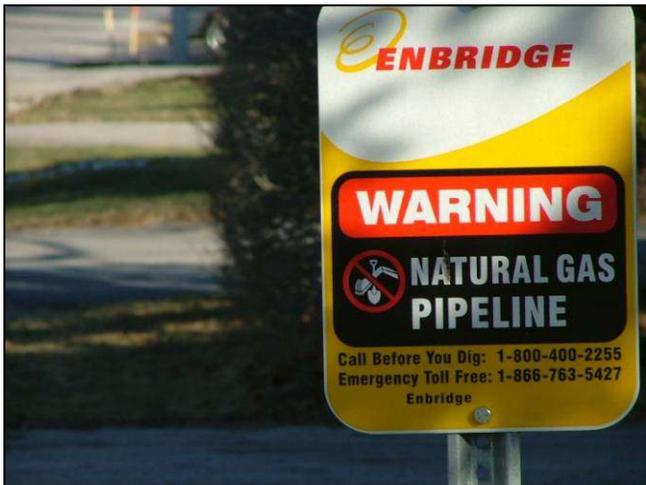
Figure 9: Many buried utilities were located along First Street and Third Street, posing a challenge for construction

Utilities both overhead and underground were located throughout the proposed locations for the LID practices. Locate information was surveyed during the completion of pre-design tasks and added to existing mapping to ensure as much utility information was available during the design phase.

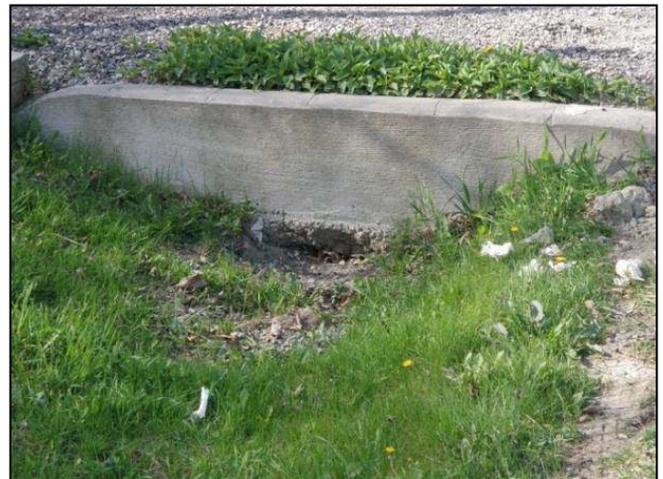
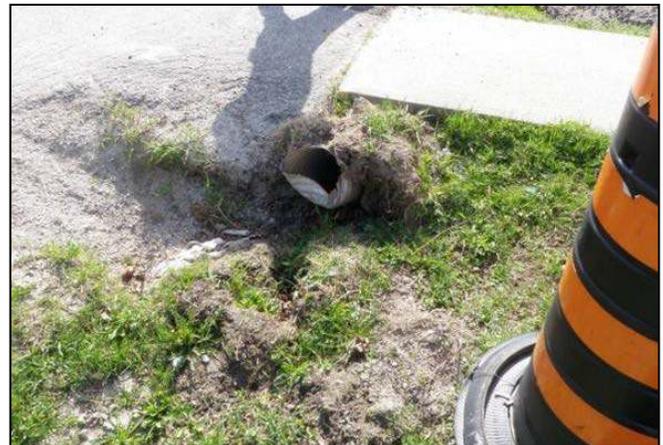
Figure 10 + 11: Obstructed and damaged culverts in need of repair.

Several residents voiced concerns about degraded stormwater and road infrastructure in the Lakeview neighbourhood. Following wet weather events, standing water was sustained within the roadside ditches for prolonged periods. In addition, the age of the area led to many encroachment issues and alterations made to existing lots and drainage system.

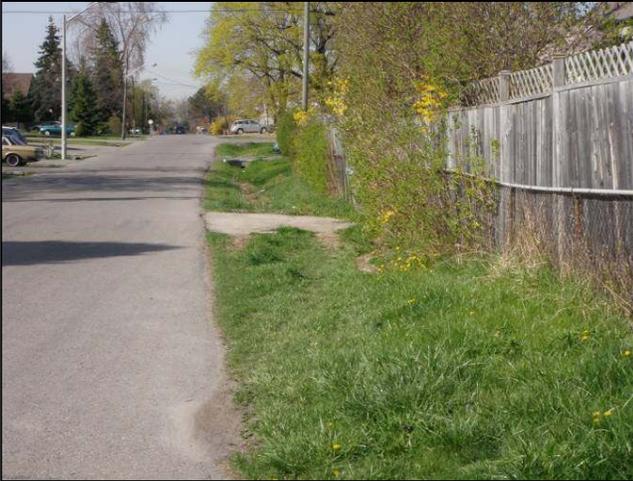
Figure 12: Ditches filled in for parking purposes

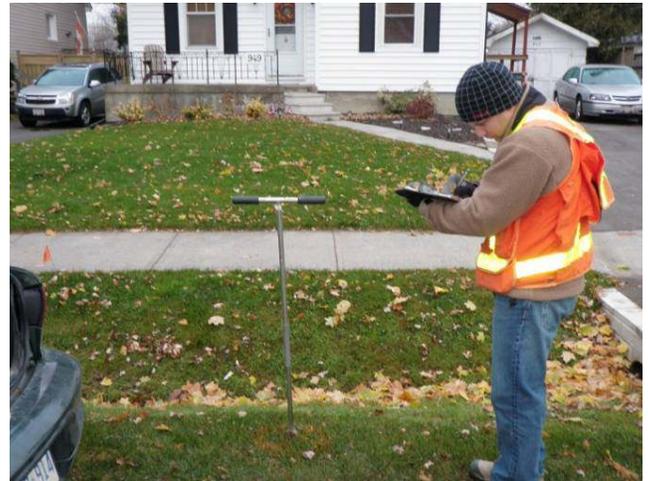
Figure 13: Infiltration testing conducted at Lakeview

Guelph Permeameter testing was performed in November 2010 to determine the saturated hydraulic conductivity (Kfs) of the in-situ soils. The experimentally determined Kfs was then converted to infiltration rate (mm/hr) and a factor of safety corresponding to the non-stratified soil conditions was applied as per Appendix C of the Low Impact Development Planning and Design Guide. The calculated design infiltration rates for were determined to range from 0.04 – 7.67 mm/hr across the site. The average design infiltration rate was determined to be 5.45 mm/hr for First and Third St and was used as the basis for design calculations for the LID practices.

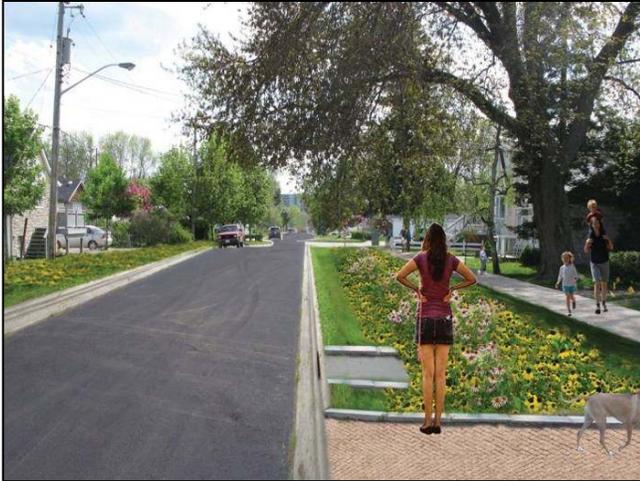
Figure 14 – Artist rendering presented by the landscape architect

The concept incorporated a combination of vegetated and grass bioretention units within the boulevard and permeable pavement at the end of driveways. The concept drawing was presented to the City in April 2010 at which time the project team discussed the overall usability of the street and other design considerations.

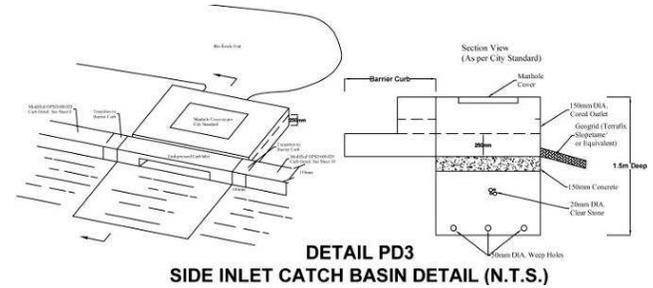
Figure 20 - Design and integration of side inlet catch basins with the boulevard bioretention units.

A simple curb cut design was selected for the Lakeview project. However, for one of the bioretention units implemented on Third St., side inlet catch basins were used. This would allow the City to assess the difference in maintenance efforts and modifications required in integrating traditional side inlet catch basins with LID design. See **Figure 20**.

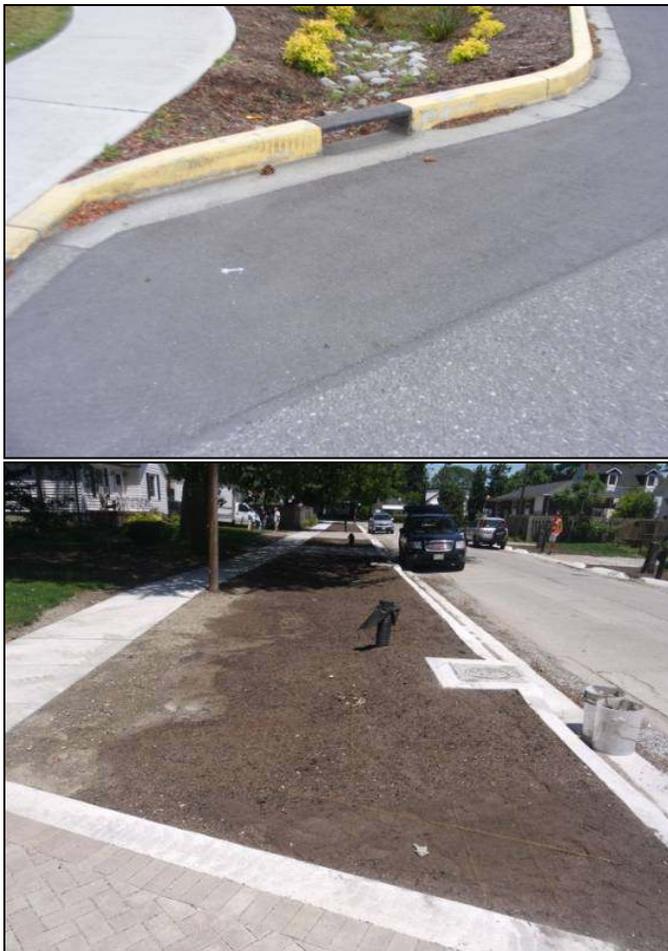
Figure 18 + 19 – Covered inlet option (top) and side inlet catch basin (bottom)

Inlet types were also discussed. Many options for covered inlets or steel grated inlets were proposed. However, concerns regarding snow removal operations damaging the covers discouraged the alternatives.

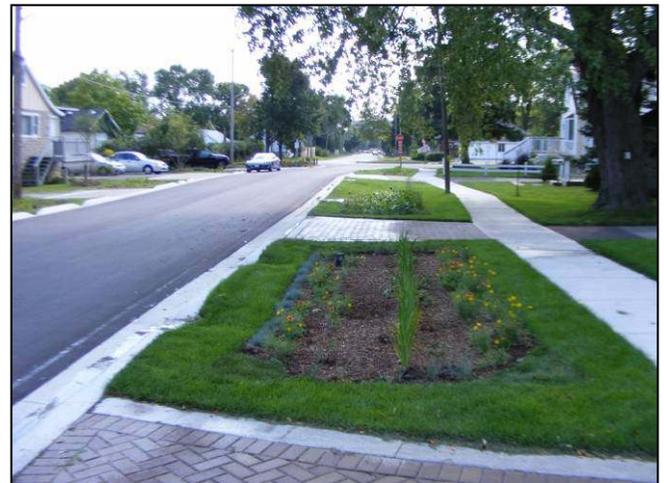
Figure 21 – Perennials planted within bioretention units

Similar to the curb and inlet selections, many other design features were added to the design following discussions related to the overall usability of the site. For example, non-woody vegetation was proposed for the bioretention units since the areas were to be used for snow storage during the winter months. Woody vegetation in the bioretention units would have been damaged by snow load. As such, low maintenance sod and perennial plantings were selected for the landscaping plans

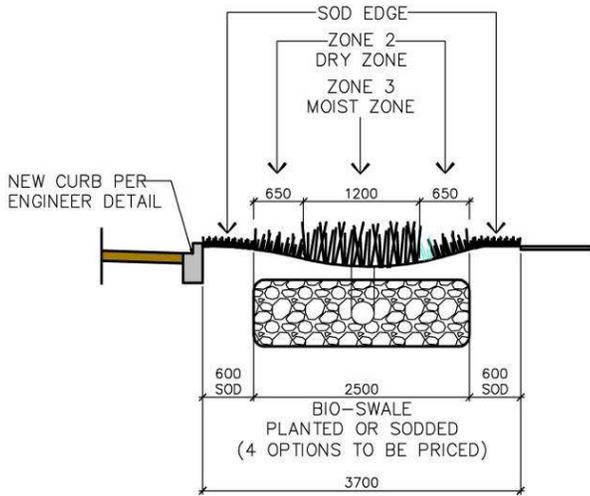
Figure 22 – Bioretention unit planting configuration

Initially, it was proposed that perennials be planted throughout the entire bioretention unit from back of curb to the resident property line. However, the design team felt that encroaching vegetation and lack of available foot space would make it difficult for individuals parking on the street to exit their vehicles. To resolve this issue a 0.6 m buffer was added around the bioretention units which were to be strictly sod. This area would provide access for residents exiting street parked vehicles and also provide a formalized snow storage area. See **Figure 22**.

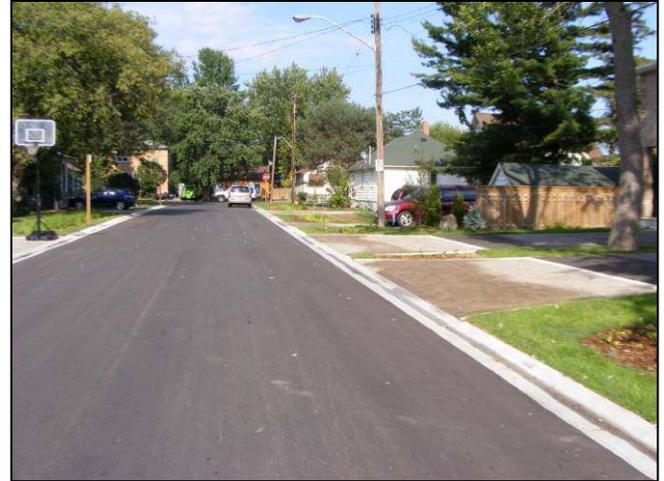
Figure 23 – Permeable pavement driveways

A different sub-base is used in the construction of asphalt driveways compared to permeable pavement. However permeable pavement and bioretention use the same base material, 20mm clearstone. Ensuring that the two types of base materials could be adequately separated to avoid fines contaminating the bioretention reservoirs was a concern. Phasing construction in order to properly incorporate the asphalt driveways would create additional costs and inconvenience to residents. This did not seem to outweigh the additional costs of the permeable pavers or the convenience of using only one type of base material. For these reasons and the fact that the residents highly accepted the aesthetics of the permeable pavement concept, the use of permeable pavement for the driveways was approved.

As an added benefit, the use of permeable pavement within the driveway areas also increased the water quality storage volume provided on-site. Since no formal major systems existed for the Lakeview area the additional storage and decreased runoff volumes was considered an added benefit by the municipal staff.

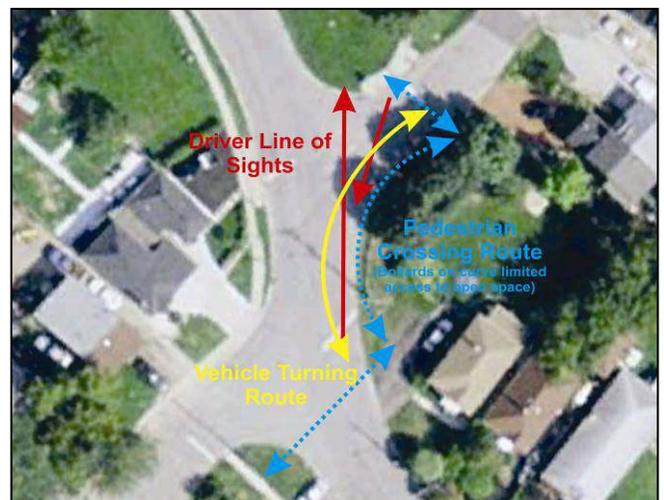
Figure 24 - Third St. and Alexandra Ave Intersection (North being top of page)

Previous discussions with residents identified the intersection as a potential traffic hazard due to the existing alignment of the intersection (Third St. being misaligned from one side of Alexandra to the other). The misalignment made lines-of-sight for drivers and pedestrians difficult and there were no defined crossing routes to ensure a safe crossing for pedestrians. **Figure 24** demonstrates the pre-retrofit intersection alignment of Third St and Alexandra Ave.

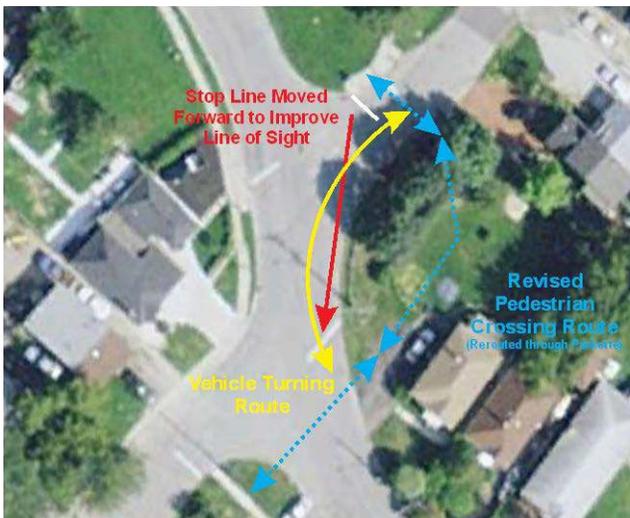
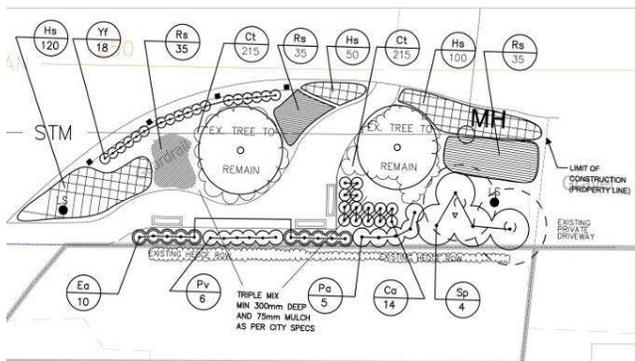
Figure 25 + 26 - Revised pedestrian route and parkette detailed design

With no option to realign the intersection, a parkette was proposed for the vacant property. The parkette would not only create a community space for local residents but also provide a safer crossing route for pedestrians. The stop line of Third St. was also moved forward in order to improve driver's line-of-sight to northbound drivers on Alexandra Ave.

Figures 25 & 26 provides an overview of the revised layout and travel route provided by the parkette.

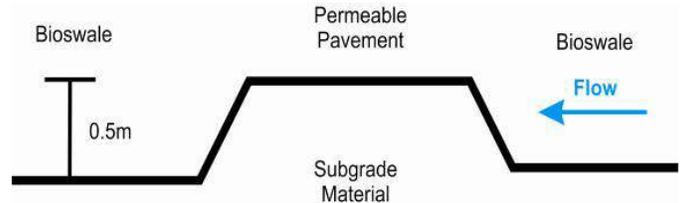
Figure 27 - Grading of the bioretention unit and permeable pavement driveway subgrade.

It was established that pipe heaving was not an issue due to the overall depth of underdrain and thickness of the free draining bedding material situated below the

invert of the underdrains. Clay plugs were determined to be unnecessary due to the proposed grading of the bioswale and permeable pavement subgrade. The variations between the subgrade of the permeable pavement and boulevard bioretention sections created a series of check dams which would control subsurface flow rates.

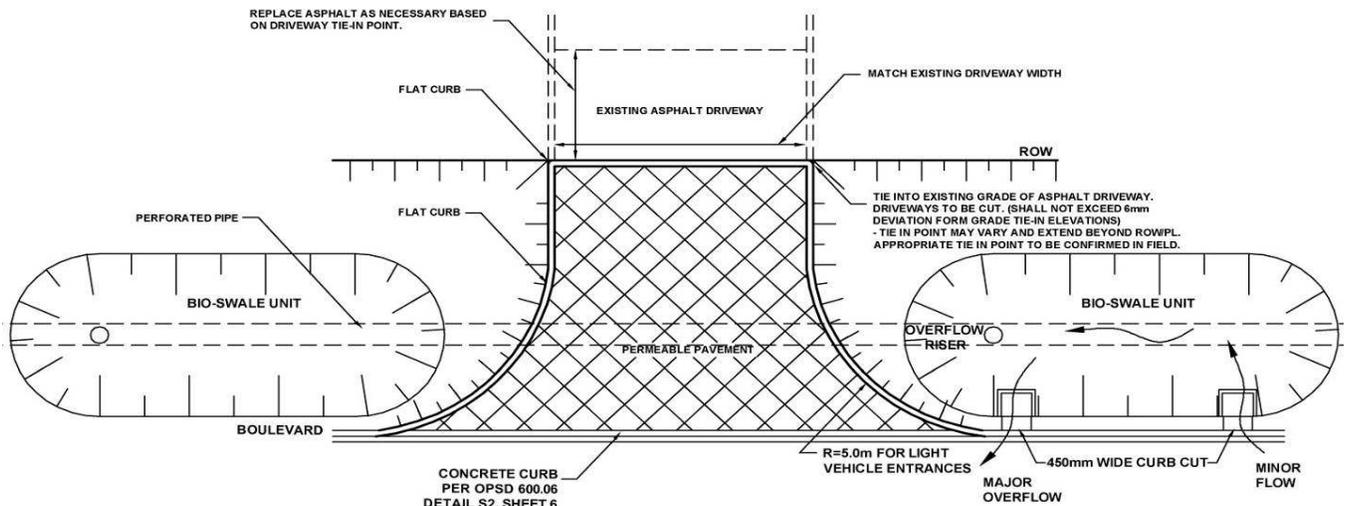
Figure 28 – Configuration and layout of LID features implemented within the residential road ROW

These LID practices improve water quality and reduce the quantity of runoff reaching local drainage features. The following sections provide additional detail with respect to the characteristics and function of the individual LID practices implemented in the Lakeview Project. **Figure 28** below demonstrates the layout and

configuration of the LID practices implemented at the Lakeview site. Sizes of LID practices installed throughout the Lakeview neighbourhood were dictated by the maximum area available for implementation. Although structural analyses were conducted for the permeable pavers and general sizing calculations were completed for the bioretention units, actual storage volumes were dictated by the following two design constraints:

- Depth of storage available above the underdrain was restricted by the existing ground surface elevations and the tie-in location of the underdrain to the existing storm sewer system
- Width of the systems was restricted by the available distance between the proposed back of curb and property lines

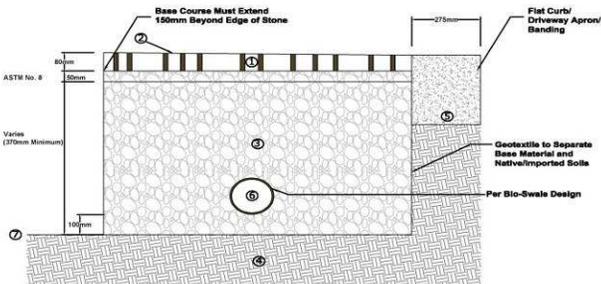
Figure 29 – Permeable pavement driveway cross section

An aggregate depth of 370mm was used as a minimum based on the result of the structural analysis and the site conditions (**Figure 29** and **30**). In many cases, aggregate depths for the driveways were much greater than 370 mm given the required location of the underdrain.

System component	Value
Paver thickness and type	80 mm – Aqua Paver (by Hanson)
Bedding	50 mm of No.8 angular chip stone (5-7mm ϕ)
Aggregate depth (min.)	370 mm of No.57 angular clearstone (20 mm ϕ)
Underdrain bedding depth	100 mm of No.57 angular chip stone (20 mm ϕ)
Total excavation depth (min.)	500mm
Underdrain system	300 – 375 mm ϕ perforated HDPE main collection pipe

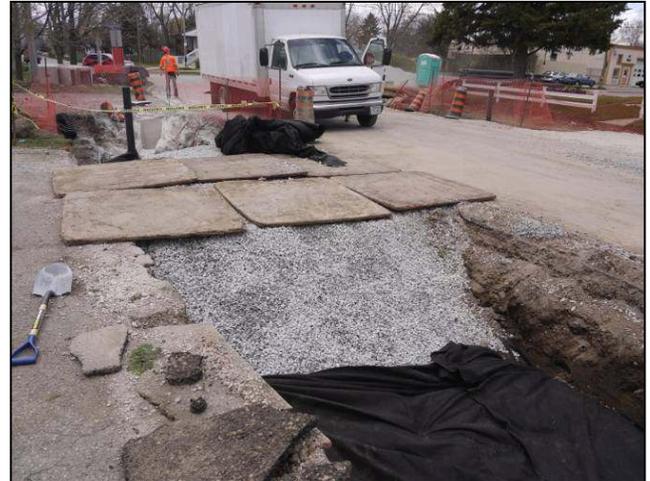
Figure 31 – Preparation of permeable pavement driveways base material

In preparation of the base material installation, a non-woven geotextile was placed directly on the prepared subgrade and up the sides of the excavated trench to prevent fines from the native subsoils from migrating into the clearstone base material. The geotextile was rolled out flat and tight with no folds. Adjacent rolls were overlapped and held in place by workers as base material was placed on top. Unlike the preparation of boulevard bioretention unit reservoirs, the top of the permeable pavement base layer was not wrapped with filter fabric.

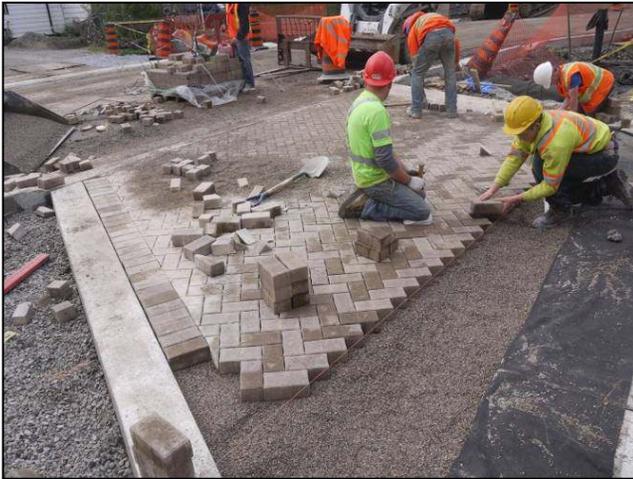
Figure 32 – Installation of bedding material and permeable pavement

Clearstone brought to grade was compacted and topped with the No.8 chip stone bedding layer. This layer was compacted prior to the placement of band curbing and permeable pavement.

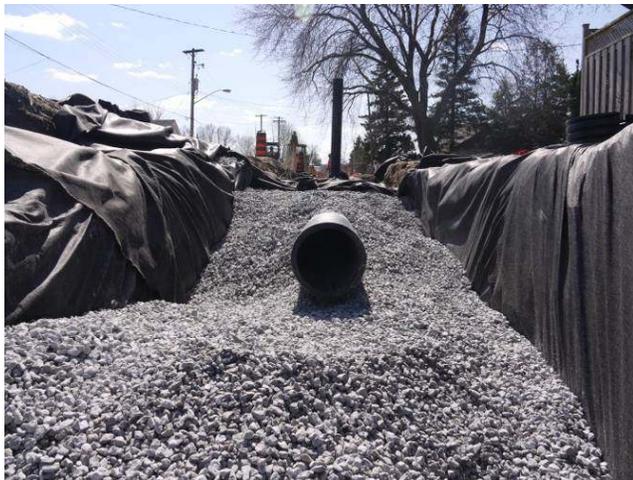
Figure 33 - Bioretention unit with non-woven geotextile, 20mm diameter clearstone with an HDPE perforated pipe

The bioretention unit underdrain systems consisted of an excavated trench lined with non woven geotextile and filled with an open void 20 mm diameter clearstone. 300 – 375 mm diameter HDPE perforated pipes situated within the clearstone bedding underdrain the entire length of the bioretention units and permeable pavement sections (see **Figure 33**). The 20 mm diameter clearstone bedding material is fully wrapped with non-woven geotextile so that it overlaps to cover the top of the clearstone bedding material.

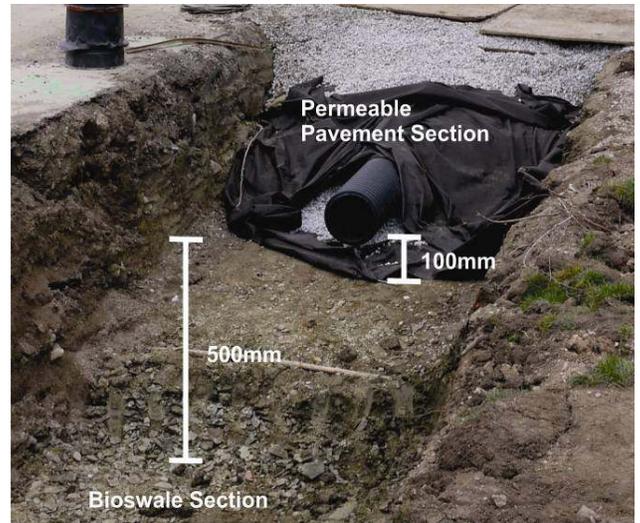
Figure 34 - Varying excavation depths for the bioswale and permeable pavement sections

Figure 34 demonstrates the varying excavation depths of the permeable pavement and bioretention unit sections. The bioretention areas were excavated deeper to provide additional water quality storage whereas storage below the permeable pavement section was constructed such that pipe bedding material would be provided but prolonged periods of standing water would be minimized in order to protect the structural integrity of the subsoils.

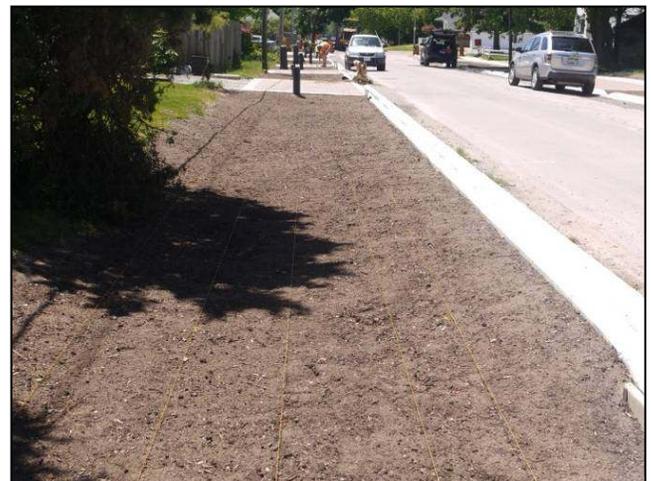
Figure 35 - Bioretention soil media placed within bioretention units along Third St.

A 450 mm – 600 mm thick layer of engineered filter media mix (see **Table 7**) was placed on top of the clearstone bedding material with geotextile separating the two materials. This was to avoid bioretention soil media from migrating into the clearstone and filling available void space within the clearstone. **Table 7** demonstrates the composition of the engineered bioretention soil media.

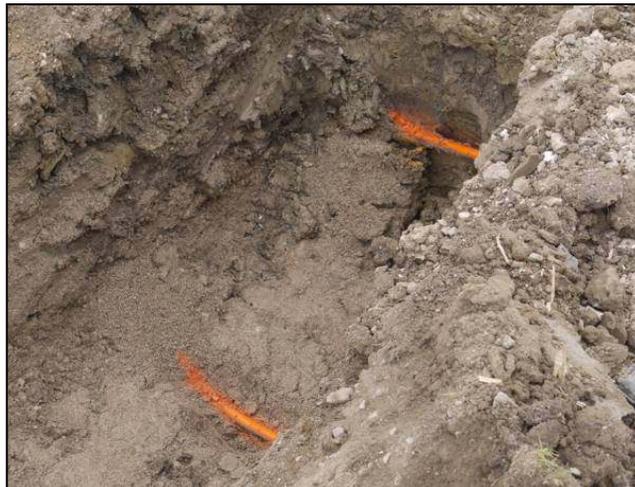
Figure 36 - Daylighting of Utilities

identified on the contractor's locate report. These utilities were generally not in service however in a few incidences, old utilities lines were used as conduits for new service lines. Such situations made identifying active utilities difficult and required caution during the construction process. To limit the potential damage to utilities, hand digging for daylighting purposes was used as a standard procedure during the construction.

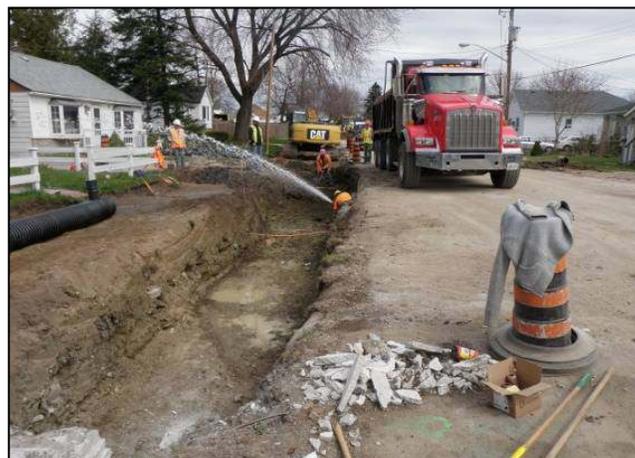
Figure 37 - Damaged water service line

Although all reasonable actions were taken to avoid damaging utilities, on several occasions utilities were damaged and had to be repaired. Repair costs were incurred by the contractor.

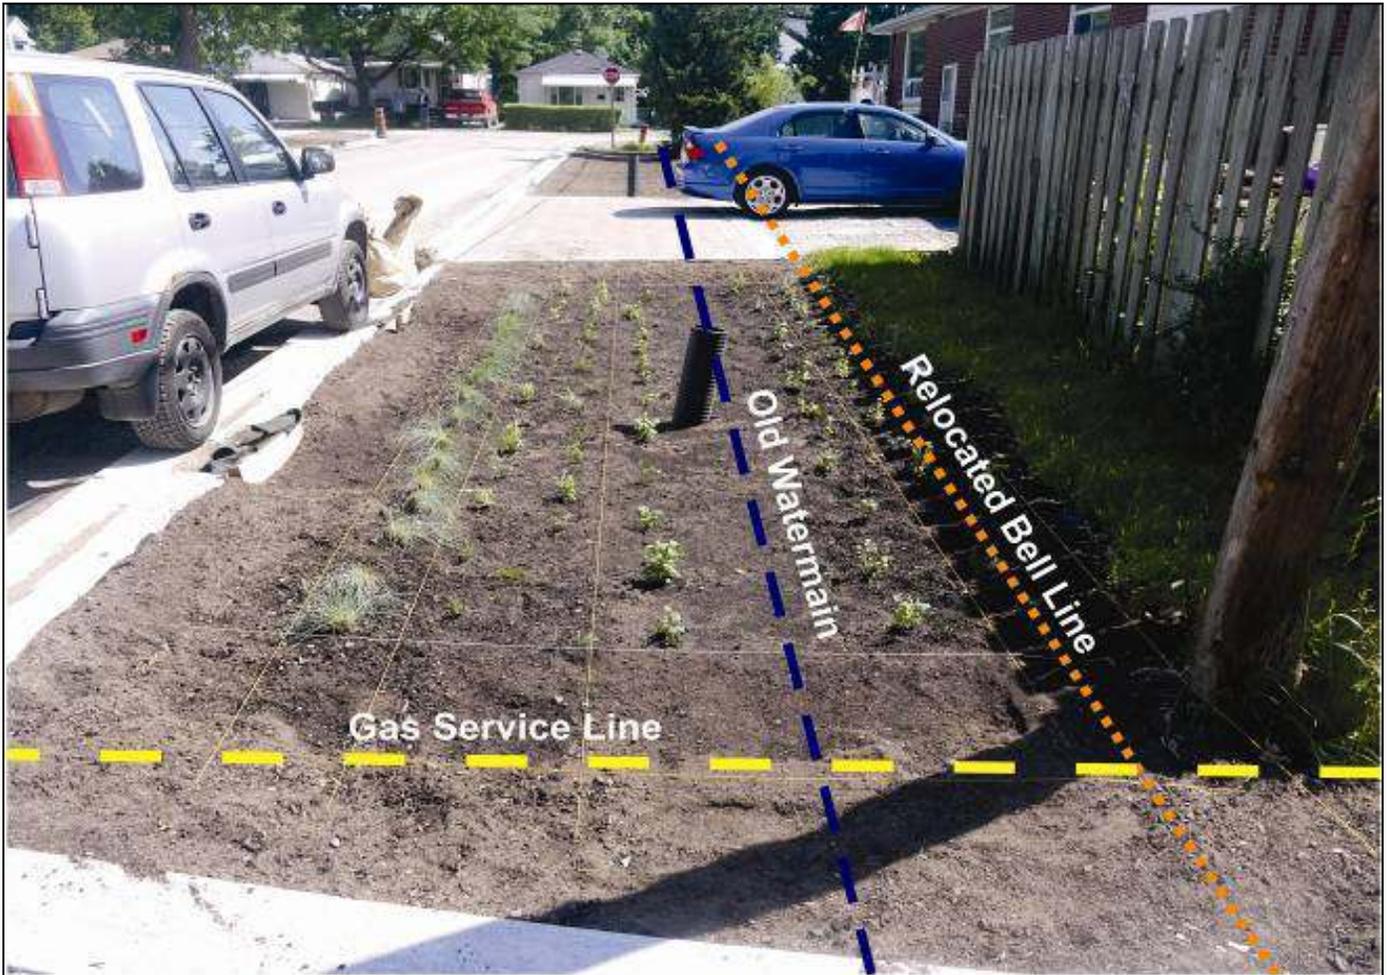
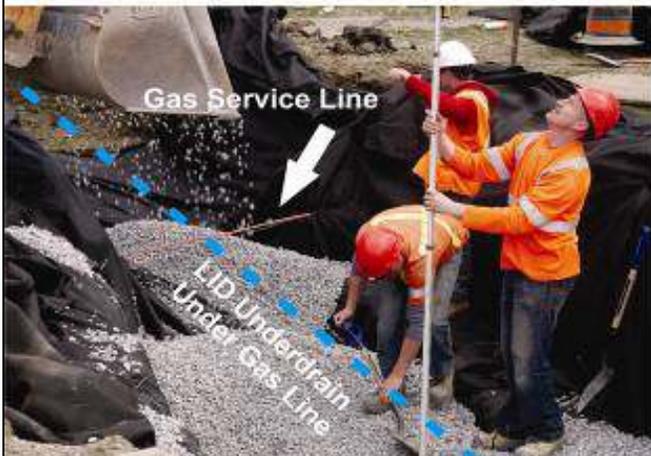
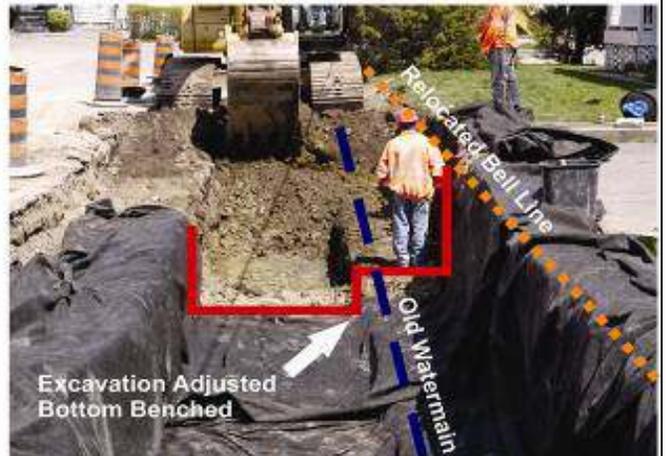
Figure 38 - Examples of utilities being avoided or accommodated

In situations where utilities interfered with the proposed design, design elements were revised to either avoid or accommodate the utility of concern.

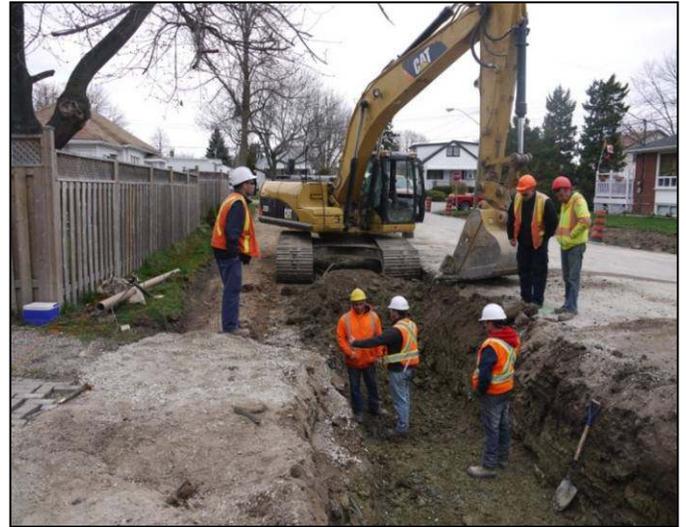
Figure 41 – Over-excavation of the bioretention unit trench by the contractor to avoid utilities

In order to avoid utilities and other obstacles, the contractor had to alter the extent of excavation either through narrowing, shallowing, deepening or widening the limits of excavation depending on the location of the obstruction. This was generally accepted as long as the final excavation would accommodate the necessary water quality storage volume specified for the design. This was accomplished by compensating for the change in excavation in subsequent sections. For example, if a section of the excavation was narrowed by 0.5 m for over a 10 m length in order to

avoid a utility, the subsequent 10 m was widened by 0.5 m to compensate.

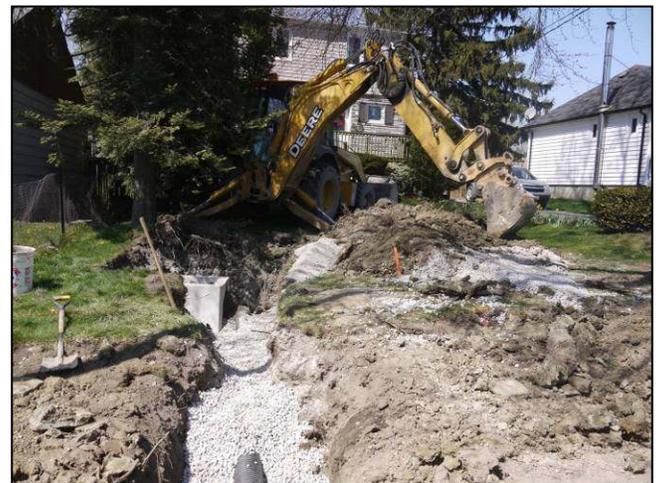
Figure 42 - Installation of provisional catch basin within resident front lawn

As part of the tender documents, provisional lot drainage was added for cases where surface drainage from resident's lots could not drain overland to the bioretention units. During the beginning of the construction, the project team and contractor identified lots which may have surface drainage issues. Following discussions and permission from the residents, surface inlets were installed on private property to collect local lot drainage and discharged to the bioretention unit underdrains.

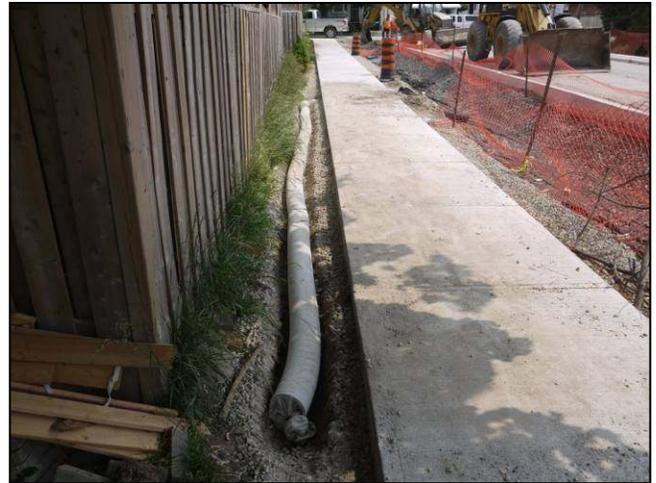
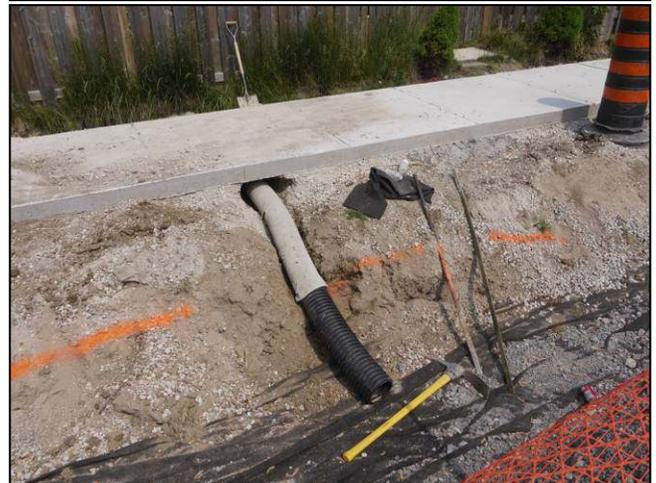
Figures 44 + 45 - Installation of subdrain adjacent to sidewalk (top) and subdrain outlet to bioretention unit (bottom)

As such a subdrain was installed along the lot side of the sidewalk to capture local drainage and discharge it to the bioretention unit.

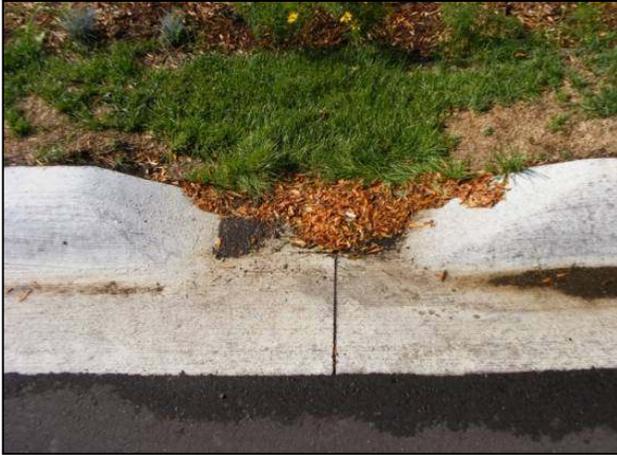
Figure 46 –the sod at the curb cut inlets was too high following construction, creating a barrier for stormwater to enter the bioretention units.

During the installation of the sod material, the contractor and designer expected much more settling and compaction of the bioretention soil media to occur. In effect, the sod acted as a barrier to runoff flowing through the curb cut inlets. During larger rainfall events a certain portion of runoff would bypass the inlets as a result. To rectify the deficiency, sod sections near the inlets were removed, soil heights adjusted and the sod reinstalled.

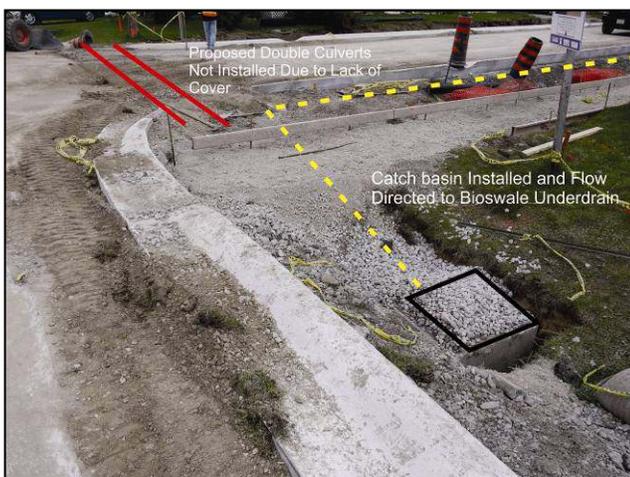
Figure 47 – Installation of required catch basin

A set of double culverts at the intersection of Meredith Ave. and Third St. were designed to convey drainage from the lots north of Third St. down Meredith Ave towards Lakeshore Blvd. During construction it was determined that an insufficient amount of cover would exist over the culverts should they be installed. Design calculations were revisited to determine if the underdrain system of the bioretention units had sufficient capacity to accept the addition drainage area from the north. With capacity available, a catch basin was installed at the end of the Meredith Ave drainage system to collect the addition drainage. The catch basin outlet pipe was connected directly to the bioretention underdrain.

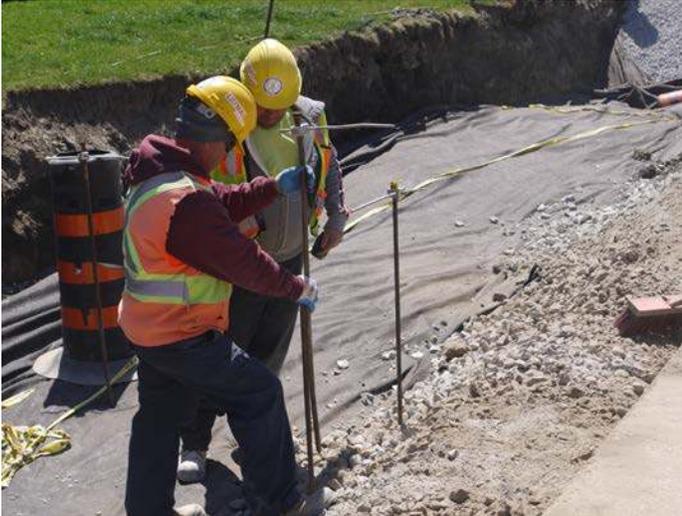
Figure 48 – Concrete subcontractor doubling up the stakes for the string line

Due to the unique sequencing aspects of LID construction, the concrete subcontractor did not expect to have a significant drop behind the curbs without any soil media. As a result, the contractor's stakes for the string line were too short and had to be doubled up in order for the string line to be at the correct height.

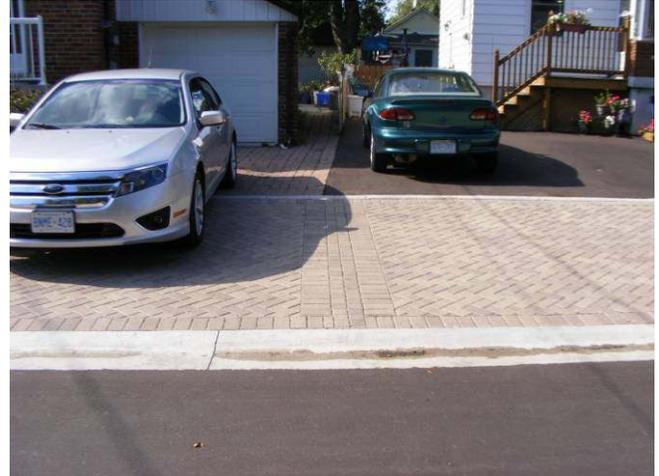
Figure 49 – Soldier course and delineation of driveways

A 'soldier course' was added during the construction phase (the perpendicular stone shown in **Figure 49**). The soldier course was not specified within the contract document; however, it was added to improve aesthetics and ease construction. This soldier course was also used to delineate property lines for residents who shared driveway entrances. This was highly valued by residents since driveway ownership was now formalized.

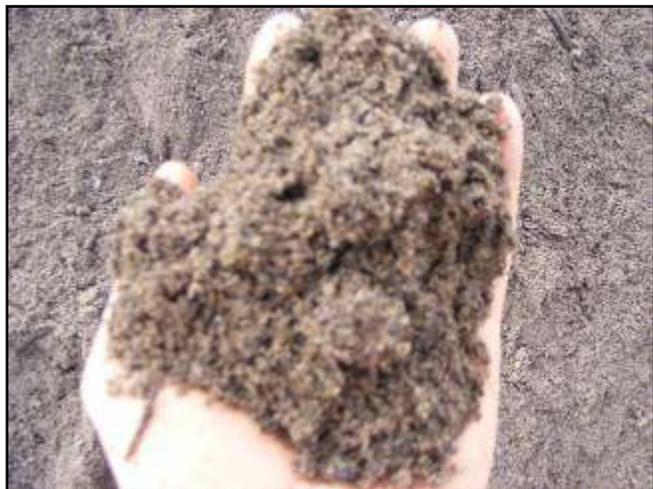
Figure 52 – Bioretention soil media consisting primarily of sand and organic material

The first samples submitted by the contractor's supplier did not meet specifications. The Lakeview design team worked closely with the contractor's chosen supplier to develop the bioretention soil media. First, hand mixed samples were submitted to the lab to get the mix close to the required portions of sand and organic prior to initiating the mechanically mixing process.

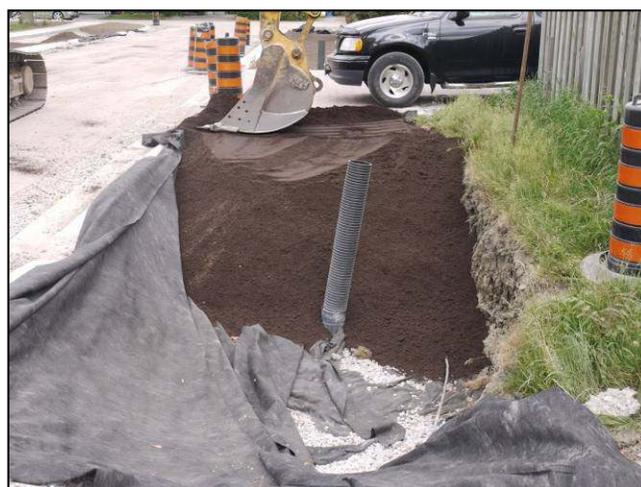
Prior to placing bioretention soil media within the bioretention units, filter fabric was installed between the media and curb base aggregate to ensure that fines from the Granular "A" material did not contaminate the soil.

Figure 53 – Installation of filter fabric to separate Granular "A" from the bioretention soil media

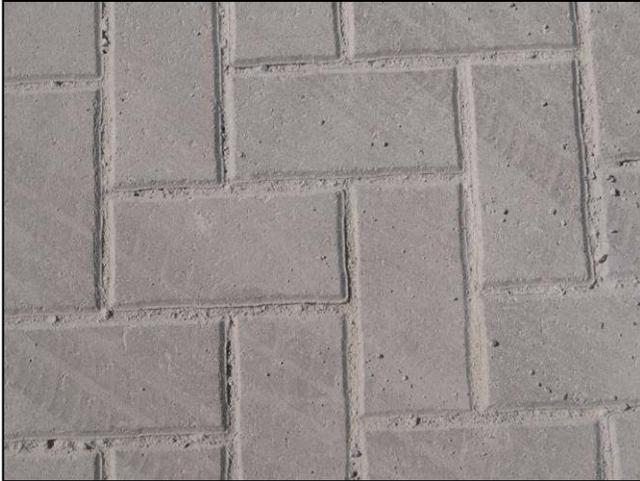
Per the contract documents and supplier installation guide, permeable pavement stones were to be tamped in place and bedding material (No. 8 stone) swept into the pavement gaps. During construction, bedding material was swept into the pavement gaps before tamping. Excess bedding material left on the permeable pavement was pulverized by the plate tamper, filling the gaps of the pavers with ultra-fine material.

To address this issue, the fine material was removed via a vacuum truck and disposed of. The gaps were subsequently filled with chip stone to ensure free drainage was provided.

Figure 54 – Gaps of permeable pavement filled with fines from tamping activities

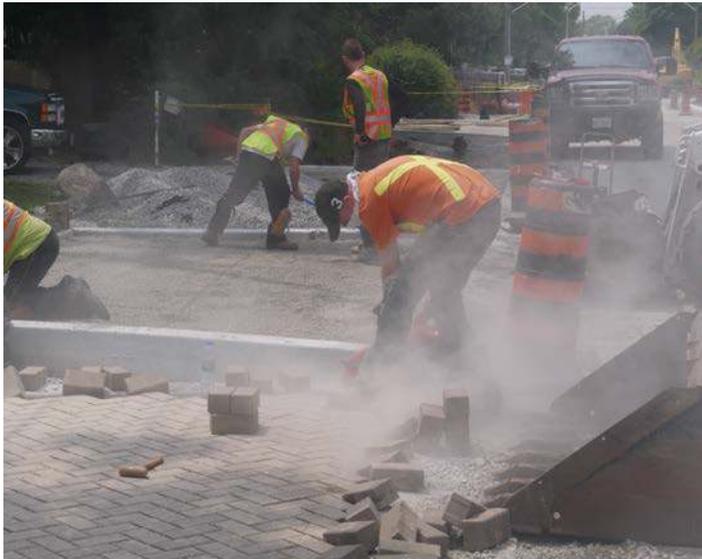
During placement of the permeable pavers, a significant amount of fine dust was created by the cutting process when the contractor was creating the soldier course. It was then requested that the contractor cut pavers away from the infiltration area or use a sacrificial piece of geotextile laid on the permeable pavers during cutting.

Figure 55 – Fine dust during cutting of permeable pavers

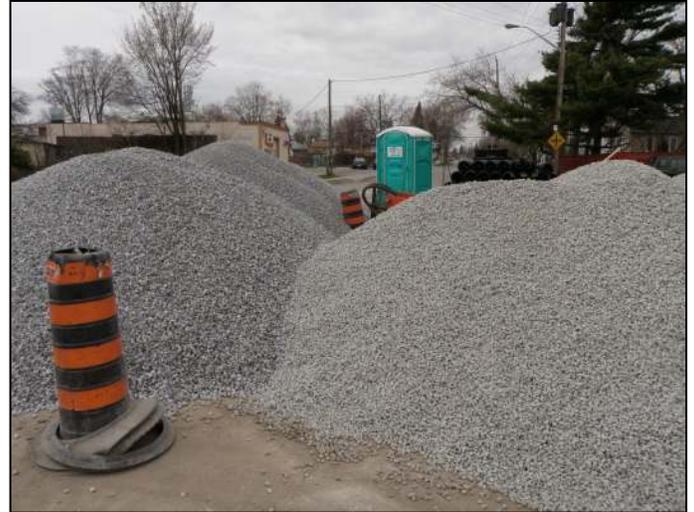
During construction, clearstone supplied to the site did not meet the specification detailed on the drawings which stated that double washed stone was to be provided. The first load supplied to the site consisted of single washed stone. Although seemingly a very minor detail to enforce during construction, the difference between the two types of material are quite distinguishable.

Figure 56 – Double washed (left) vs. single washed (right) clear stone. Specs called for double washed
