Lakeview Neighbourhood

Road Right-of-Way Retrofit

Project Objectives, Design and Performance

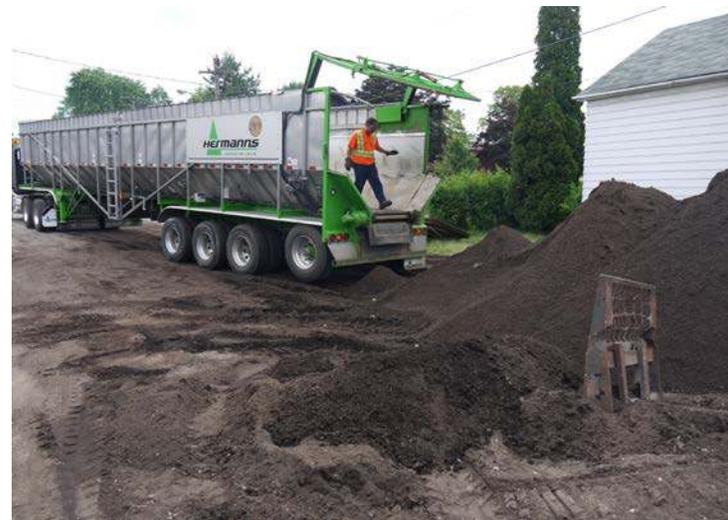
Sequencing and stockpiling material on site was also critical to successful construction. When storage areas are moved because materials are delivered with too much lead time, chances of contamination increase significantly. Materials were not moved as it was stressed how crucial it was to have infiltration areas free of contaminated materials.

Figure 57 – Bioretention soil media delivered to one of the storage areas

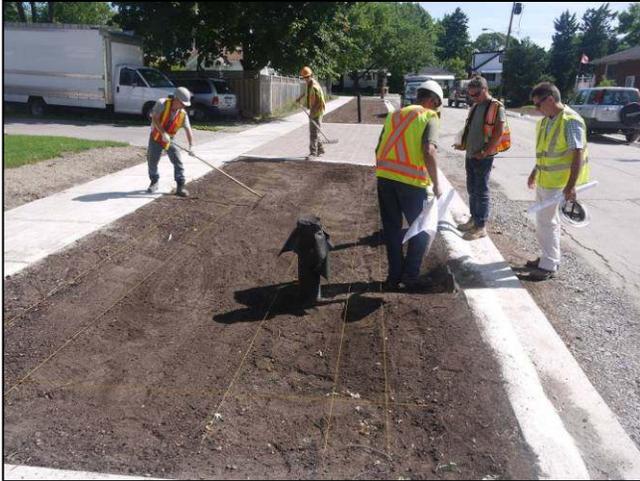
During the planting phase, staff from the landscape architect was on-site directing and supervising the planting installation and quality of the material delivered to the site. The month of June 2012 was an exceptionally hot month, which sustained a prolonged drought period following the installation of the plant material. It was prudent during the remainder of the summer that the contractor consistently watered the plant material to ensure survival.

Figure 58 – Installation of planting material

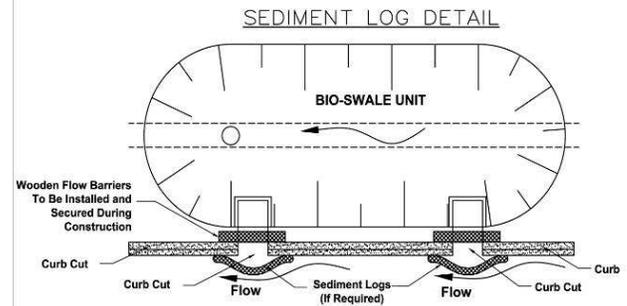
An erosion and sedimentation control (ESC) plan was included with the design drawings. It consisted of catch basin inlet controls, filter socks and other LID specific ESCs.

Figure 59 – Sediment Logs Detail for Lakeview

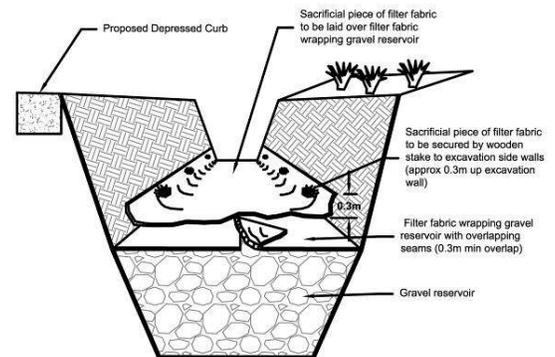
Prior to the installation of the bioretention soil media and paving of the road surface, filter cloth wrapped wooden boards were staked behind curb cuts and sacrificial pieces of filter cloth were installed to protect the bioretention unit infrastructure from contamination. The sacrificial pieces of filter cloth were installed over the cloth wrapped clearstone reservoir of the bioretention unit. This filter cloth was removed prior to in the installation of the bioretention soil media including any contaminating fines which was captured (See Figure 60).

Figure 60 – Conceptual of the sacrificial piece of filter cloth used to protect bioretention units.

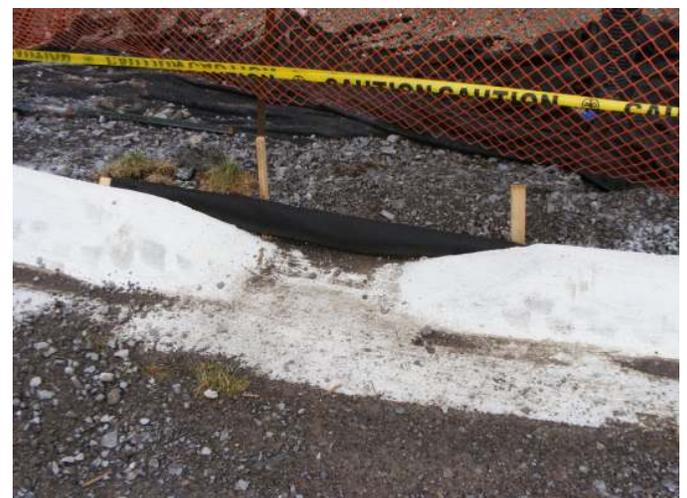
Figure 61 – Filter cloth wrapped wooden boards installed at bioretention unit curb cuts

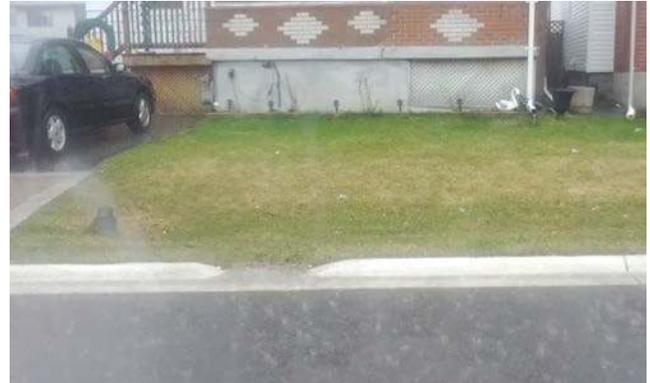
conducted during a precipitation event. The inspection revealed that several of the inlets were being bypassed. Because of this, insufficient stormwater runoff was able to enter the bioretention units at the curb cuts (shown in the following figure).

Figure 62 – Bypassing of bioretention units during a rainfall event

To better understand this issue, CVC had an as-built survey completed in the summer of 2013. The as-built survey confirmed that at some of the curb cut inlets and grade changes were insufficient to encourage the runoff to enter the bioretention unit. The as-built survey also revealed that grade changes didn't allow for positive drainage within some of the bioretention units, and that the ponding depths were not to that specified in the design.

Further investigation revealed that the primary issue with the inlets was that the sod located at the inlets was at too high an elevation, blocking flow into the bioretention cell. This was caused by bioretention soil media not settling as much as expected by the designer and contractor.

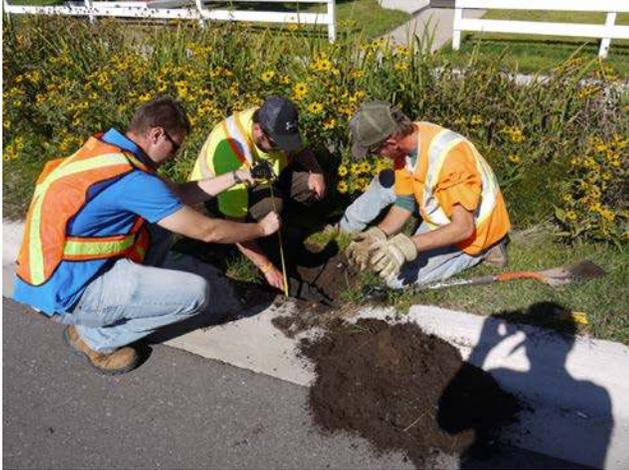
To address the issue, the sod was lowered by a minimum of 25 mm below the curb-cut invert to ensure positive drainage into the bioretention unit. Specific activities involved in adjusting the grade within the bioretention units included:

1. Temporary removal of plants
2. Media re-grading - grading, surveys, and string lining by the landscaper
3. Fine grading
4. Re-planting plants
5. Final survey of the start and stop of the planting beds

Figure 63 - Adjusting inlets by removing excess media

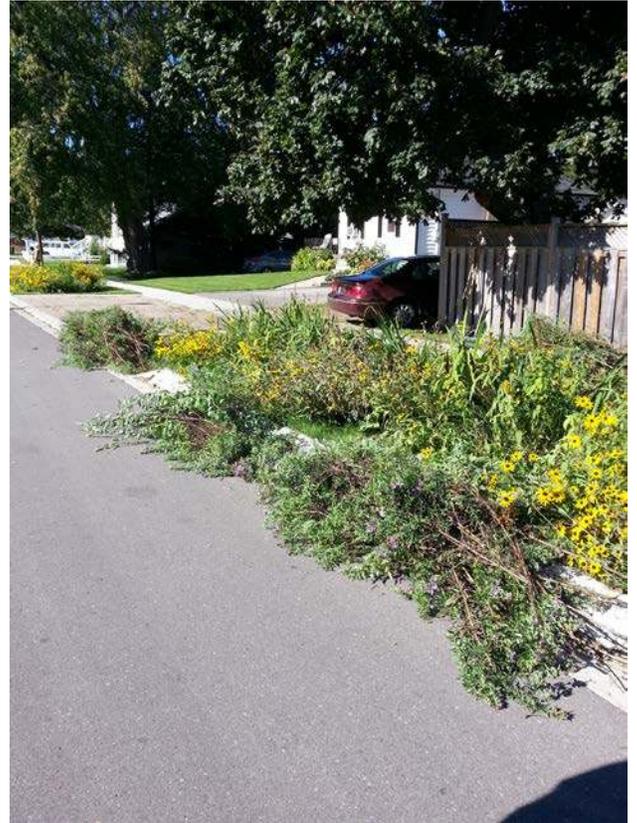
In September 2013, contractors removed all the green headed coneflower and New England aster from many of the bioretention units and disposed of the material off-site. Unattractive grasses were also removed. The contractor replaced them with butterfly weed, black-eyed Susan, bee balm, obedient plant, and blue flag iris. These plants were chosen because they were already planted in the gardens, residents liked them, and they had established well. The bioretention units were then mulched and watered. For more information about regular landscaping maintenance that took place

Figure 64 - Overgrown New England Asters that were removed from the bioretention unit.

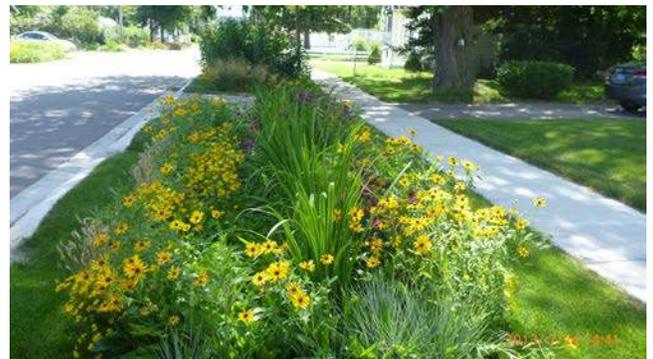
Figure 65 - Plants chosen to replace green headed coneflower based on this bioretention unit. Irises in the center, black-eyed Susans, and bee balm

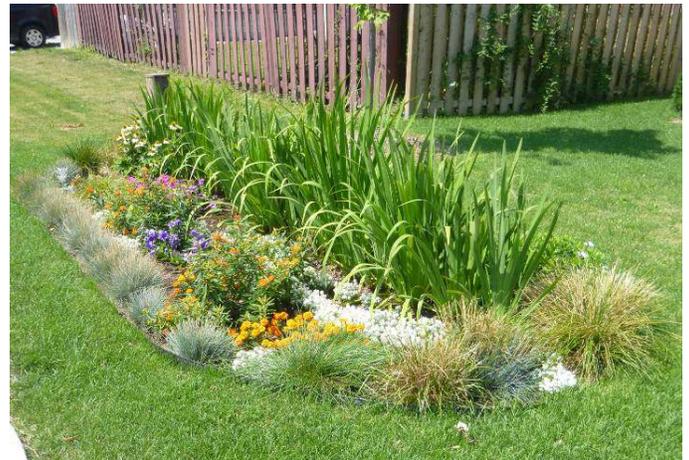
Feedback from PICs indicated that local residents were willing to undertake 2-4 hours of maintenance per month. However in reality, the level of maintenance done by each homeowner varied. Residents were encouraged to undertake maintenance activities such as weeding, pruning and general clean up. Some residents were renters or away for most of the summer so they maintained their bioretention units and permeable pavement less frequently. The amount of maintenance needed also increased if the landscaped option was chosen instead of turf for the bioretention unit.

Figure 66 - Example of a boulevard bioretention feature that is being well-maintained by the homeowner

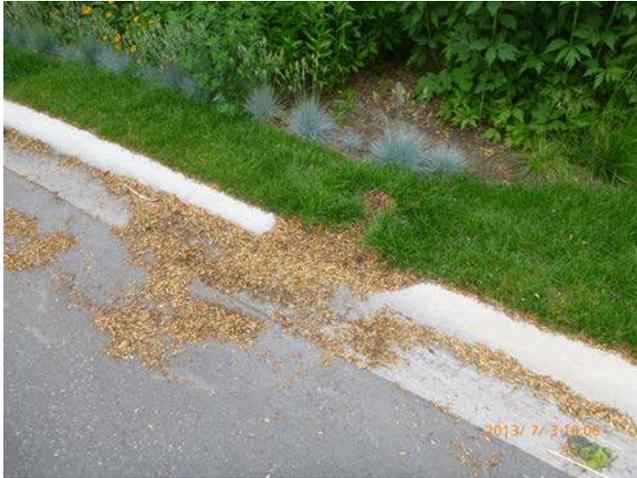
Figure 67 - Accumulation of debris in the inlets from nearby tree

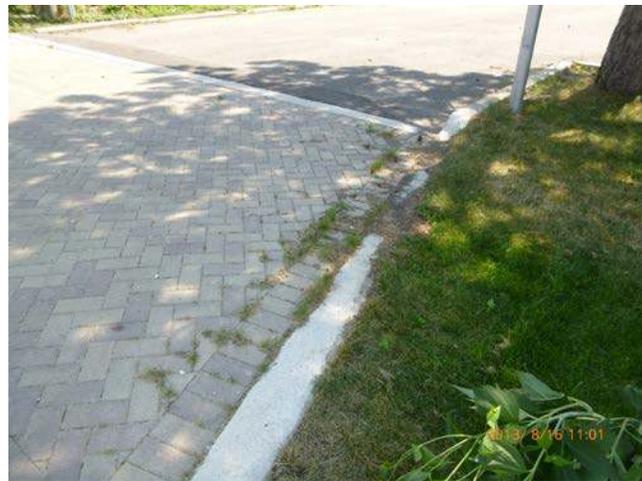
Figure 68 - Sediment build-up and subsequent weed growth in between permeable pavers

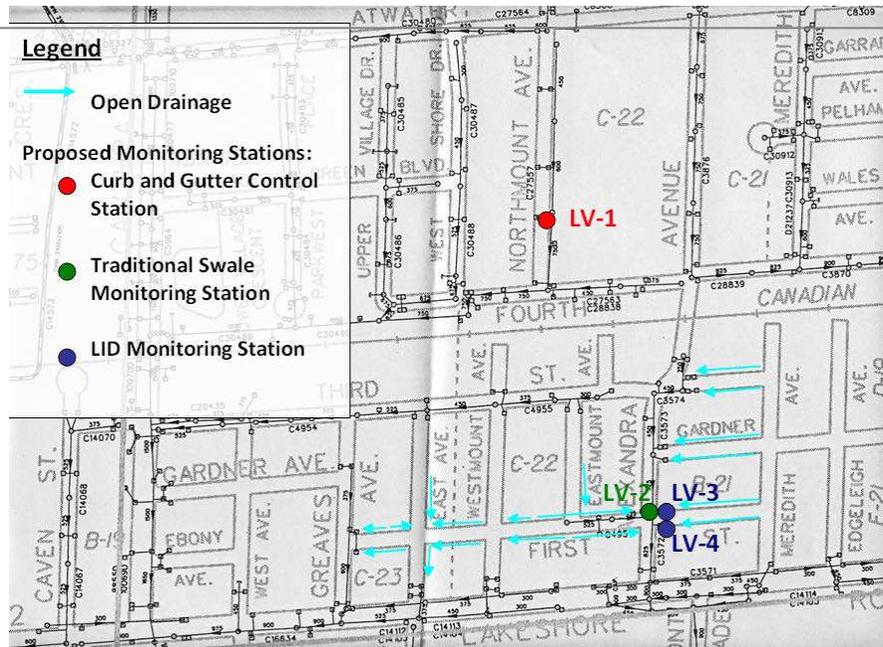
Four monitoring stations have been installed for infrastructure performance assessment purposes. Currently, performance assessment efforts have been focused upon First Street only. Two LID performance assessment stations have been implemented at the downstream extents of the LID infrastructure for both the north and south side of First Street. A control site located on a nearby street with a traditional curb and gutter drainage system is being assessed as well as another station monitoring a swale (traditional roadside ditch) system. The individual performance assessment locations are as follows:

- Location 1 (LV-1):** located on Northmount Avenue north of Fourth Street. The street has curb and gutter drainage and will be used as a water quality control site. Four catch basins collect water from this street and convey it to the sampling manhole.

Figure 69 - Performance assessment locations within the Lakeview neighbourhood

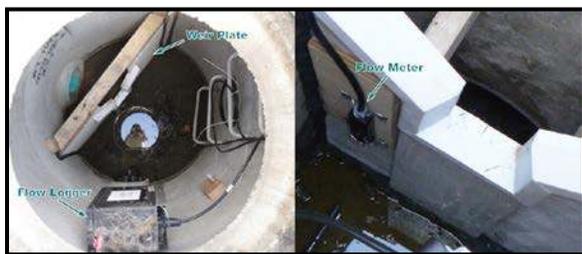
Outflow from the underdrains of the bioretention units and permeable pavement driveways are measured using a stage-based method with weirs and water level loggers.

A compound weir plate has been installed and calibrated by a consultant at all four performance assessment stations. An ISCO 4150 or Hach FL900 flow meter was installed in each manhole with the probe secured to the weir to make certain that accurate water level measurements are recorded. The flow meters are set to record water levels at 10-minute intervals.

Figure 70 - Flow monitoring equipment and compound weir

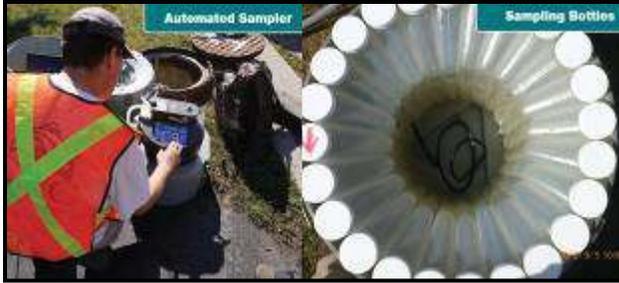
A minimum of ten precipitation events will be sampled per year from three of the performance assessment locations (LV-1, LV-2, & LV-4) with an ISCO 6712 Automatic sampler. The samplers are connected to the water flow loggers and triggered when a predetermined water level is recorded by the flow logger. The monitoring program will continue until a minimum of thirty precipitation events have been collected.

Figure 71 - Water quality sampling

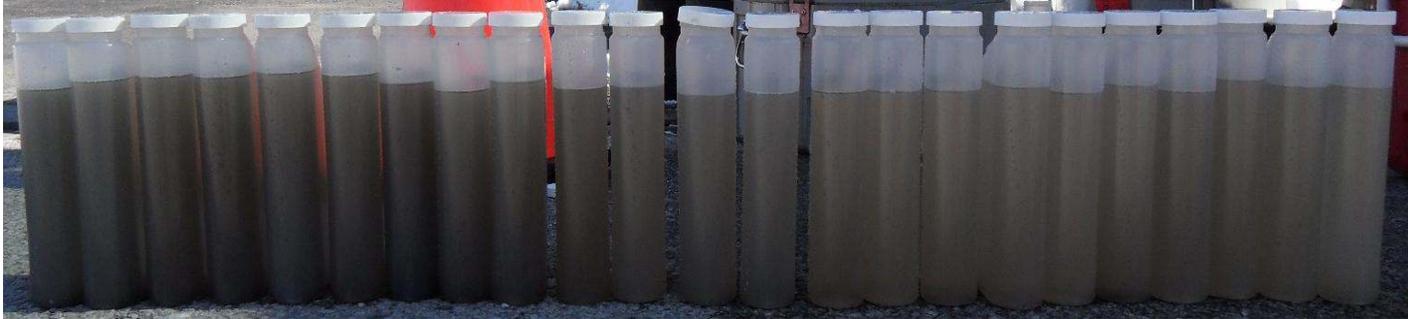
Figure 72 - Sampling bottles depicting the first flush, first six bottles from left and composite samples

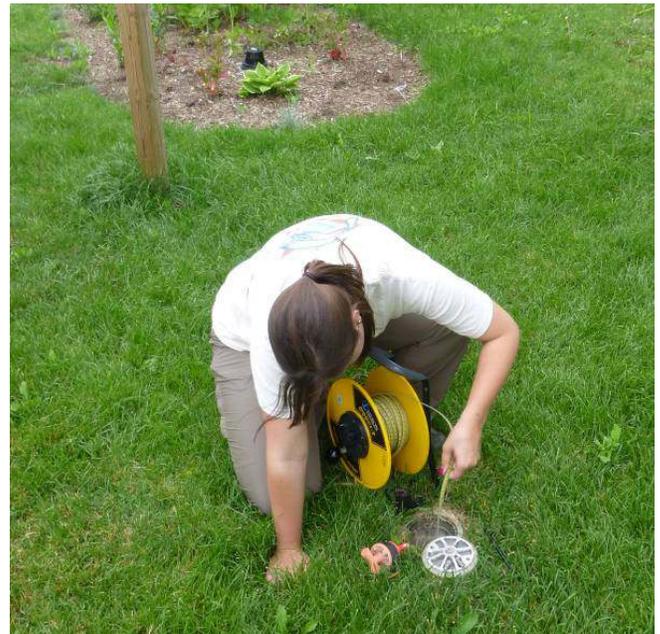
To assess surface water infiltration, two piezometers were installed within the First Street bioretention units during construction. The piezometers are located near monitoring stations LV-3 and LV-4. HOBO U20 continuous water level loggers were placed in the piezometers to measure variations in water level throughout the profile of the bioretention units. Level readings are then compared to rainfall amounts to calculate surface water infiltration in the cells and determine the drawdown time required for stormwater to fully infiltrate through the bioretention units.

Figure 73 - Manual level measurements are taken to verify the accuracy of readings and level logger is calibrated as needed
