## Overview

Credit Valley Conservation's (CVC) head office is located on Old Derry Road in Meadowvale Conservation Area in Mississauga.

The new addition to CVC's head office is registered with the Canada Green Building Council and is certified LEED Gold. The building features numerous low impact development (LID) practices such as a permeable pavement parking lot with grass swales and a rainwater harvesting (RWH) system supplying non-potable water to toilets, urinals and outdoor hose taps.

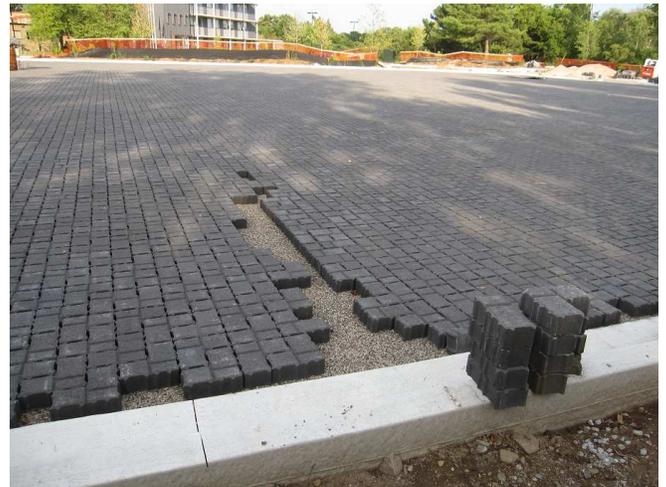
Permeable pavement expansion. Parking lot during construction

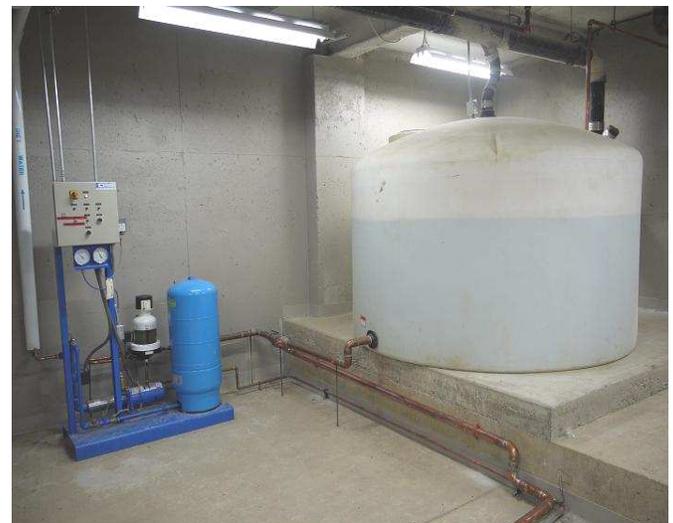
Indoor rainwater storage tank located in the basement

The RWH system uses a 5,000 litre rainwater storage tank located in the basement of the building. Rainwater from the roof is directed through interior rain leaders to a central mechanical room. All excess rainwater is discharged through the building’s storm drain, connected to an on-site wetland.

Rainwater is treated by a 100-micron particle filter.

In times when the tank is nearly empty (from insufficient rainfall or excess demands from indoor or outdoor use) a ‘top-up’ system is used to supply the tank with potable municipal water.

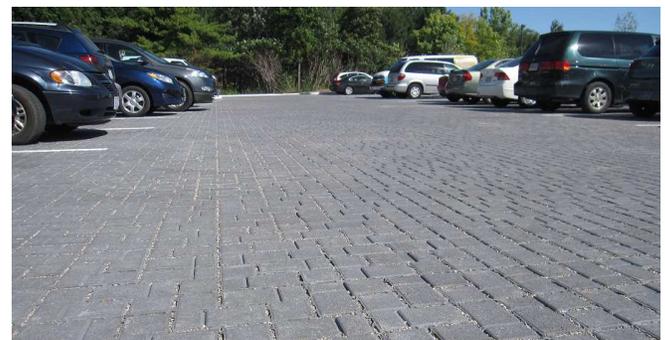
Photograph of the expanded parking lot after construction

Two permeable pavement lots were designed with different coloured pavers - one light grey and the other dark grey. The performance of these two lots will be compared over time for the amount of de-icer required. It is anticipated that the dark grey stone may experience fewer instances of black ice due to its ability to absorb more light/heat during winter months.

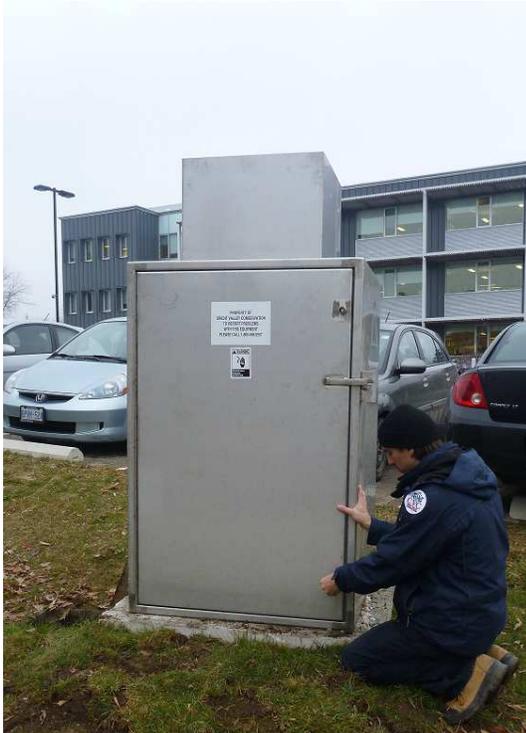
Installation of exterior housing for performance assessment equipment

Performance assessment equipment will be used to quantify reduction in stormwater runoff volume, peak flows and pollutants from the parking lot (and the site overall). It will be compared to a typical office building and parking lot without any LID controls.
